FORMOSA 46 BACKSTAY PLATE AND CHAIN PLATES

Ralph Ferges – Sola Gratia F46 San Diego, CA. USA

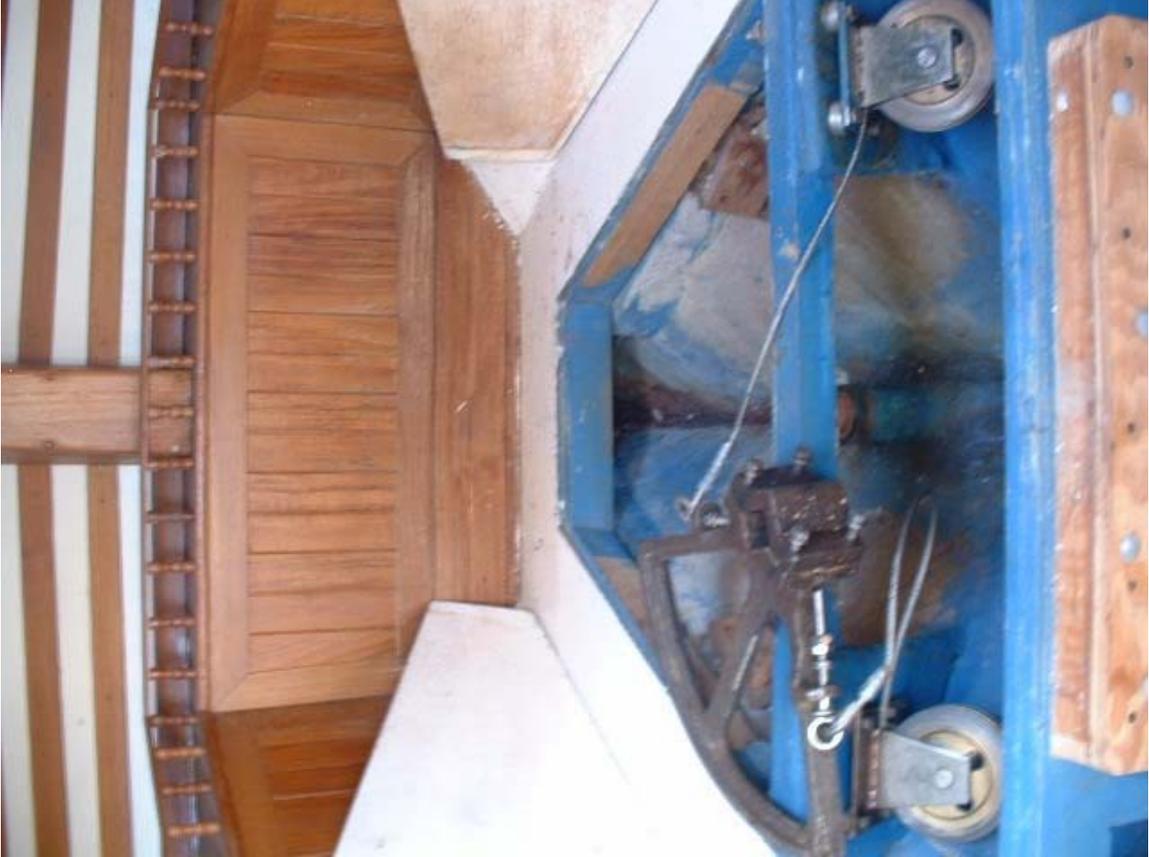
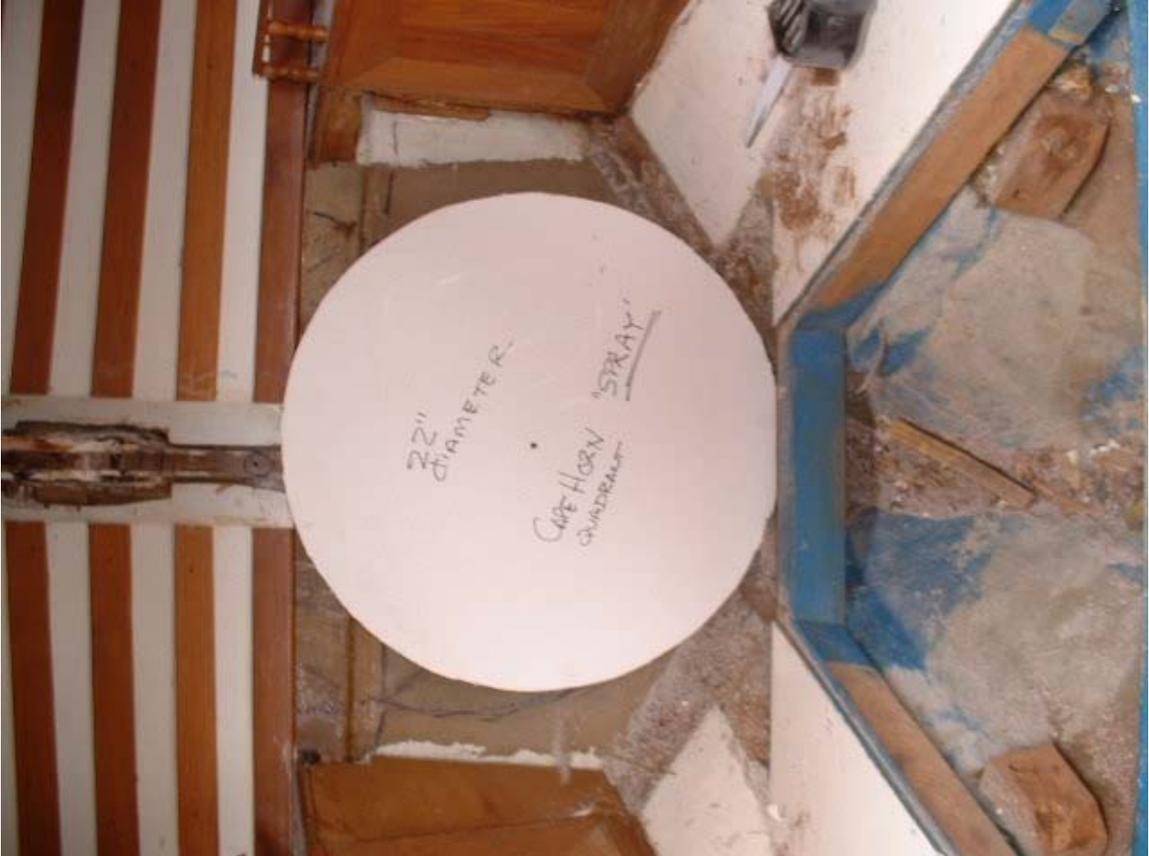
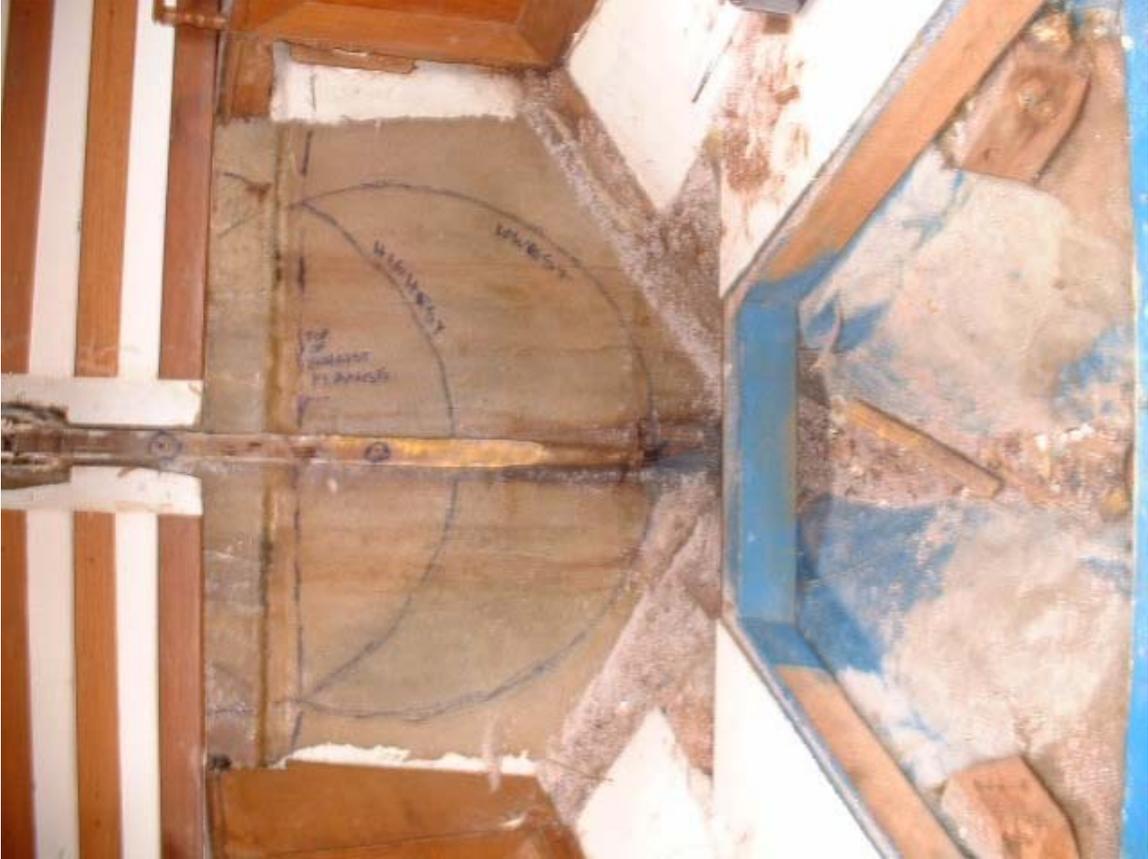
The photos of the backstay show a vertical brace that runs from under the deck, between the 2 stainless steel plates. All of this is covered with the centerline box at the aft of the cabin.

This brace is made of mahogany about 1" thick and is bonded to the transom and deck with lots of cloth and resin. It has been drilled for two bolts – wood left unsealed – to match the stays. The stay is inserted from the outside of the transom angled up towards the deck.

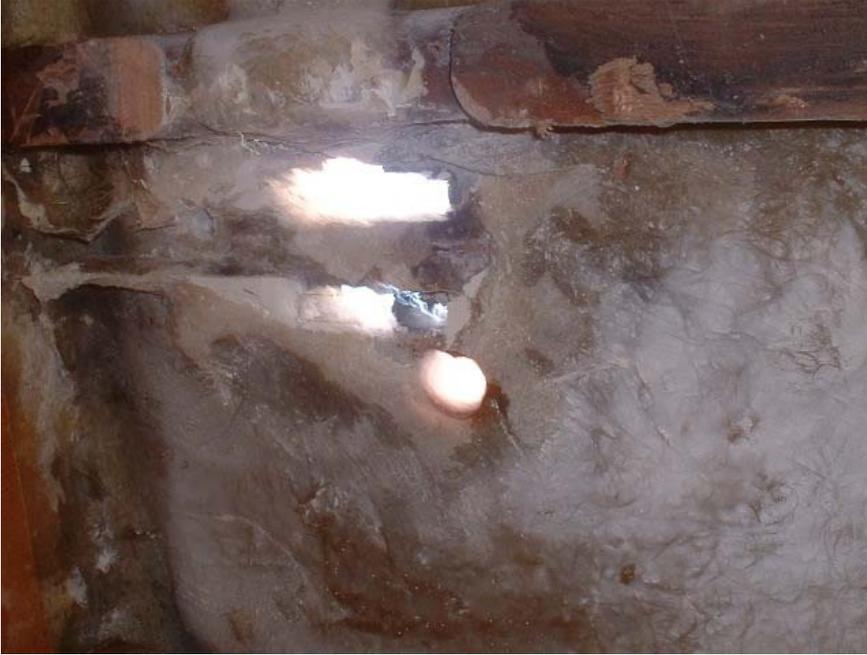
It had a large amount resin putty between the stays and the holes/slots cut into transom and some squished into the area covered by the circular external plate.

Large amounts of thickened resin – looks a lot like marine tex white – was added between the stay plates and the vertical mahogany brace and then two through bolts were inserted.

Then all of this was covered with many layers of mat, cloth and resin from the underside of the deck to the very lower portion of the vertical mahogany centerline brace.

The end result of all this is that the backstay stainless steel is imbedded into a water tight cup along with the mahogany brace. Over time water ingress at the backstays that are above the aft deck has no place to drain. Great environment for rot and SS corrosion. I gutted it all back to the hull laminates and have started over.

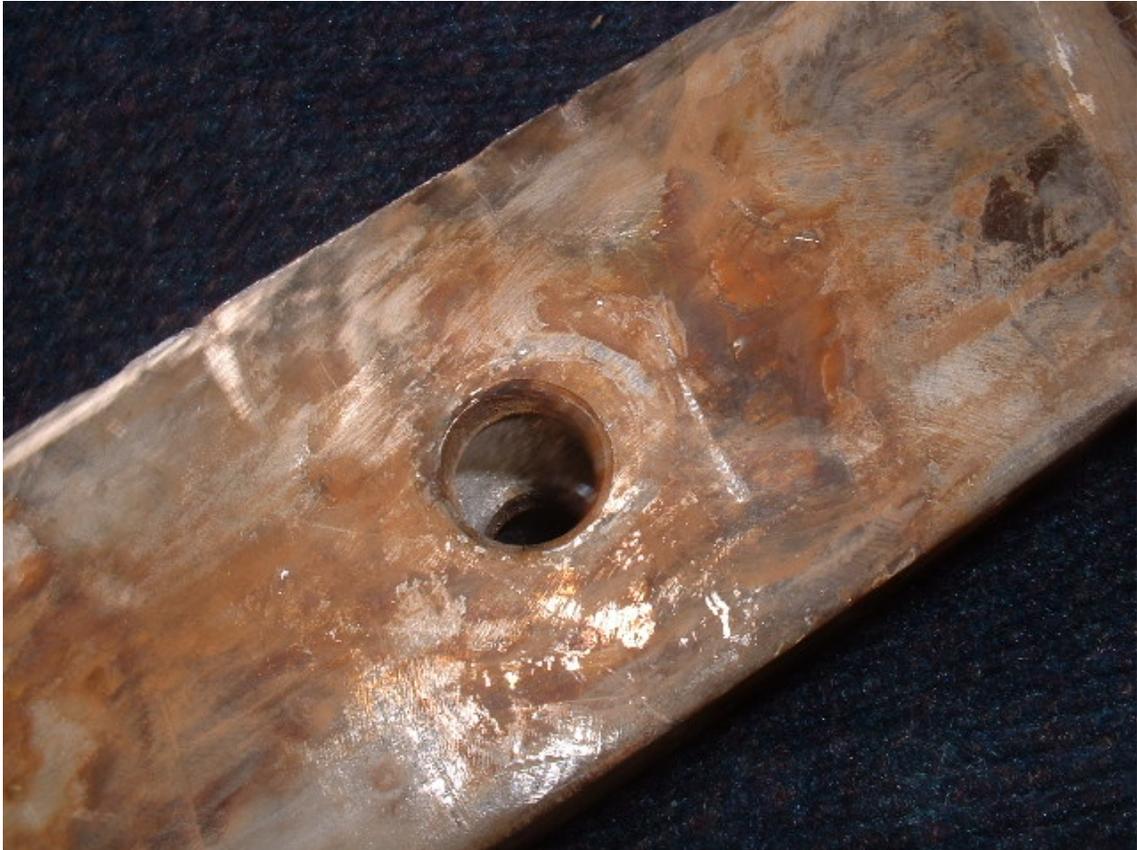
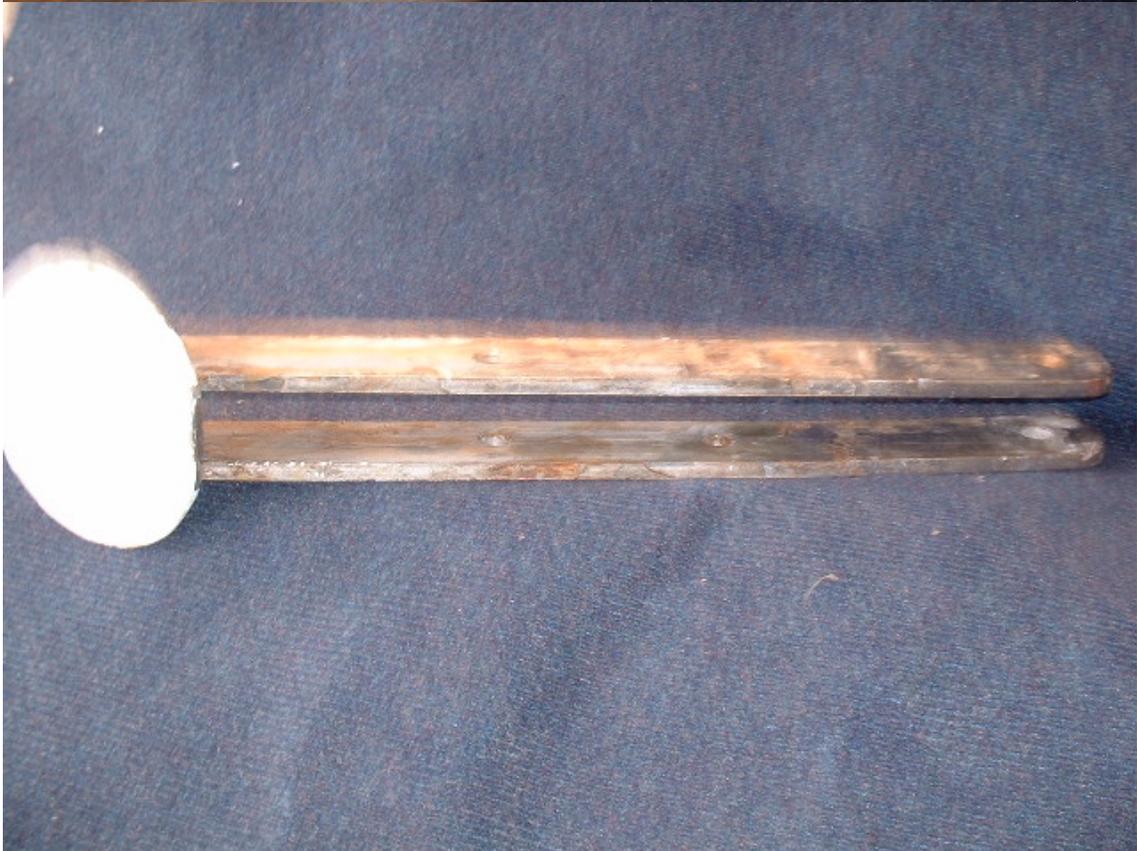
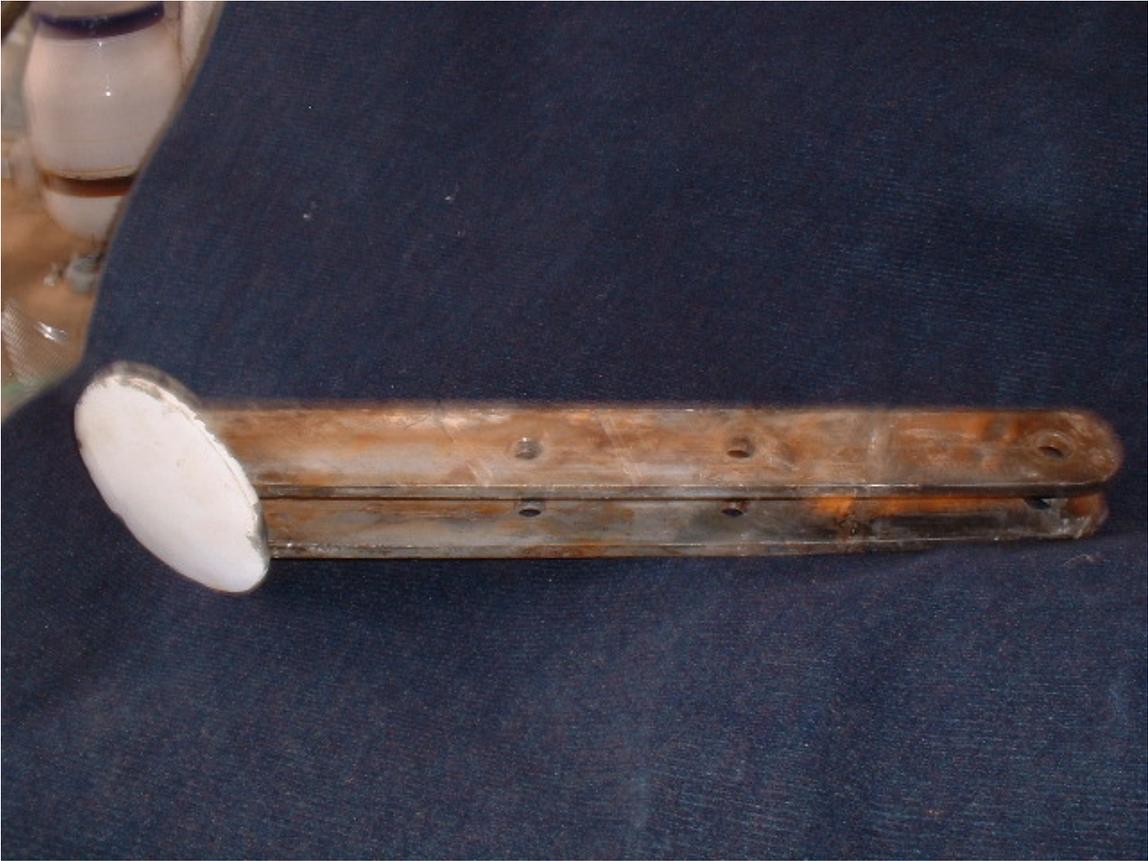
Another major concern of mine was the metal parts themselves and from the photos you can see some corrosion of the stays but more importantly to me is the attachment of the stays to the circular plate

IMHO, the welding is inadequate as the welds (TIG) are only on the outside portion of the plate/stay junction, not on the inside, are very small or thin and do not look to have penetrated much at all.

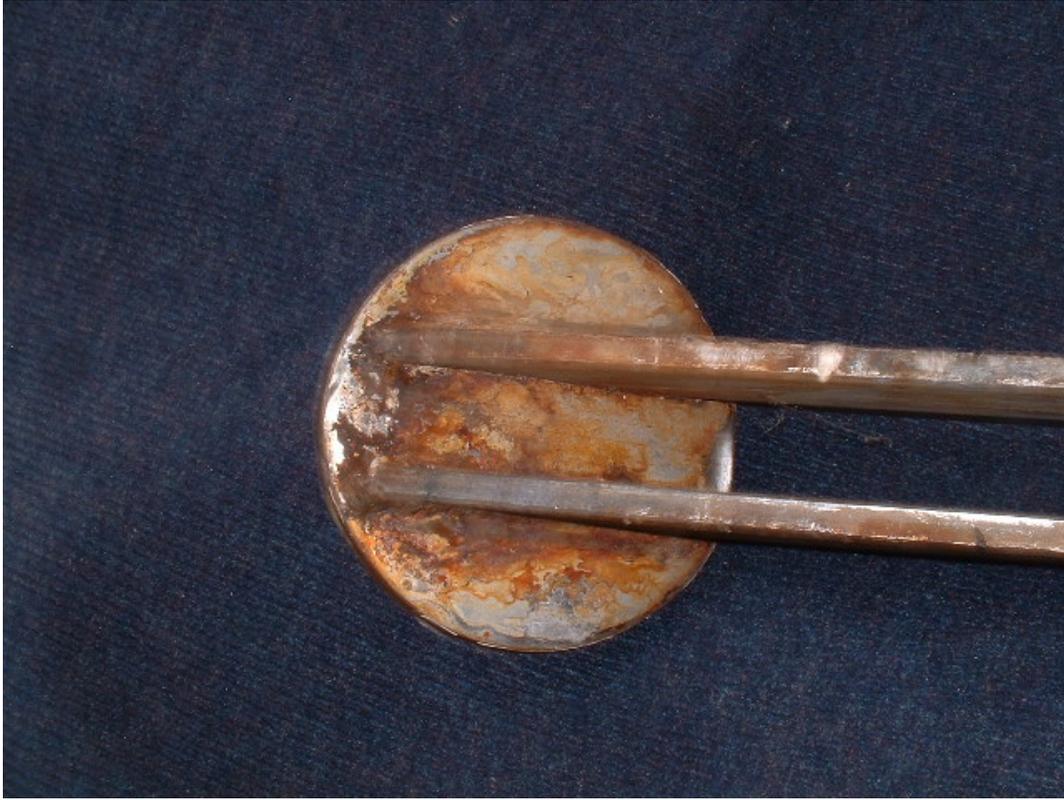
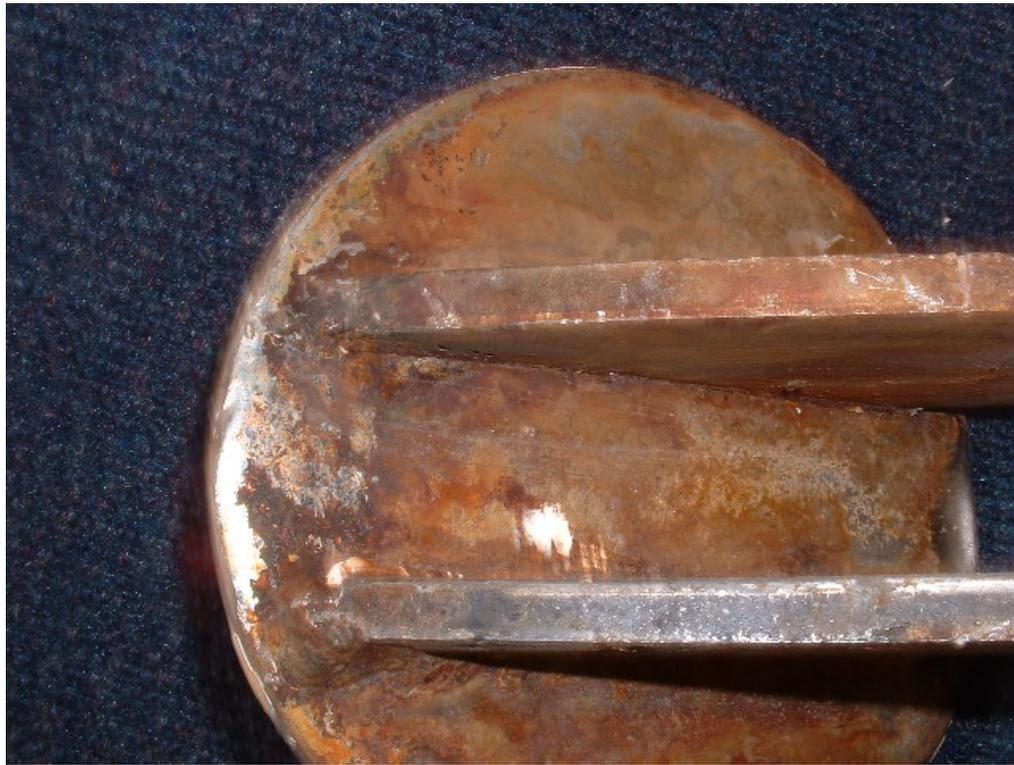
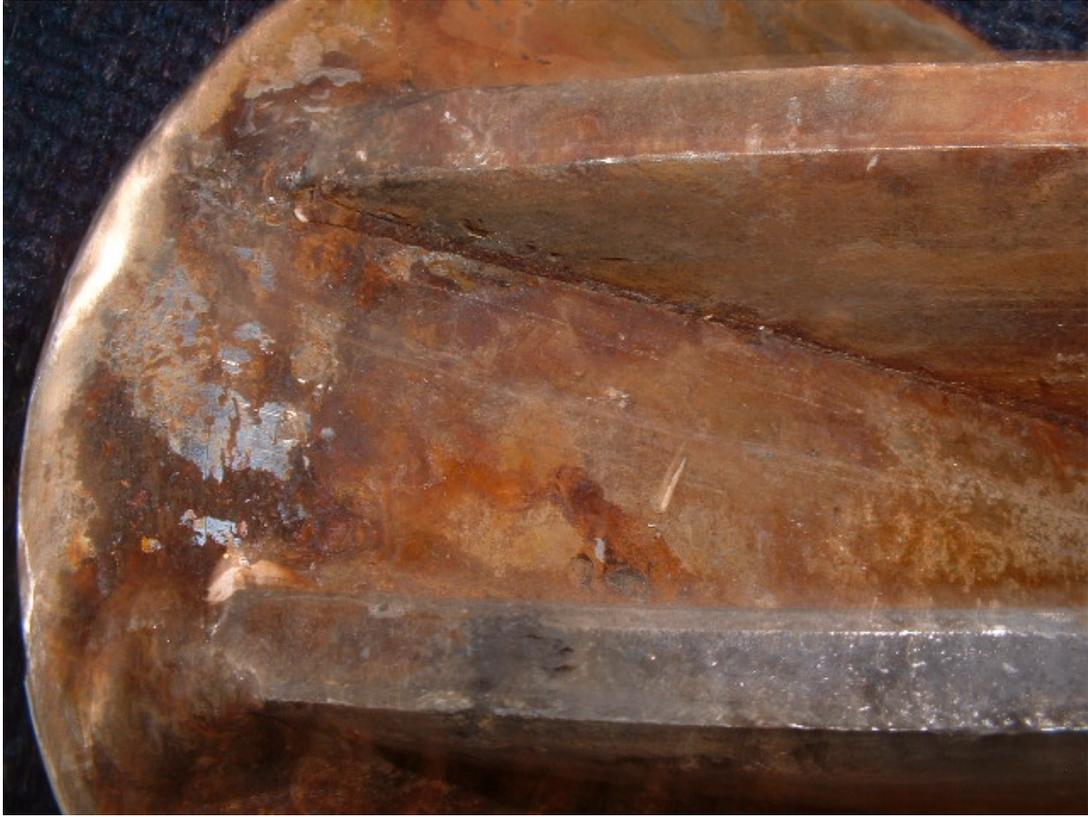
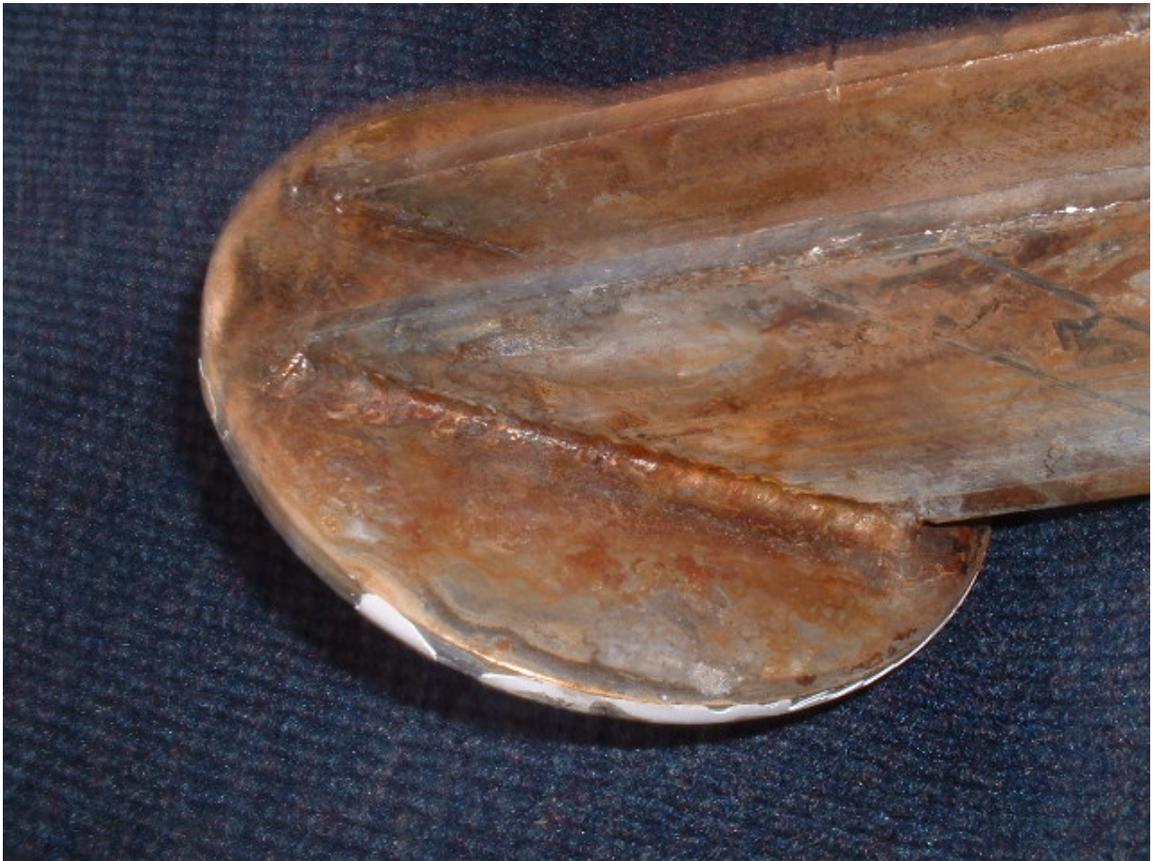
While I like the idea of using the external circle to carry some load due to all the rot in the rest of the system mine was responsible for all the load. I don't think the welds would take it as they looked like fine light duty welds you might see on a bimini or dodger frame. They need to be structural welds not just cosmetic welds.
