***s/v Beatrix* Repair, Maintenance and Improvements Log**

**January 14, 2004
To
August 8, 2020**

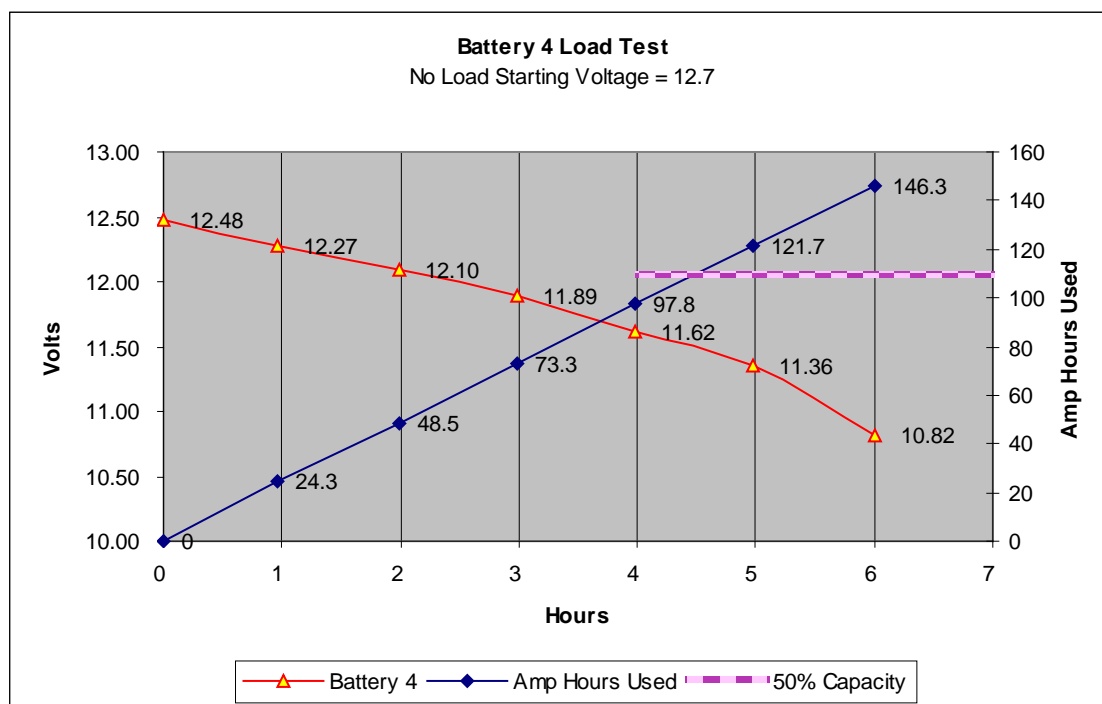
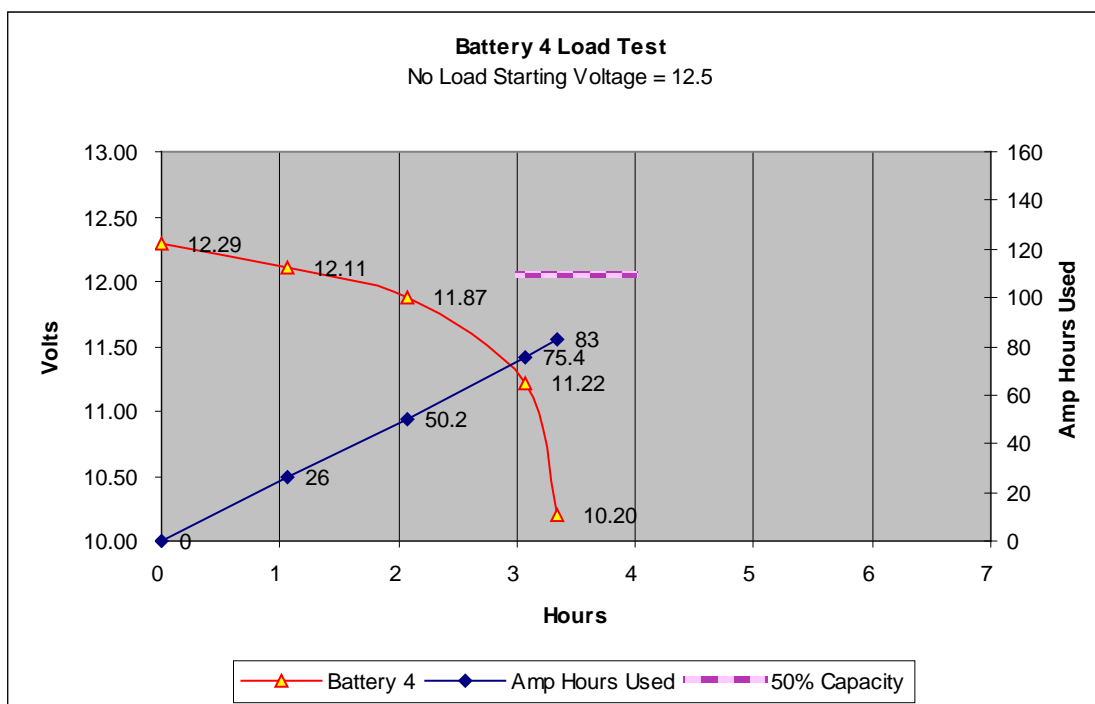
Battery problem analysis: Deep cycling of these batteries, plus parallel string degradation, has led to a decline in capacity. However, the batteries are NOT dead because a 12-hr resting voltage test is 12.7 on all 4 strings. The load tests tell this story. About 60AH is the max we can draw out of a single string, which means that if we can not let the AH get below 150 we might make these last a bit longer. Compare the Aug 2009 load test with the May 2010 load test.

We need to be more watchful of battery consumption.

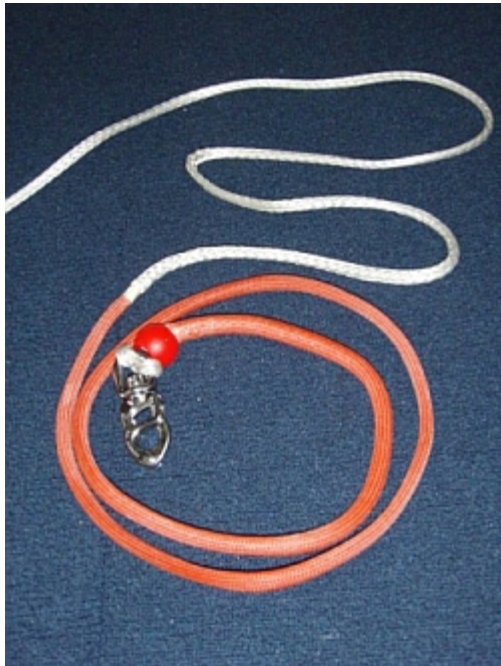
Found serious chafe in the genoa halyard that has parted the cover and one or two core fibers. The halyard is made of 7/16" Validator SKB and was installed in July 2004. We are also experiencing main halyard chafe. I am wondering if a Spectra cover and a Halyard Ball Stop would improve things. What I would like is one of Brion Toss's step-by-step diagrams for making the splice. This photo appears to be a locked Brummel with a ring-hitch, Spectra Chafe Guard and stopper ball.

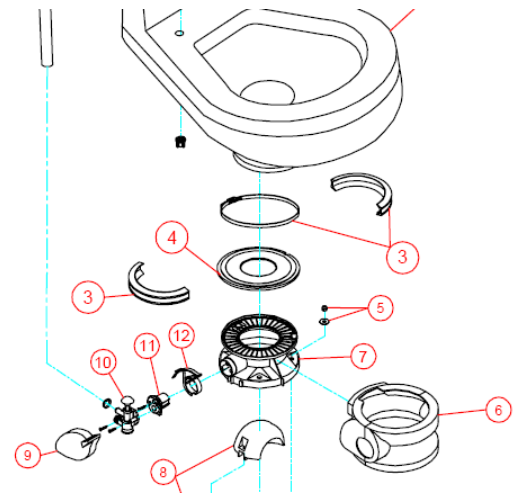
There was a ring of scale around the bottom of the toilet where it seals to the ring. I scaled it with a paint scraper and sandpaper. The ball was cleaned and sanded and polished progressively with 600/1000/1500 grit.

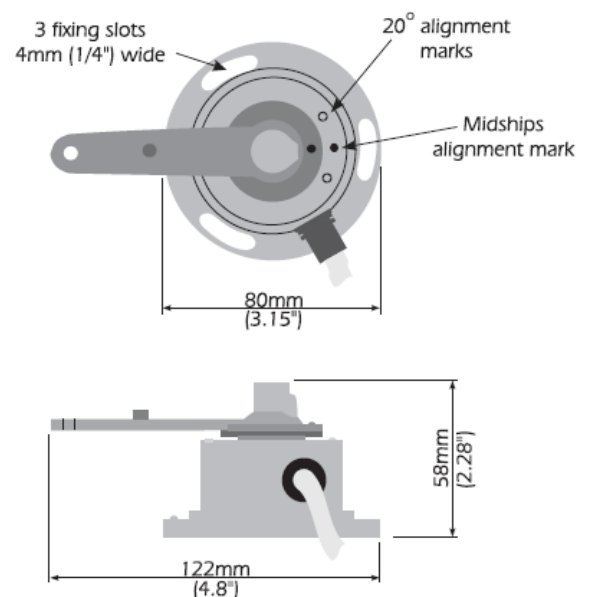
Recent major maintenance was on the autopilot after its total failure several weeks ago in the Hawkesbury River. It is odd that I did not note the failure in any of the logs. No matter, the main problem was a breakage of the Rudder Feedback Unit 930809. The plastic arm had broken off at the shaft. I do not understand why this would be unless something was in the way (unlikely) or the connecting arm

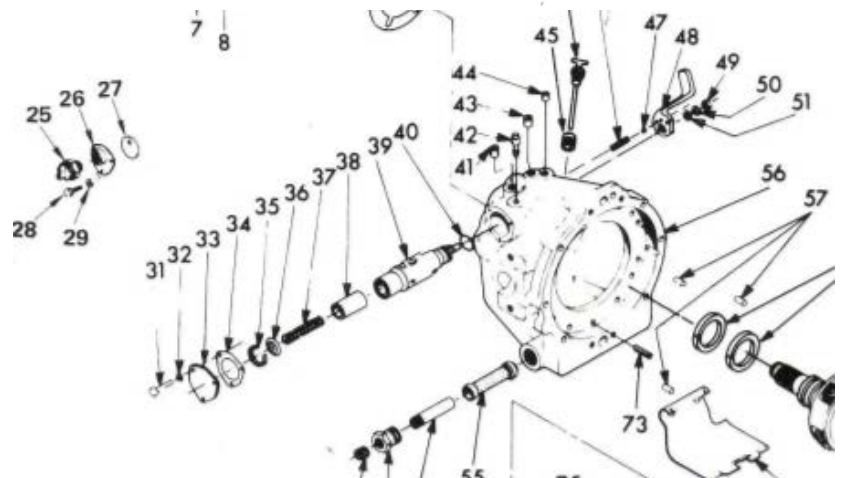
The “forward/reverse gear transmission valve” (39) is easily removed BUT DON'T LOSE THE DETENT BALL (47) when taking it apart. I did not disassemble the valve; I did replace the worn transmission O-ring. It was “flat” on the rim so hopefully the new O-ring will stop the leaking of ATF.

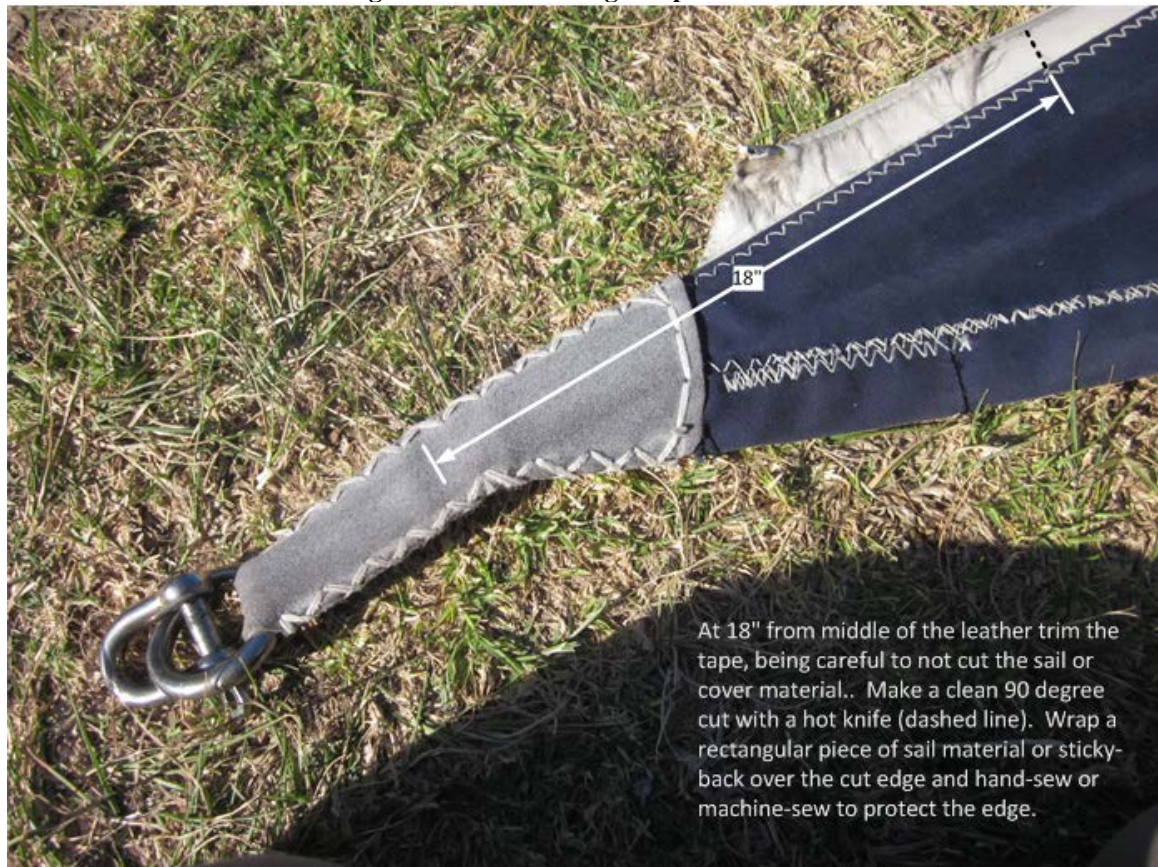
Genoa fix to shorten the luff length and fix the damaged tape.

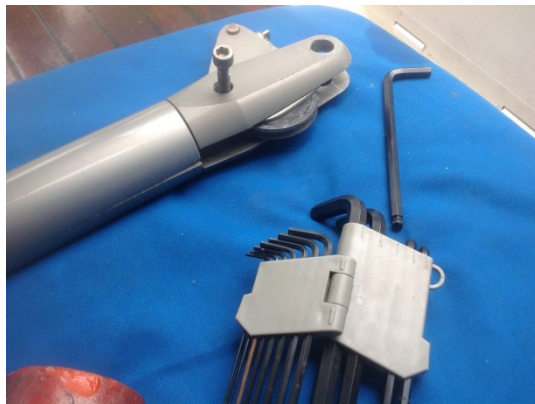
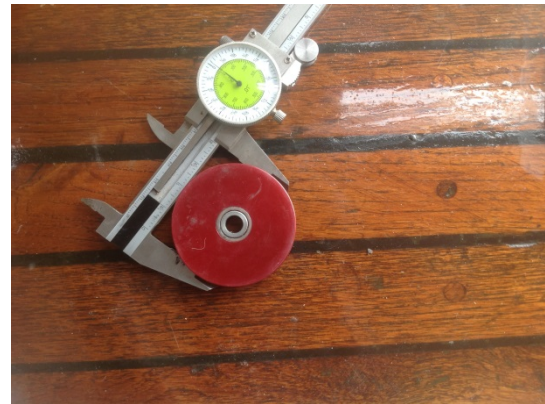
I replaced the frayed wire in the Hall Quickvang "C" with 5mm Dyneema, using very small "sailmaker's thimbles". In doing this I discovered that we STILL have sheaves that are two small and

this continues to wear a groove in the aluminum tube and will certainly chafe or fray the Dyneema line. The part is available and listed as a 2 1/4" sheave. I suppose that is the outside diameter, in which case maybe they are worn just a bit, but not much (about 1/16 in diameter). I have wrote Hall Spars and it turns out these are the correct size, just worn (I hope) and we will be receiving new ones shortly (\$32 x 2). Of course, the tube is compromised and probably should be replaced but it appears strong enough to me.
