BLISTERS AGAIN?

The Wonderful World of Hull Blistering and Other Interesting Scams

by David Pascoe, Marine Surveyor

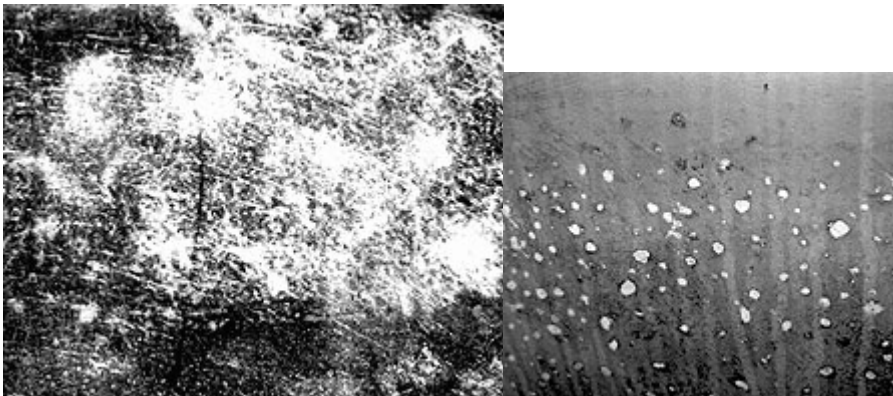
Left: Photo of hull with gelcoat removed, revealing that the mat is very poorly wetted.
Right: photo of same area prior to removing gelcoat. Pimple blisters are all beneath gelcoat and not under the mat, none of which grew to any significant size.

- In a four year casual study that involved examining every hull that I ran across that had the outer coatings removed (involving hundreds of boats), the lack of complete wet out was appallingly bad in well over 50% of all boats that I looked at. The nearby photo typifies the lack of wet out found in most boat hulls. There is a direct correlation between low quality resins and poor wet out on blistering.

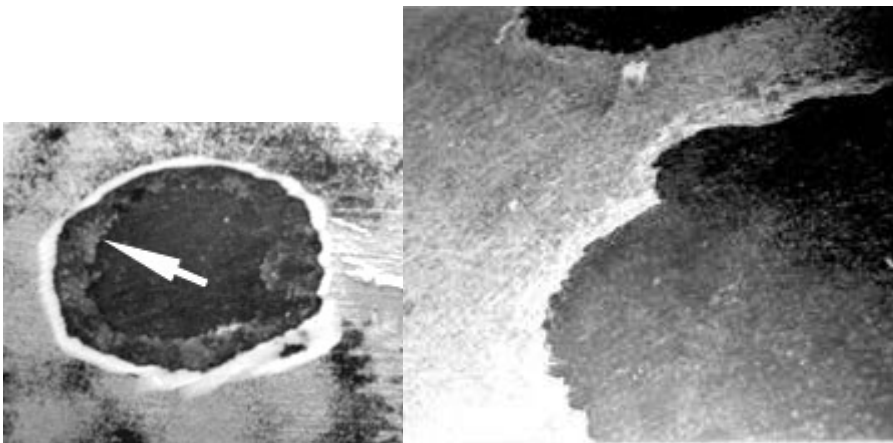
- Major blistering problems are often related to bonding failures of both gelcoats and skin out mats. I was not aware of this until about a year ago, when, one day, I watched a blister repair contractor stripping the gelcoat from a hull. Not only was the gelcoat coming off, but the entire skin out mat was peeling off (see actual

photo of this boat). On closer examination I found that major areas of the skin out mat had never achieved bonding and could be peeled off by hand. As I continue to examine boats for this condition, I am finding more and more of them.

Left: In this ground away blister, the ply separation is clearly evident around the perimeter as shown by arrow. When it is repaired, the void or incomplete bonding will

remain. **Right:** The skinout mat on this hull never was fully bonded. This is the result after six inch blisters were peeled away. This large section was peeled off with a screwdriver. Note that the mat is less than 50% saturated.

- If there is evidence of poor bonding, a permanent solution may involve peeling the skinout mat off the entire hull.
