Failed Blister Repairs

A Case History and Solutions

by David Pascoe

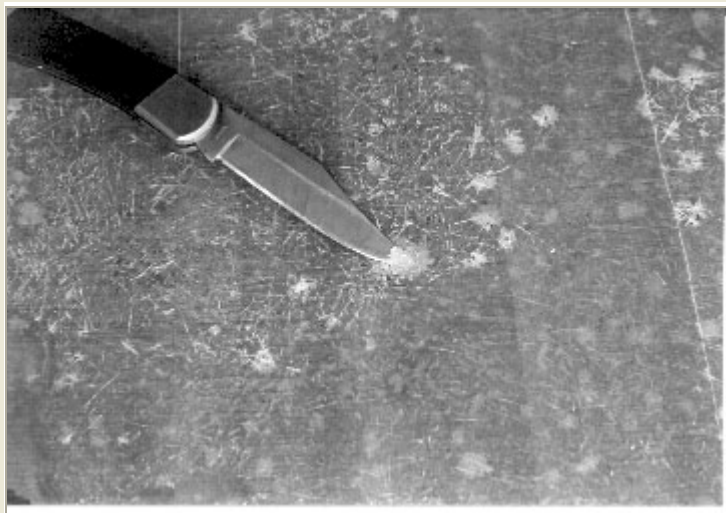
After removal of the newly applied barrier coatings, this is what Mr. Williams hull looked like. Knife blade is inserted into the void spot caused by the old blister. Most, if not all, of the original blister voids remained. At right, the new resin can be seen to have been applied directly over the old blisters.

- As shown in nearby photos most, if not all, of the old blister cavities were still present. As far as we could determine, no effort was made to grind away the cavities or void areas and fill them.
- Scattered and random areas of the original skin out mat, as part of the original lay up, had significant areas of unsaturated fibers and minute voids, i.e. air bubbles in the original lay up.
- Some areas which had been faired with an unknown filler, but looks like two-part epoxy, were very soft and pliable, giving the appearance that it had not been mixed in proper ratios and did not cure properly. Since some of this material was

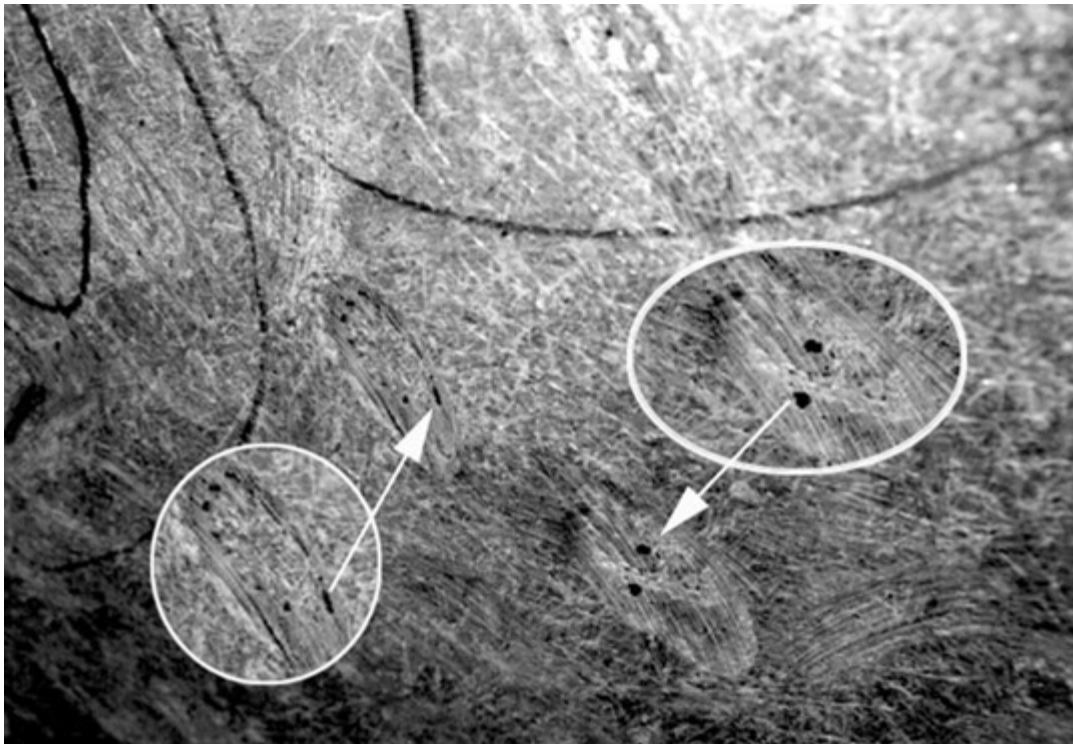
Although these blisters were ground away, the void spots or air bubbles within the skin out mat that initiated the blisters are clearly evident in this photo. The circled insets are enlarged for clarity. The polyester plastic here is not hydrolyzed (dissolved) as some researchers claim is the cause of the problem. The plastic is hard and unaffected. If these voids are not removed, then the potential for reformation remains. Also note how dry some of the fibers are.

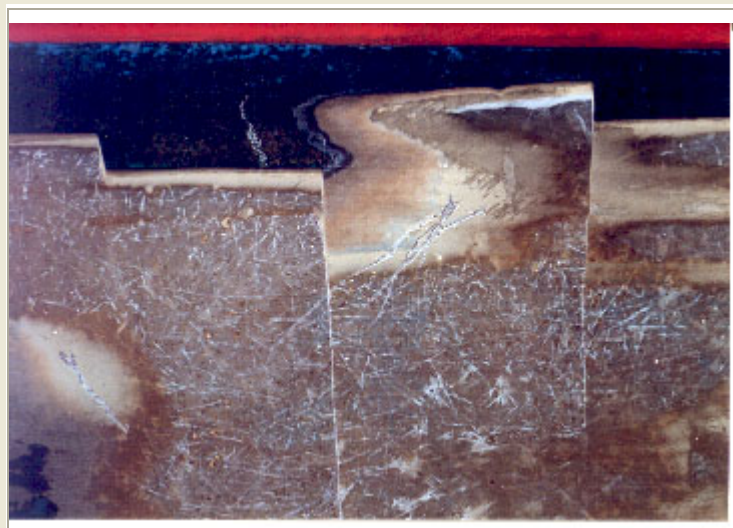
Fairing material that either turned soft or was not properly mixed and catalized. Scrape marks were made with the end of a ball point pen to indicate how soft is is, a perfect environment for blister formation. This is the pointit where the bottom was faired into the old gelcoat at the boot stripe. Note blister voids at lower center.

It also appears that a two-part epoxy filler was used in the fairing process that amounted to no more than 25% of the bottom area. This included spot filling depressions of what might have been larger blisters, as well as fairing around through hull fittings, fairing the waterline into the removed bottom gelcoat, as well as just general fairing. The fairing process was poorly accomplished, resulting in a "lumpy" appearance to the finished job. Most significantly, as we have found in a large number of other failed blister jobs, the fairing material, whatever it is, was found to be soft and pliable. Whether this resulted from improper mixing and incomplete curing, of if the material softened from water exposure or resultant chemical reactions, was not precisely determined. However, it would certainly be difficult to sand a filler that was not completely cured, and the fact of the lumpy appearance of the bottom suggests this possibility. On the other hand, our finding of so many other fillers that turn soft also suggests the likelihood of problems of (1) incompatibility of materials being combined, or (2) that these materials are severely affected by contact with sea water. All we can say for certain is that it is a two-part mix and that the material in many areas, although not all, was very soft.

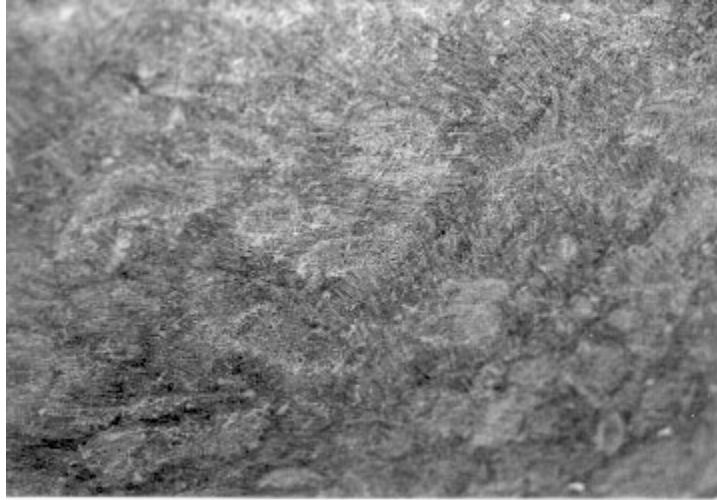
This photo, not this essay's subject vessel, shows a boat bottom with at least two dozen grind spots in little more than one square foot area. Despite all the grinding, hundreds of voids and areas of unsaturated fibers remain. When the condition of the skin out mat is this bad, it cannot be successfully repaired. It must be removed completely. Unfortunately for the owner, the yard simply filled the holes and recoated it, with a high probability that the repair will fail.

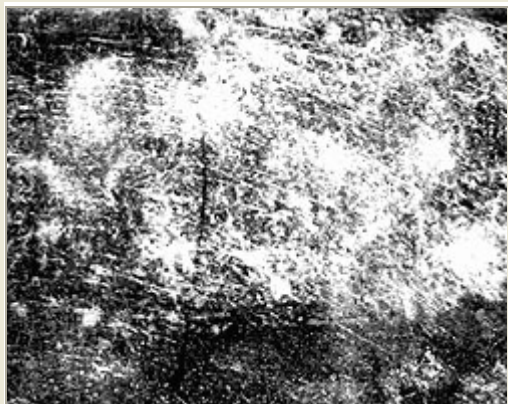
Here is a particularly good shot of unsaturated fibers in a skin out mat. These really stand out because the layup resin in this hull is tinted dark blue. In most cases, the poorly saturated fibers do not stand out this well. In this case, as in so many others, the repairer simply applied a new barrier coat on top of this mess and the blisters reappeared with six months.
