Failed Blister Repairs

A Case History and Solutions

by David Pascoe

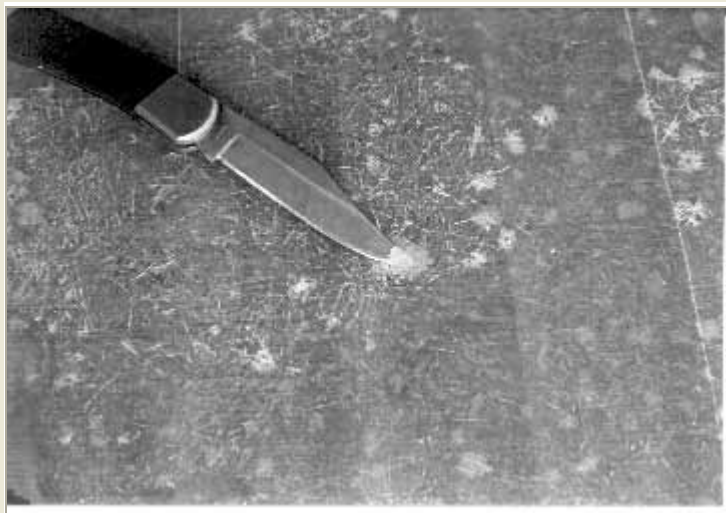
After removal of the newly applied barrier coatings, this is what Mr. Williams hull looked like. Knife blade is inserted into the void spot caused by the old blister. Most, if not all, of the original blister voids remained. At right, the new resin can be seen to have been applied directly over the old blisters.

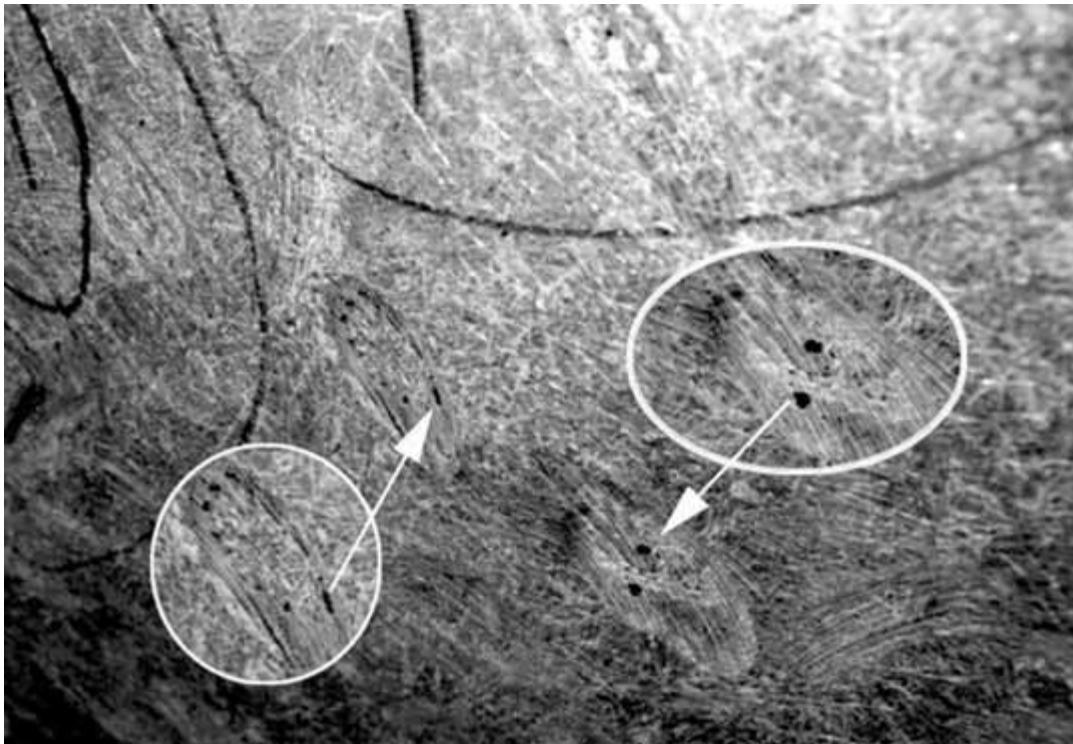
Although these blisters were ground away, the void spots or air bubbles within the skin out mat that initiated the blisters are clearly evident in this photo. The circled insets are enlarged for clarity. The polyester plastic here is not hydrolyzed (dissolved) as some researchers claim is the cause of the problem. The plastic is hard and unaffected. If these voids are not removed, then the potential for reformation remains. Also note how dry some of the fibers are.

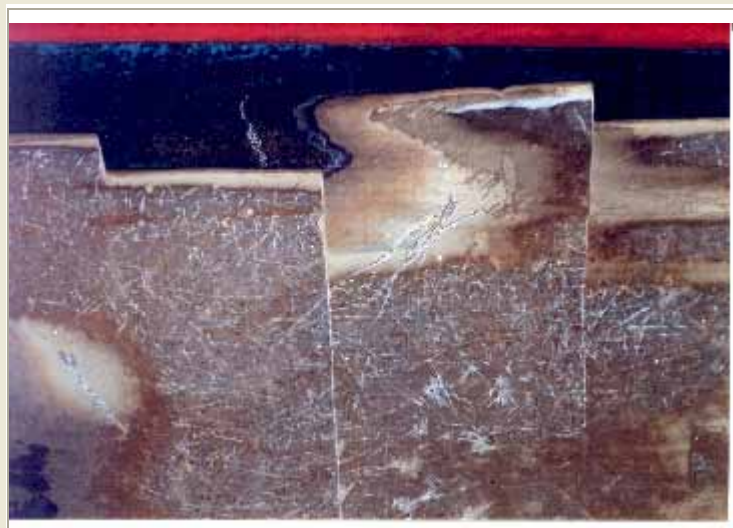
Fairing material that either turned soft or was not properly mixed and catalized. Scrape marks were made with the end of a ball point pen to indicate how soft is is, a perfect environment for blister formation. This is the pointit where the bottom was faired into the old gelcoat at the boot stripe. Note blister voids at lower center.

It also appears that a two-part epoxy filler was used in the fairing process that amounted to no more than 25% of the bottom area. This included spot filling depressions of what might have been larger blisters, as well as fairing around through hull fittings, fairing the waterline into the removed bottom gelcoat, as well as just general fairing. The fairing process was poorly accomplished, resulting in a "lumpy" appearance to the finished job. Most significantly, as we have found in a large number of other failed blister jobs, the fairing material, whatever it is, was found to be soft and pliable. Whether this resulted from improper mixing and incomplete curing, of if the material softened from water exposure or resultant chemical reactions, was not precisely determined. However, it would certainly be difficult to sand a filler that was not completely cured, and the fact of the lumpy appearance of the bottom suggests this possibility. On the other hand, our finding of so many other fillers that turn soft also suggests the likelihood of problems of (1) incompatibility of materials being combined, or (2) that these materials are severely affected by contact with sea water. All we can say for certain is that it is a two-part mix and that the material in many areas, although not all, was very soft.

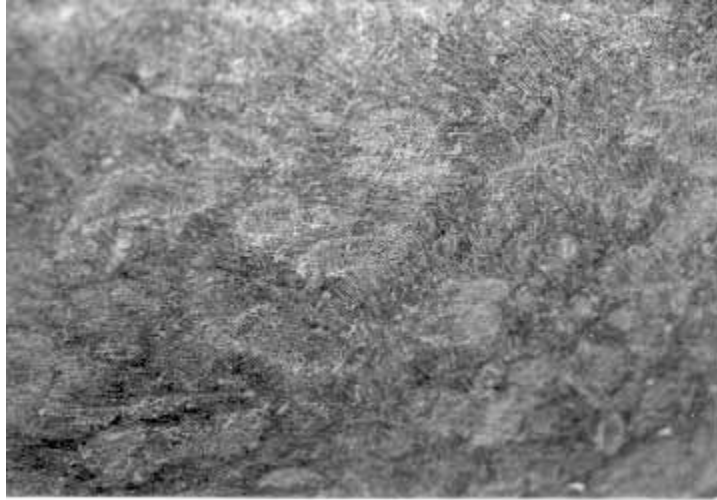
This photo, not this essay's subject vessel, shows a boat bottom with at least two dozen grind spots in little more than one square foot area. Despite all the grinding, hundreds of voids and areas of unsaturated fibers remain. When the condition of the skin out mat is this bad, it cannot be successfully repaired. It must be removed completely. Unfortunately for the owner, the yard simply filled the holes and recoated it, with a high probability that the repair will fail.

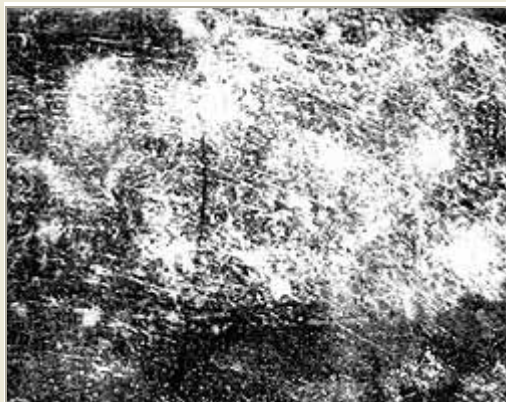
Here is a particularly good shot of unsaturated fibers in a skin out mat. These really stand out because the layup resin in this hull is tinted dark blue. In most cases, the poorly saturated fibers do not stand out this well. In this case, as in so many others, the repairer simply applied a new barrier coat on top of this mess and the blisters reappeared with six months.

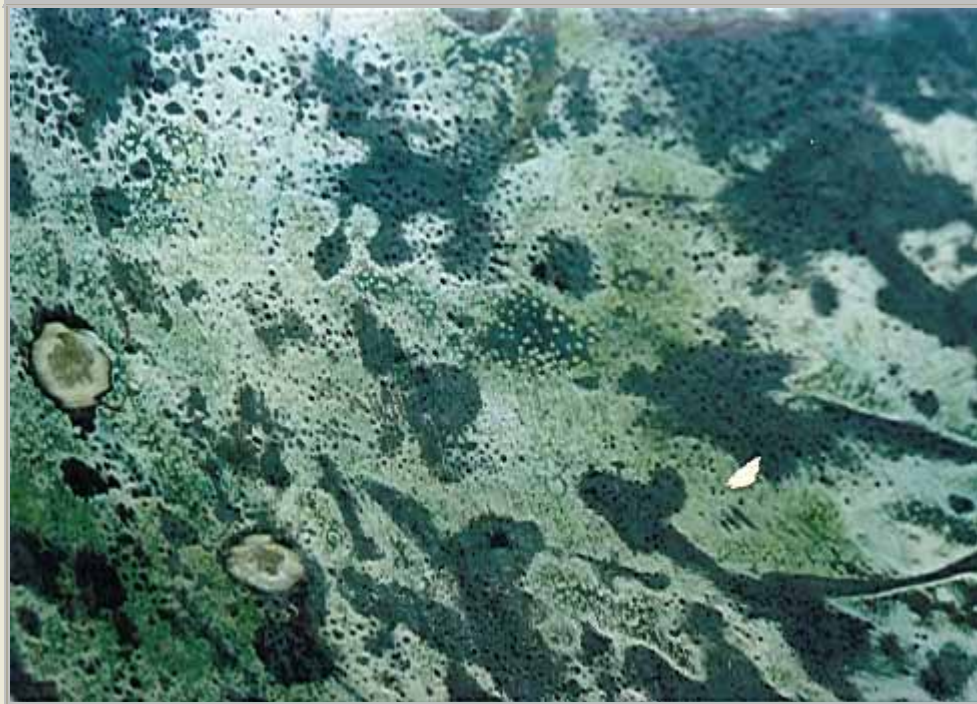
Another failed repair job. This one looks like the so-called "hot coating" where the bottom paint is applied over a wet barrier coat. At left are two larger blisters to which a grinder was applied. The skin out mat layer is plainly evident, is around 3/16" thick and is completely opaque, in addition to having a faulty bonding surface to the structural layers. Under the white layer, which you might think to be gel coat, is a black layer. We can't even imagine what that might be. What has been done to the bottom of this boat over the years (it is 15 years old) is beyond even guessing, but the one thing that is certain is that there is no hope of successfully repairing it, even though the owner is going to try again. Applying a new coating over this mess is like painting over dirt.

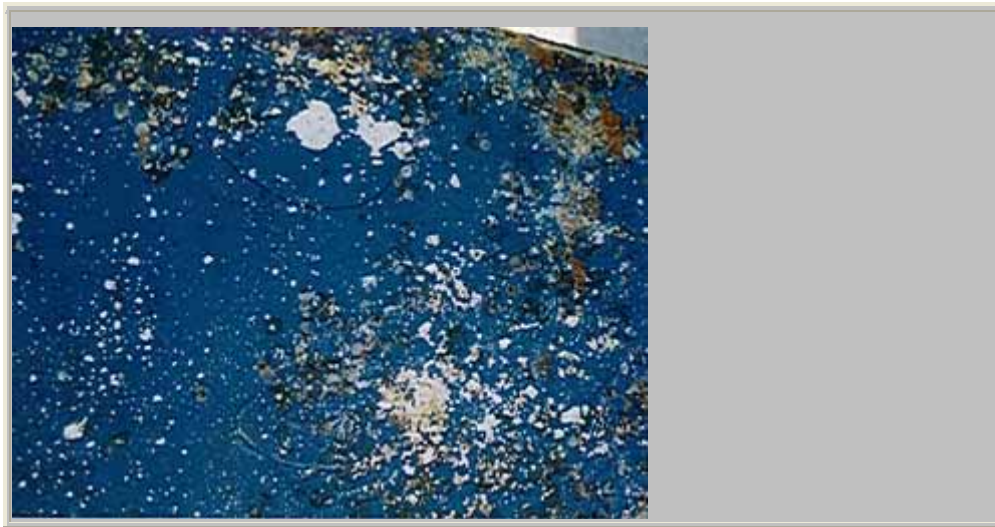
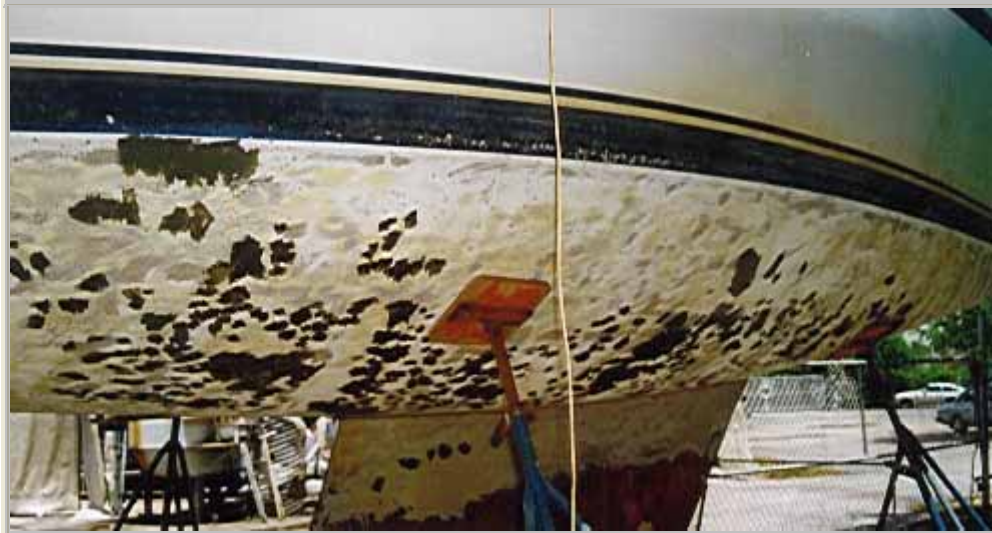
Top: What you see here may look like gel coat blisters but actually the white spots are a chemical reaction between a variety of gunk that was smeared on the hull. There was almost no gel coat left. **Below:** This is what it looked like after some kind of machine was used on the bottom. Here we can count four different kinds of filler, in addition to the black stuff that is now being applied on top of all the others, another patch up job. After he's done, he is going to seal all this mess over with a barrier coat. This owner's efforts are a complete waste of time and money.

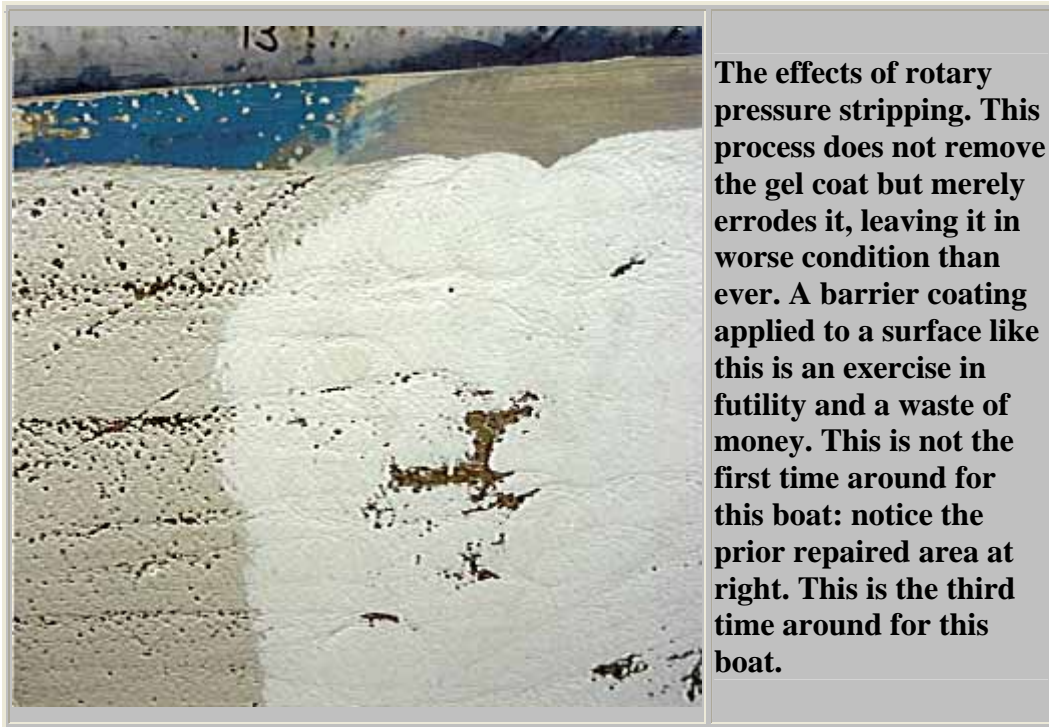
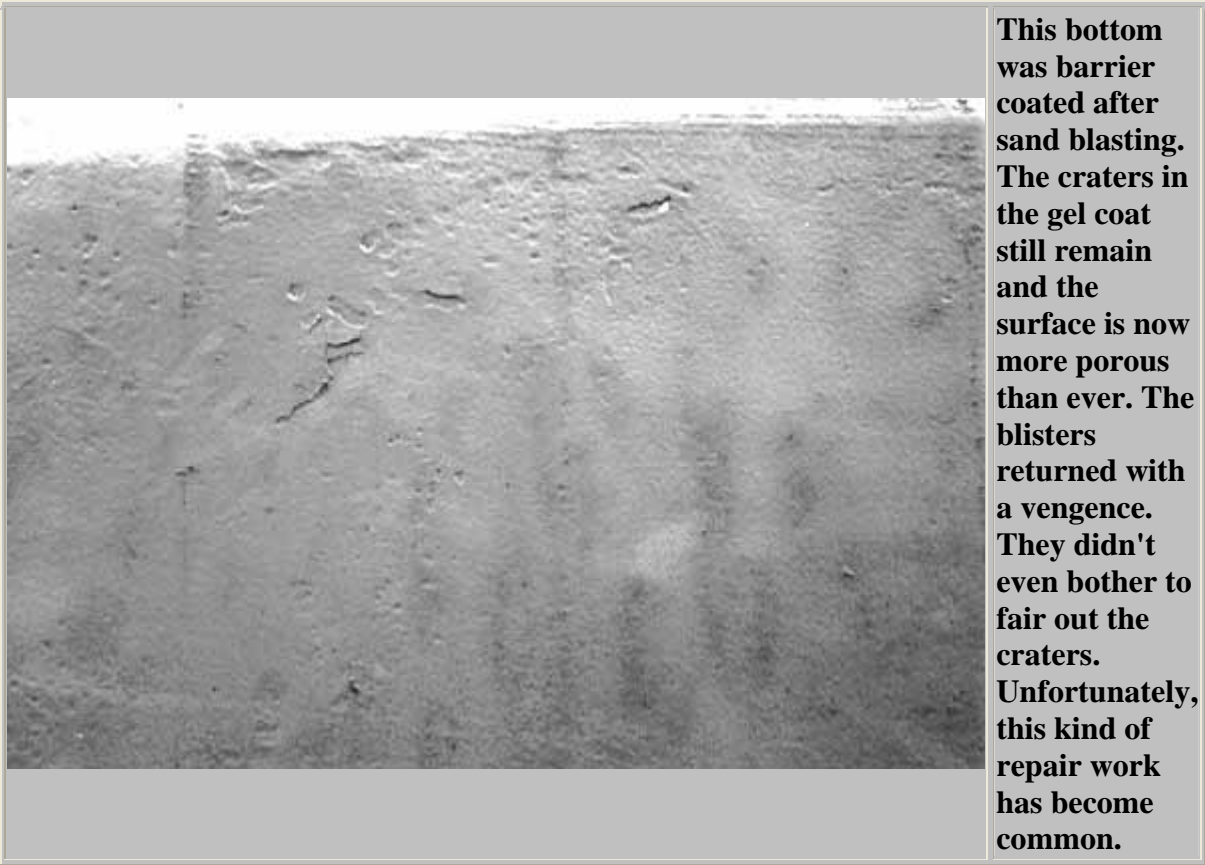
This bottom was barrier coated after sand blasting. The craters in the gel coat still remain and the surface is now more porous than ever. The blisters returned with a vengeance. They didn't even bother to fair out the craters. Unfortunately, this kind of repair work has become common.

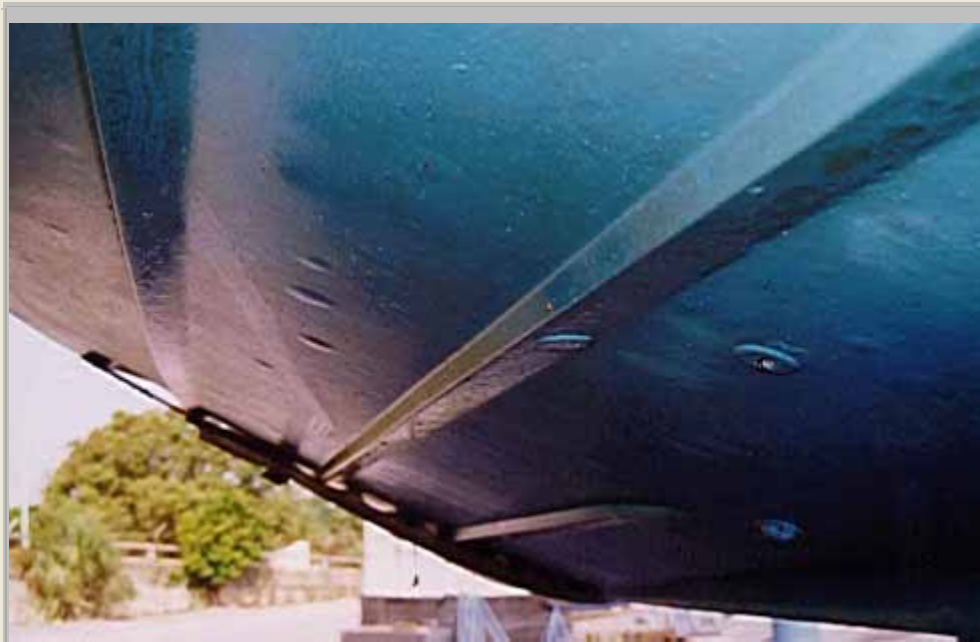
Here's a 22 year old Bertram with about 100 blisters on the bottom. It has never had any kind of repairs. Is it worth tearing up the bottom and risking making the situation worse? Or would the owner just be better off leaving it alone? We'd opt for the later.

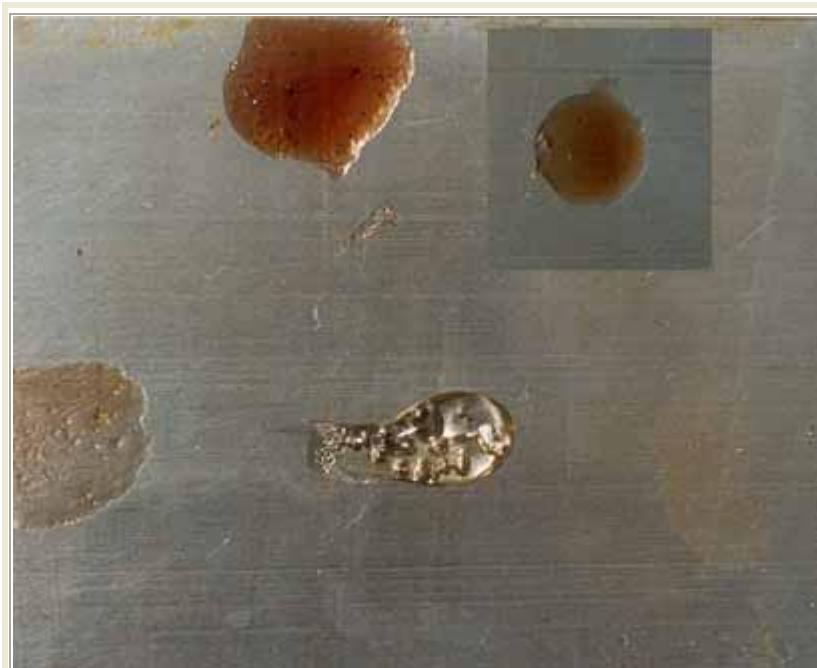
These are samples of blister fluid after 2 weeks of air drying. The three at top and right are hardened to the touch and have shown almost no shrinkage due to evaporation. The large one at the tops is roughly 2mm in depth. The volume of fluid placed on the plate remained

essentially the same. Water has been added to the sample on the left. Note that it has dissolved completely, dried up and left the residue spread around. The one at bottom center developed those large bubbles when placed in the sun. The one at the top also developed bubbles, but most of them dissolved after removal from sunlight.

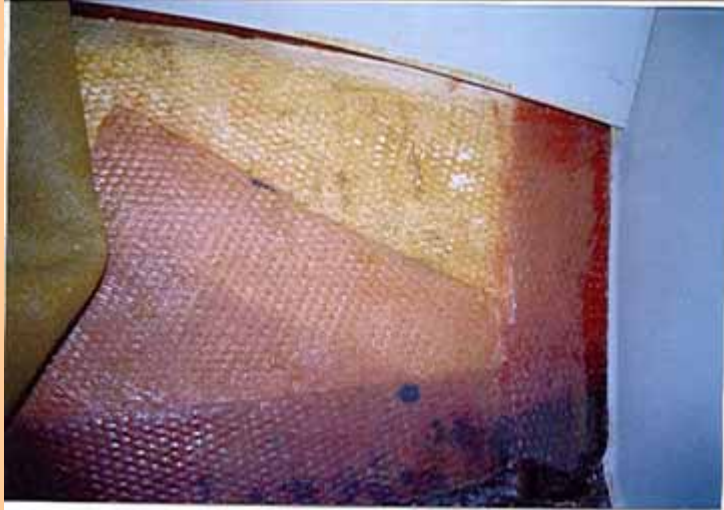
1.

Photo #1. This photo is taken in the forward cabin just above the point where the sole is taped into the hull sides and below the waterline. When I first lifted the carpet here, I was taken aback because my first impression was that the cabin sole tabbing had been laid over painted fibreglass, since the aft section of the interior hull was painted. As you can see, the tabbing is a pink color while the hull laminate seen at the top of the photo is not translucent like the tape but completely opaque. (Tape or tabbing are the strips of fibreglass used to join parts together, such as a bulkhead to the hull in this case.)

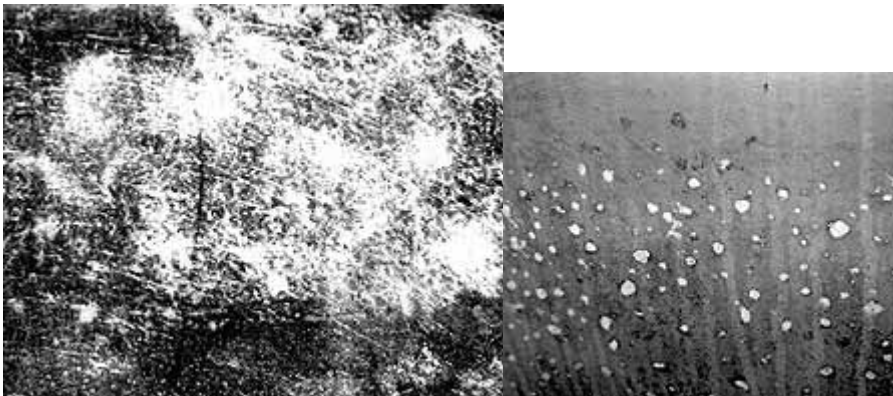
Left: Photo of hull with gelcoat removed, revealing that the mat is very poorly wetted.
Right: photo of same area prior to removing gelcoat. Pimple blisters are all beneath gelcoat and not under the mat, none of which grew to any significant size.

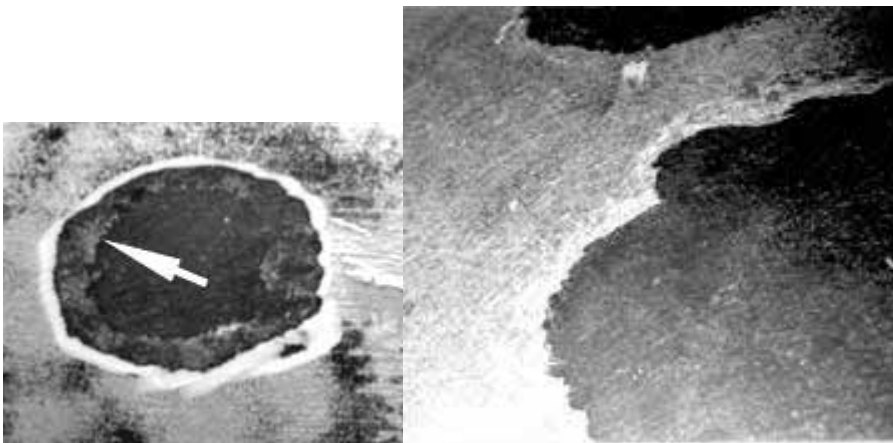
Left: In this ground away blister, the ply separation is clearly evident around the perimeter as shown by arrow. When it is repaired, the void or incomplete bonding will

remain. **Right:** The skinout mat on this hull never was fully bonded. This is the result after six inch blisters were peeled away. This large section was peeled off with a screwdriver. Note that the mat is less than 50% saturated.

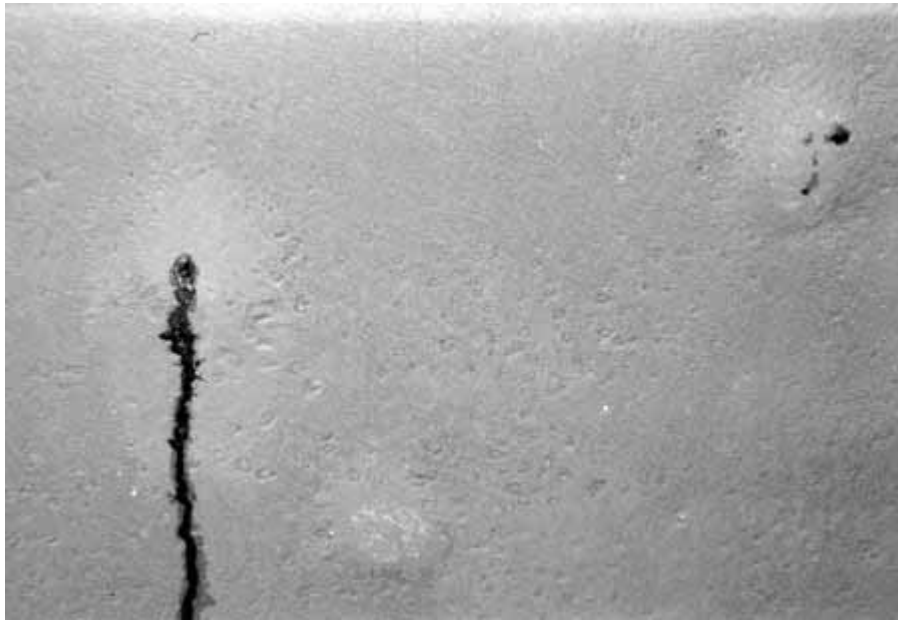
There are three blisters appearing in this photo of a boat bottom which is very clean and smooth. Two of them are easily revealed by the fluids that leaked out after the boat was sitting for many weeks. But the blister at lower center is barely visible. All of these blisters were highlighted by good artificial lighting used to take the photo. Without that lighting, and absent the weeping, it would have been very difficult to locate these blisters. After wetting down with water, they became much easier to see. If the bottom were dirty, it's not likely that they would have been located.

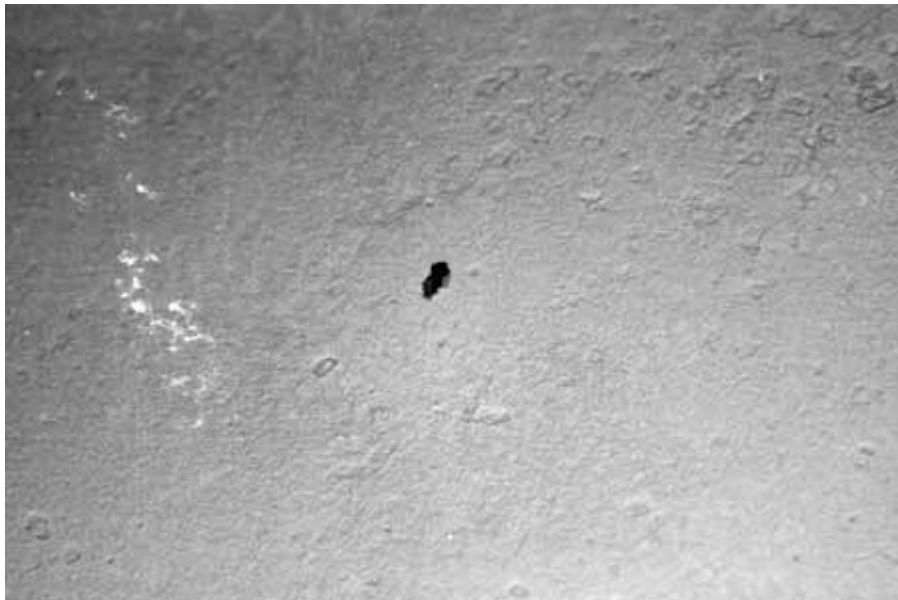
Without the dark weephole to announce its presence, this blister is not visible under ordinary conditions. It has very little raised contour and is only slightly revealed by a strong light played across it at a low angle. Yet tapping it with a coin clearly reveals the separation of the gelcoat by sound.

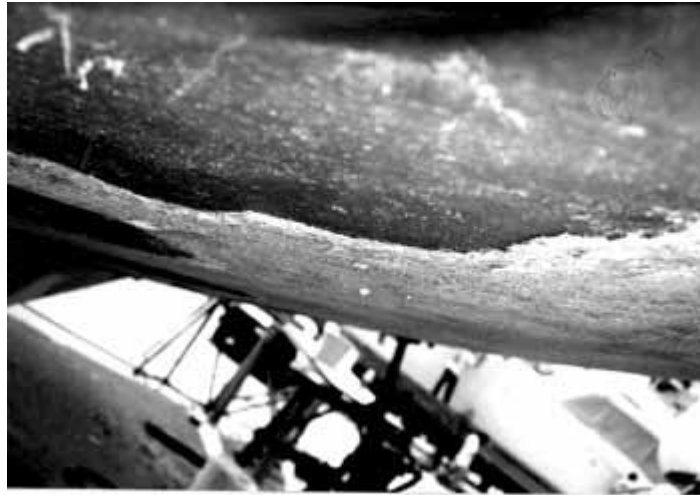
This is an example of severe ply separation. The peeled away ply here measures about 3 feet across. In this case the skin out mat was so dry that there was little bonding to the inner structural laminates. The whiteness clearly indicates how dry it is. This allowed the interface between the two plies to fill with water. While this is an extreme example, incomplete bonding to lesser degrees is commonplace. To make matters worse, it was not detectable by sounding, although there was a bit of a warning sign in that the whole hull sounded somewhat "dead." These were not blisters but water filled ply separations that do not appear to have been initiated by osmotic pressure but rather enhanced by it. Scraping with a knife below the gelcoat easily revealed the dryness of the fibers.

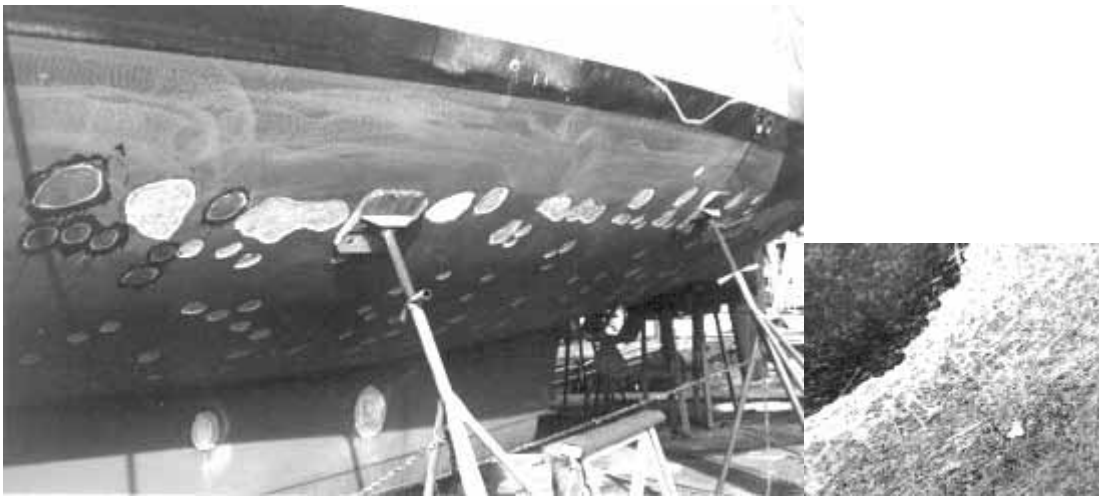
Notice on this hull how the blisters run along a band about one foot below the waterline. Also note how they appear in clusters lower down on the bottom, and that some areas between clusters are not affected. Examples like these prove once and for all that blistering is not merely a function of material, but also a matter of the quality of the layup. On this boat, the areas of blistering are not random but area-specific and directly related to permeability of the laminate due to imperfections. Once again, the skin out mat was found to be poorly saturated. Photo at right contrasts the dry mat against the fully wetted out structural laminate.
