# Blister Repairs Part II

*The Alchemist Still Hasn't Found the Philosopher's Stone*

by David Pascoe

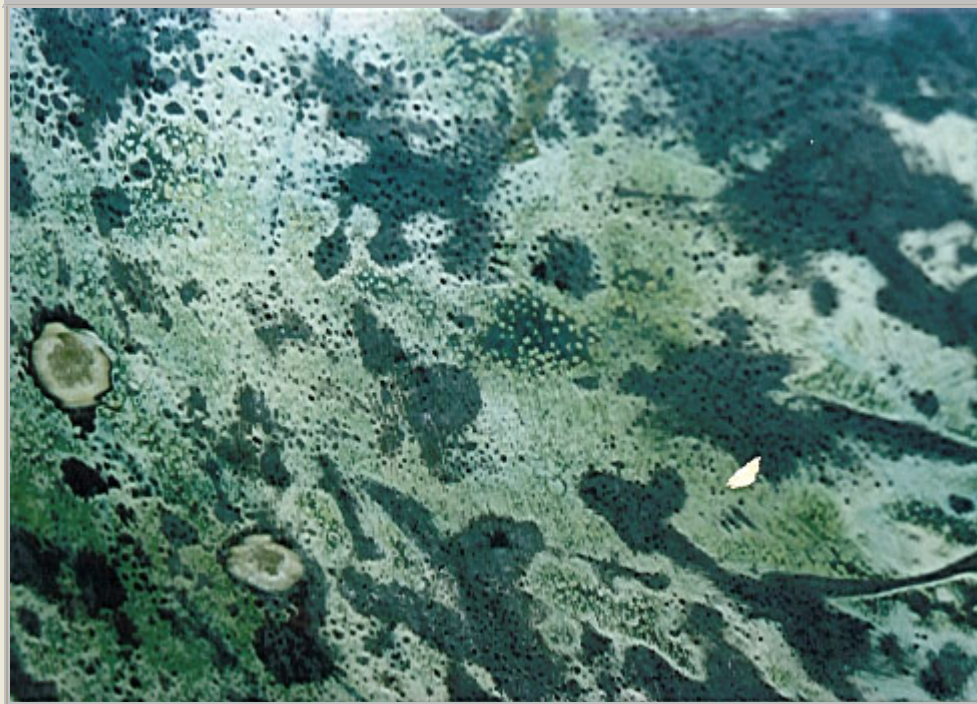
**Another failed repair job. This one looks like the so-called "hot coating" where the bottom paint is applied over a wet barrier coat. At left are two larger blisters to which a grinder was applied. The skin out mat layer is plainly evident, is around 3/16" thick and is completely opaque, in addition to having a faulty bonding surface to the structural layers. Under the white layer, which you might think to be gel coat, is a black layer. We can't even imagine what that might be. What has been done to the bottom of this boat over the years (it is 15 years old) is beyond even guessing, but the one thing that is certain is that there is no hope of successfully repairing it, even though the owner is going to try again. Applying a new coating over this mess is like painting over dirt.**

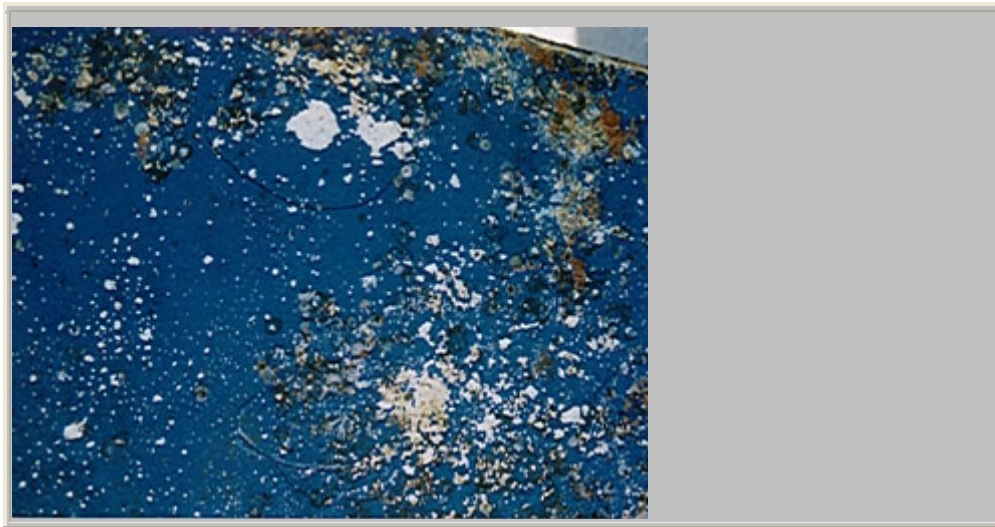
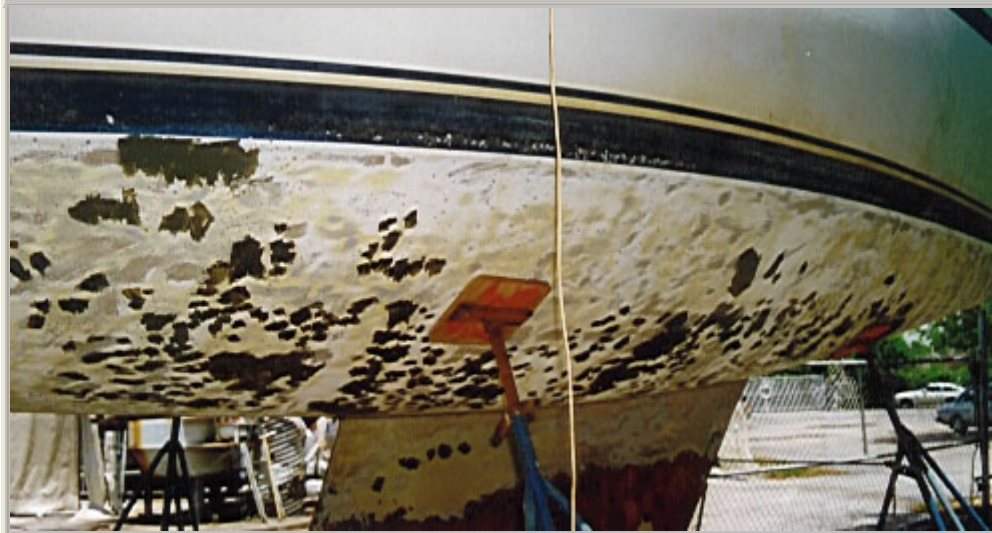
**Top:** What you see here may look like gel coat blisters but actually the white spots are a chemical reaction between a variety of gunk that was smeared on the hull. There was almost no gel coat left. **Below:** This is what it looked like after some kind of machine was used on the bottom. Here we can count four different kinds of filler, in addition to the black stuff that is now being applied on top of all the others, another patch up job. After he's done, he is going to seal all this mess over with a barrier coat. This owner's efforts are a complete waste of time and money.

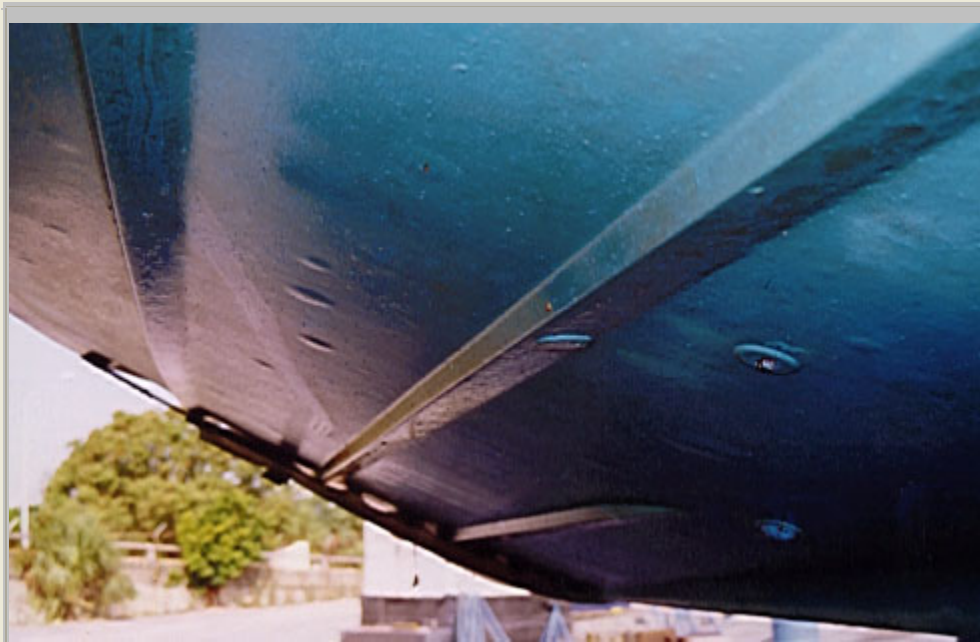
**Here's a 22 year old Bertram with about 100 blisters on the bottom. It has never had any kind of repairs. Is it worth tearing up the bottom and risking making the situation worse? Or would the owner just be better off leaving it alone? We'd opt for the later.**

Boats with a relatively small number of larger blisters (1" for example) are amenable to spot repairs, which are often successful. If the bottom of your boat has, say, 100 blisters on the bottom, we would recommend spot repairs over stripping and recoating the bottom. We would not recommend barrier coating after spot repairs. Spot repairs are inexpensive, and if they do fail, at least you won't be out a lot of money.
