FORMOSA 46 BACKSTAY PLATE AND CHAIN PLATES

Ralph Ferges – Sola Gratia F46 San Diego, CA. USA

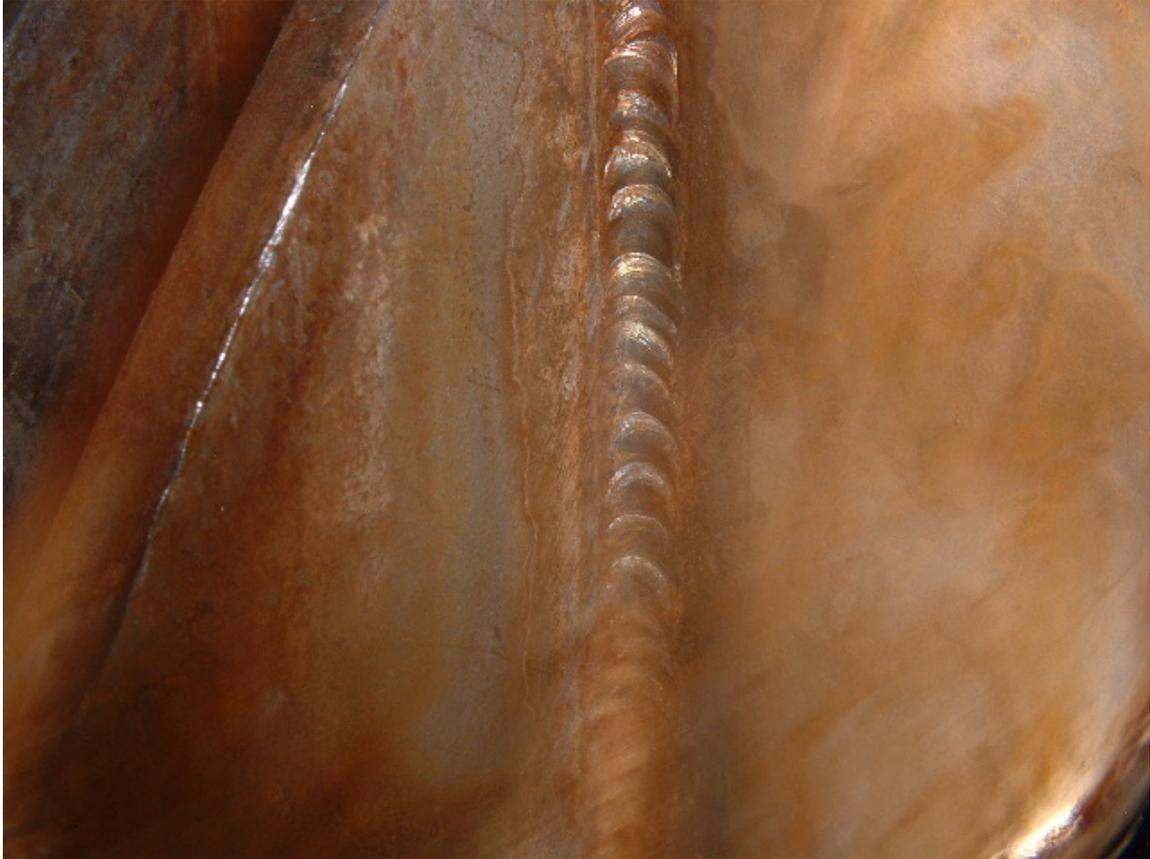
While I like the idea of using the external circle to carry some load due to all the rot in the rest of the system mine was responsible for all the load. I don't think the welds would take it as they looked like fine light duty welds you might see on a bimini or dodger frame. They need to be structural welds not just cosmetic welds.
