***s/v Beatrix* Repair, Maintenance and Improvements Log**

**January 14, 2004
To
August 8, 2020**

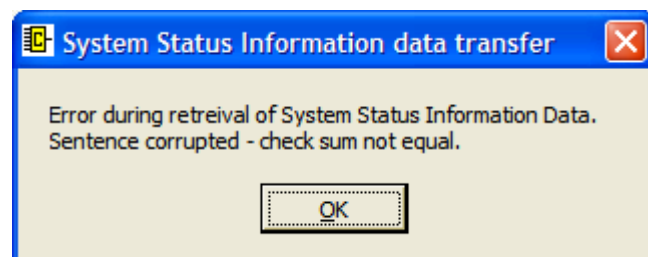
Patched the NDC-3 with new software. The following error message was given by the NDC Controller.

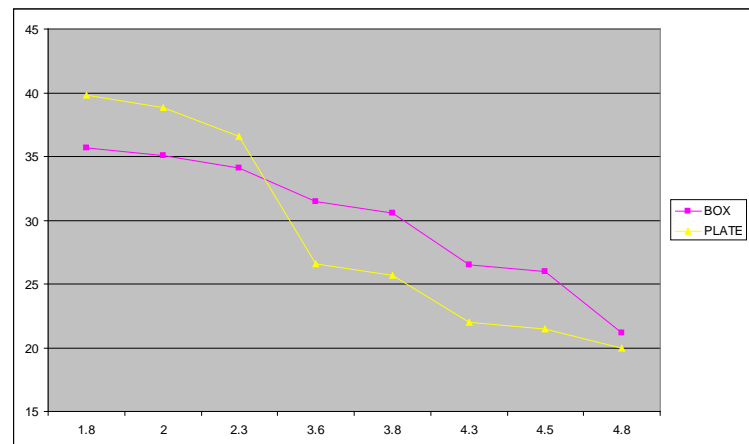
REFRIGERATOR			
HOURS	BOX	PLATE	DIFF
0.0	?	55.7	
1.8	35.7	39.8	4.1
2.0	35.1	38.8	3.7
2.3	34.1	36.6	2.5
3.6	31.5	26.6	-4.9
3.8	30.6	25.7	-4.9
4.3	26.5	22.0	-4.5
4.5	26.0	21.5	-4.5
4.8	21.2	20.0	-1.2

FREEZER		
HRS	BOX	PLATE
0	15.3	11.2
0.2	13.8	10.5
0.4	12.3	9.7
4.3	0.0

- Results suggest: probes are OK, thermostat is OK, solenoid is OK.

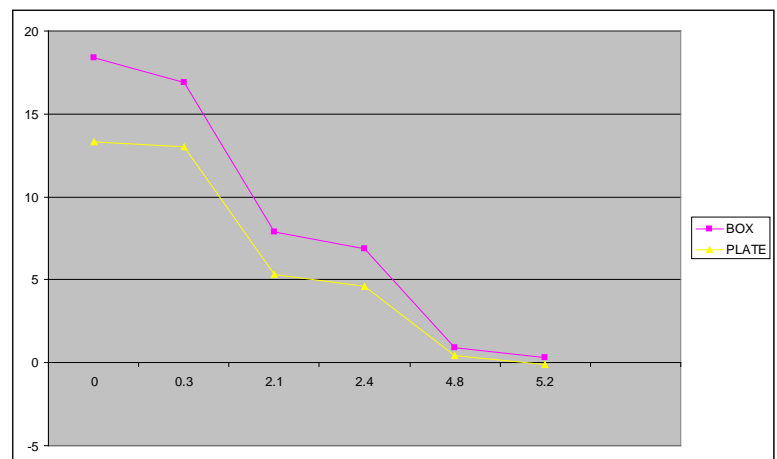
Reefer would not only not pull down, it got hotter. It's been off all night. Now have turned on the freezer:

FREEZER		
HRS	BOX	PLATE
0	18.4	13.3
0.3	16.9	13.0
2.1	7.9	5.3
2.4	6.9	4.6
4.8	0.9	0.4
5.2	0.3	-0.1

Freezer pulled down over FIVE HOURS. Reefer won't pull down at all! Time for gauges. Need to consult with Mark.

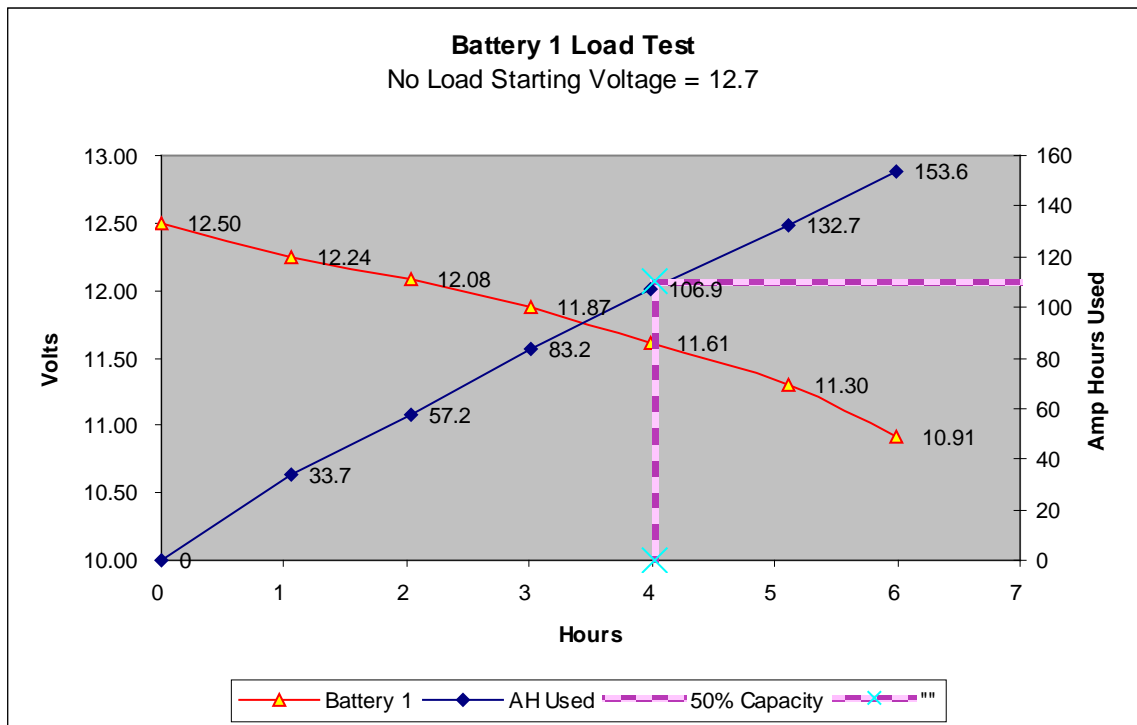
Finished equalization and 25V load test on Battery Bank 1. The test looks good, I think. It seems like the voltage should be higher, but then again it does put out the right amount of amps over the test. "OK" is defined as reaching 10.5 VDC in 6.5 hours. I stopped the test at 6 hours not wanting to draw it down any further. Theoretical capacity for the bank is 220AH / 2 = 110AH. This was reached at 11.4V before 4 hrs.

Temp measurements on one 6V during recharge: 35°-38°C with 80A charge current. Wires at 30°C.

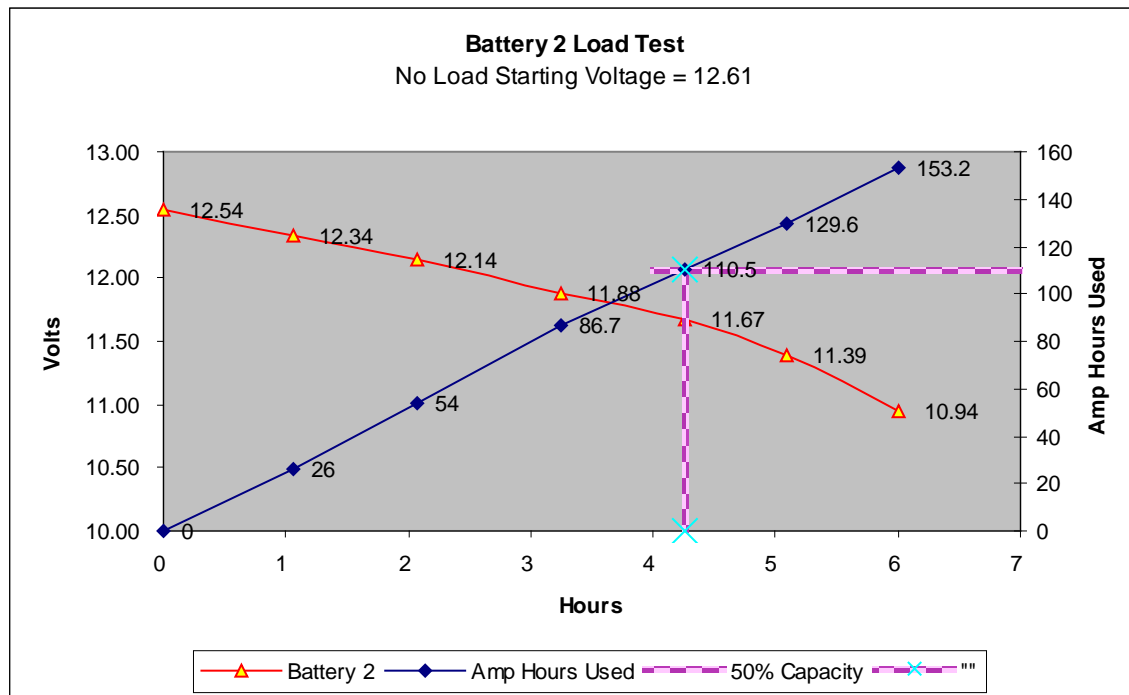
Load Test on Battery 2 performed. Battery appears healthy. Tried a reefer compressor start at 10.9 VDC and it would not start. It started fine at 12.3 VDC once the charger was started.

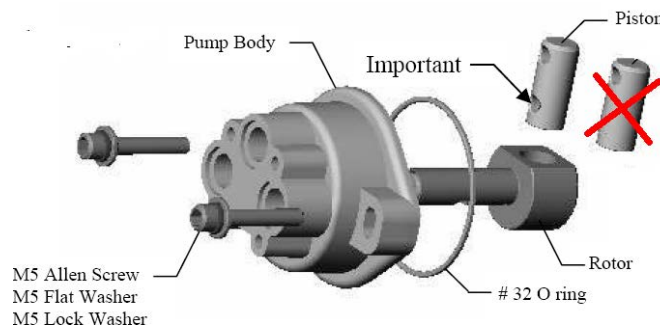
Noted earlier was that the main problem was the pump motor detaching itself from the pump. In fixing that, and inspecting the motor, we lost the prime on the hydraulics. We attempted to figure out the best way to fix this. I think the main problem was that we put the piston in backwards. Although it shows

the correct orientation in the instruction diagram it isn't obvious that the lower hole does not go all the way through. I added the crossed-out piston in the diagram.

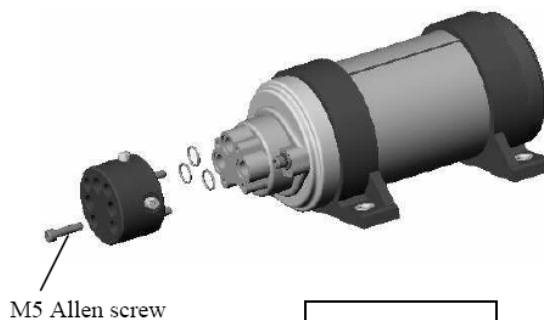
When we finally took it ALL apart I discovered the proper way to insert the piston. Although Dave Shannon at Octopus had supplied us with his "new" method for filling the lines, cylinders and pump it was oriented around draining and re-filling the entire system. Since our hydraulic actuator and hoses were already full the only problem was with the pump. The 3 shutoff valves must be closed. This keeps

fluid in the lines. The 4 Allen screws are removed to expose the front of the pump body.. We found that to fill the entire pump cavity you start with the pump tipped about 20° from horizontal. The third opening is the vent and it opens directly into the pump cavity. As it fills tip the entire pump towards the vertical. This lets air out. We used a plastic syringe to fill. The next "trick" we used was to dunk all three ends of the hoses (they are about 5m long) in a jar of ATF (we used a clear plastic soft drink

bottle). Then we ran the pump until bubbles stopped coming out. It was very gratifying to see those bubbles as our previous efforts (before getting the piston orientation correct) had been unsuccessful. Kathy was great and helpful in this entire endeavor.

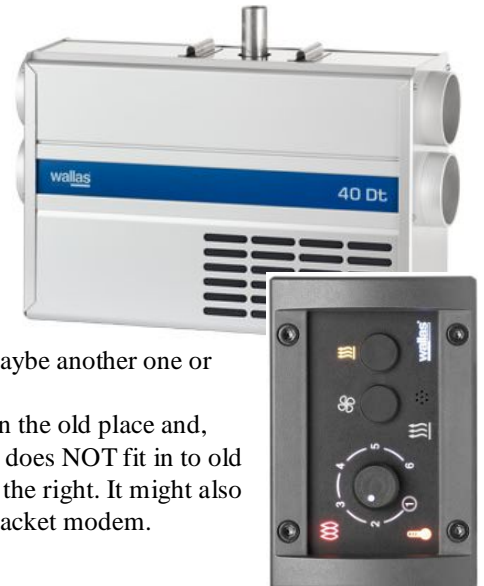
- Received replacement Wallas 40Dt diesel heater. It almost fits in the old place and, unfortunately, we also need to locate a new control panel which does NOT fit in to old place in the panel, not unless I rotate it 90° so it is vertical, as at the right. It might also fit in the spot on the nav panel that was originally for the SSH packet modem.

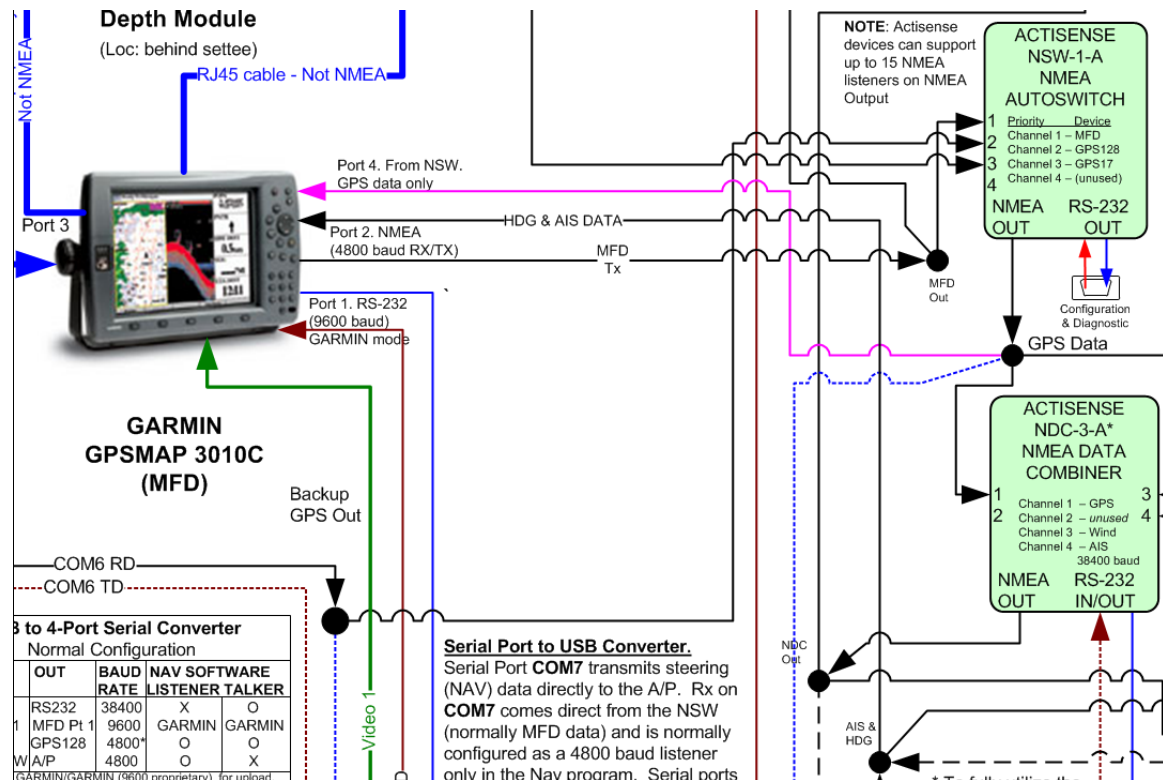
AIS and heading sensor data seems to be missing from the NMEA data stream.

The network diagram (below) shows that AIS/HDG data is fed directly to the chartplotter but the serial combiner reads output from the NDC-3. This argues that the problem is with the NDC-3 but in that

case why was nothing seen earlier on the chartplotter? It is conceivable that there were no AIS targets in the Mary River, although I would have thought the Fraser Island Ferries would have AIS.

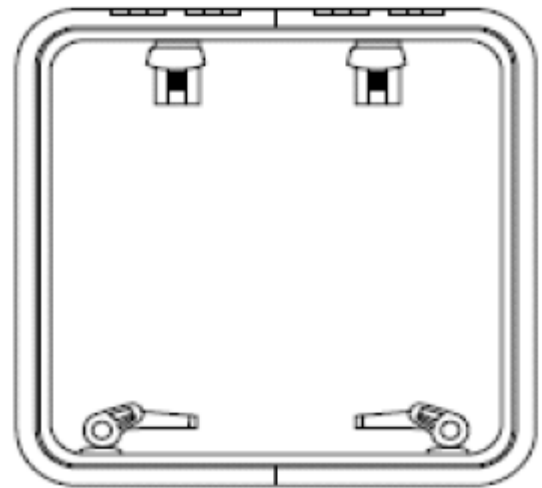
Noted this morning that the forward large hatch is leaking at the spot where I tore the seal during installation. Note that the hatches are:

Also order new seal kits from Select Plastics:

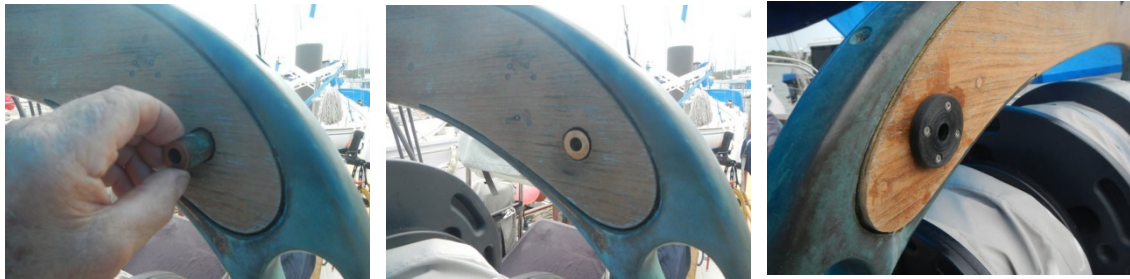
Bronze bushings have been installed in the newly cleaned and sanded boom gallows. The bushings “float” slightly in their holes and are secured by custom-made Delrin retainers. The float allows for easy installation of the awning frame studs but will keep the studs from sawing away at the wood.

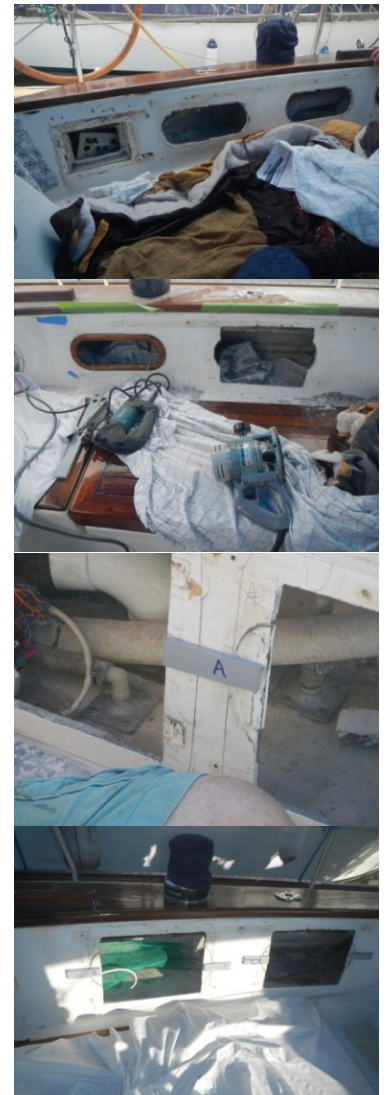
- Removed teak trim
 - Cut out old control panel (shocking glass work)
 - Used leftover cut pieces to make half-moon inserts to fill that part of the coaming opening that was too wide.

- The brilliant technique used was to cut small rectangles of PVC plastic and hot glue them to the face of the half-moon. Then the edges were lathered with thickened epoxy (West System with 406 filler) and the hot glue employed to stick the piece in place. You have to move fast with hot glue but it was the only way to get the half-moon face registered with the face of the coaming. After the epoxy cured a sharp rap with a hammer and pry-bar knocked the plastic off. A sharp smooth flexible knife was used to cut the squeeze out and a final sanding smoothed it all down.

- Sanded all surfaces with a variety of hand and electric sanders.
- An “abrasive nylon end brush” was discovered in the tool bag and proved incredibly good at cleaning out the diamond pattern

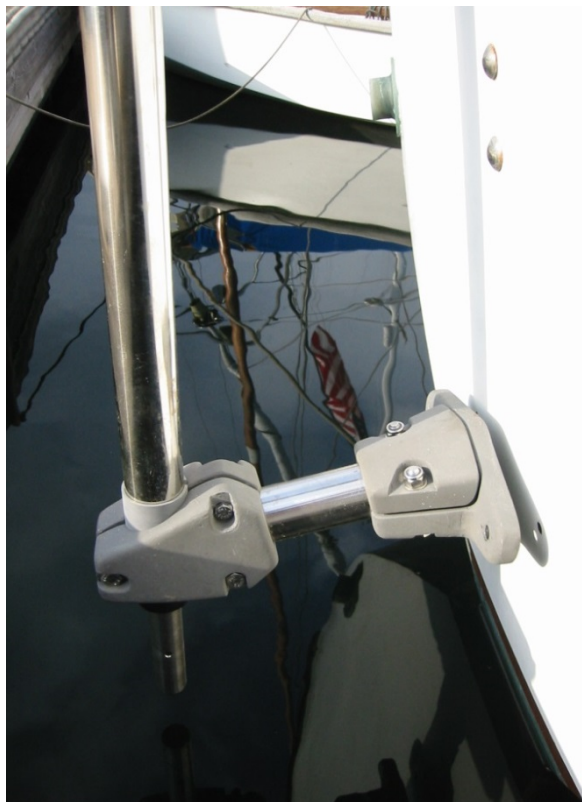
Hydrovane on Wheat strong

We have decided to go with a slightly off-center installation to port so as to leave the swim ladder completely unimpeded. These photos are from the installation on Wheatstrong (MJ Patterson) which has no swim ladder. Unlike Wasabi the lower unit points DOWN at 15°. Also note the tiller extension

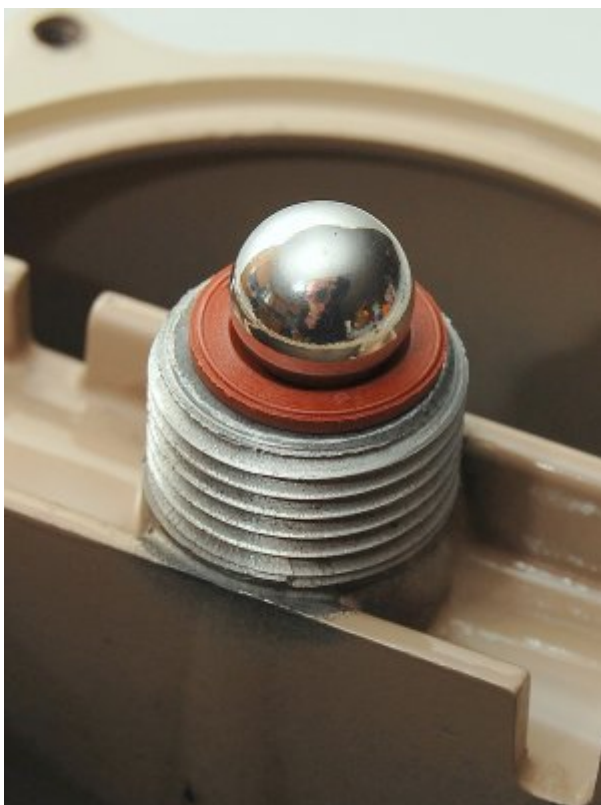
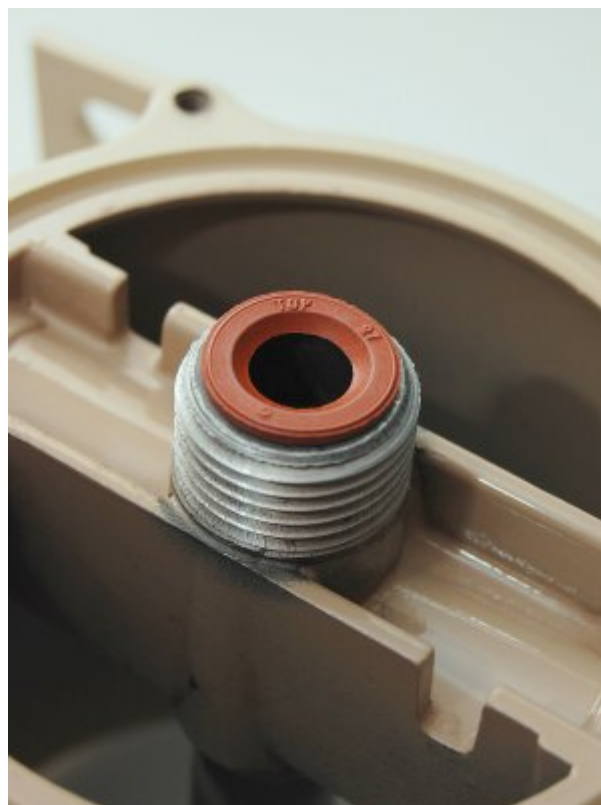
It is important to put the floating aluminum check ball in correctly. I did it backwards the first time and

it prevented all flow through the filter which was very confusing at first. This is the correct way:

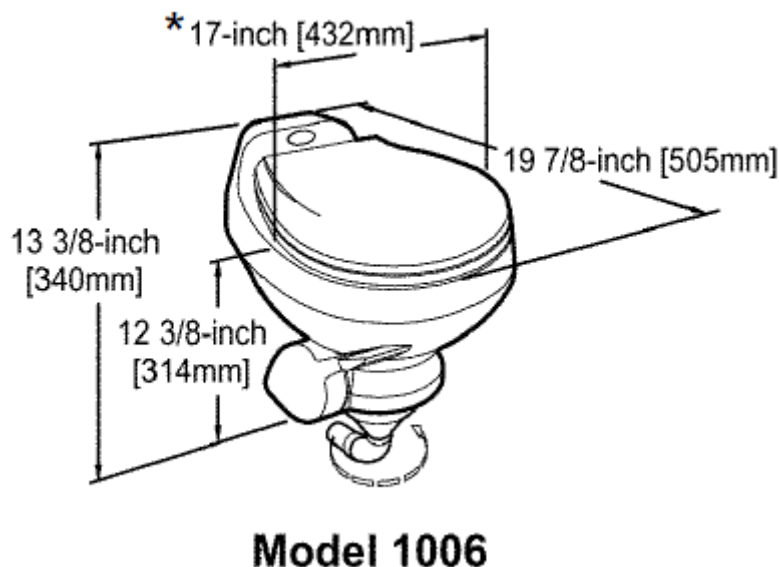
Servicing Vacuflush toilets – complete rebuild of forward head and seal replacements on aft head.

- Removal and cleaning of vacuum chamber with HCl.
- Disassembly of pump and cleaning with HCl.
- Replacement of Motor with W-series conversion kit: New quiet motor
- New bellows
- O-rings for pump

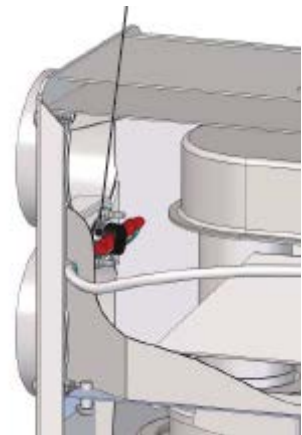
Flashing yellow after startup followed by flashing red is overheat signal. Flashing yellow at start means low voltage. It takes 15 seconds to do the voltage test. Any error after that is NOT voltage. First starting current can touch 15 amps, but normal run is less than 5 amps and the trip out is 10.5 volts. This means that I MIGHT need a generator running to start the unit but after Flame On it should run fine on anything over 10.5 volts. So no heavier wiring than the 11AWG (5mm) should be necessary. They prefer a direct hookup to the battery but I judge this not worth the effort of re-wiring once again.

Doug suggested that I run this test. Take at least one of the outlet ducts off the heater. On outlets pop the grill and make sure its wide open. Classic overheat is what is on the video.

The system needs intake air. Unobstructed intake air is important as the unit SUCKS air which is less powerful a flow than pushing air. There is a big squirrel cage fan for the blower and a small fan for the combustion chamber. Overheating can occur when there is not enough fresh intake air.

The thermostat is located between the outlet ports. Tripping temp on thermal shutdown is 80°C. It is possible that the narrow constriction of the Y-connectors causes this to heat up.

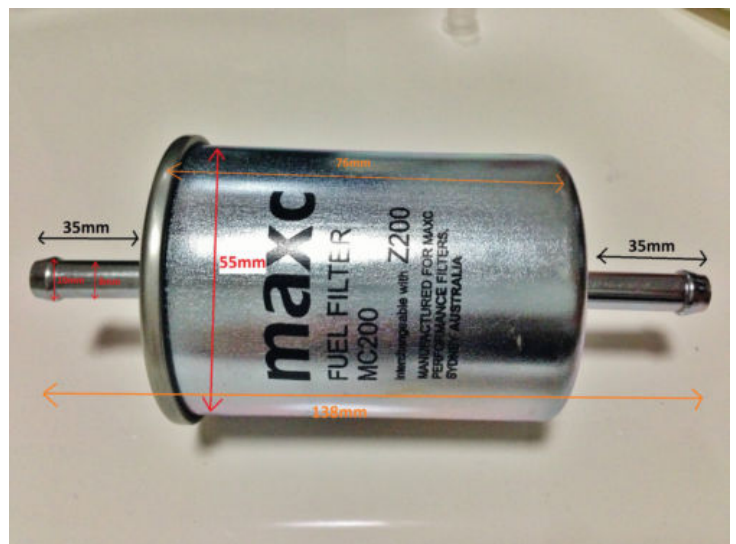
Yesterday I disassembled the panel to see the interior of the fuel system. It all looks OK and the fittings are super tight. I did discover the outlet hose from the FRB to the Kubota was not clamped at the pump. I remedied that. I have also ordered a fuel filter off eBay which filters out any particles larger than 3 to 5 microns. Pressure is max six bars or 87 PSI. This will be the final filtration before the injector pump. **NOTE: This filter was later removed.**

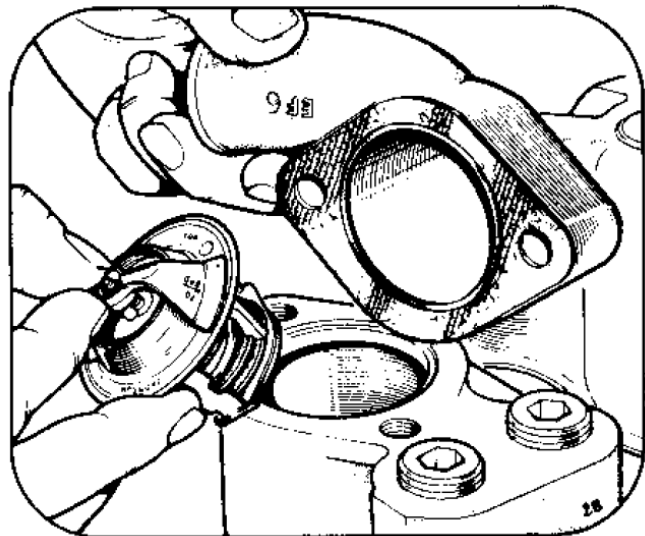
It's not as easy as in the picture. First we had to saw through the old steel-reinforced hose. There was no way to reach the nut underlying the thermostat housing elbow, which was on a stud (not in the picture). The opposite was a bolt which was easy to remove. The gasket was destroyed in the process, of course. The nut was rounded and getting worse as we tried to bend a 14mm (or 9/16”) end wrench to reach. Clearly the engineers had designed this part without marinizing in mind. Peter finally got the nut off.

To remove the thermostat, which was stuck in fairly hard, we tied a length of small line through the top and pulled it off using a breaker bar as a lever. After that it was off to the hose store to find a thinner-walled 2” ID heater hose to make re-assembly easier.

We had both a new gasket and a new thermostat in spares. To re-assemble the system I cut the hose as short as I could to overlap both the thermostat connection and the heat exchanger hose barb. This allowed me to slide the hose onto the thermostat elbow as far as possible; then slide the mounting hole onto the stud. The hose then was moved as far as possible onto the heat exchanger. Then I could get the nut on and begin to tighten it up. I did this “dry” and then with sealant. Hylomar Aerogarde P32 for the gasket; and Permatex Aviation Form-a-Gasket #3 for the hose sealant. Normally I don't use hose sealant but the aluminum hose connections had been seriously scaled and somewhat corroded. I had de-scaled and sanded them down as much as possible and they were pretty smooth. Nevertheless I felt a non-hardening, non-adhesive sealant was appropriate.

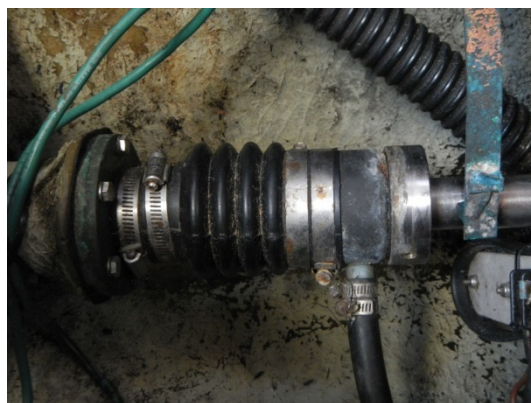
Today we are anchored up the river in Bundaberg Town Reach. Kathy noted we diesel in the stringer well portside. I confirmed this; and there is a bit of diesel in the bilge at the moment. Even though I had attempted to shift the collar towards the bellows, the PSS seal leaked on the way up the river, throwing salt water in the shaft space under the aft cabin floorboard. Images show possible damage to the carbon and stainless. It is not leaking while at anchor (although it was a few days ago). The electric switch that runs the aft holding tank pump out was shattered by the storage box under the bunk and needs replaced.

If the seal does not leak at rest but under power, there is not enough compression on the bellow. I would slide the stainless steel rotor aft 1/4" this should solve the problem. Visually there does not look like there is much compression on the bellow.

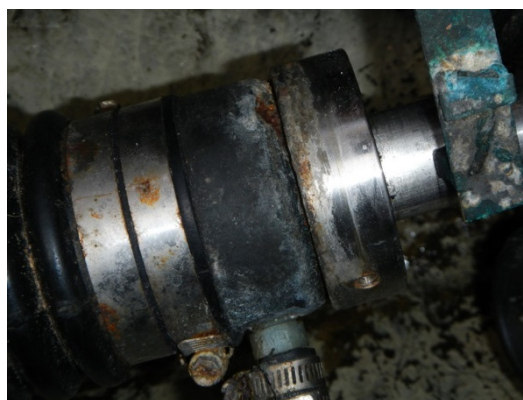
22 Oct. moved collar about 18mm aft. Set screw cups are worn and should be replaced as soon as I can find some replacements. Testing showed the seal still spraying water. Fred Hutchinson gave this advice:

It is normal for the carbon to move around, but if it is leaking while moving you more than likely have some oil or grease build up on the faces.

Take some 600 grit wet dry sand paper and fold it so that it is rough out on both sides. Pull the carbon away from the steel and slide the paper in between them and let the carbon pinch it in place. Then pull the paper around the shaft 30-40 times to sand away any residue. Then pull the carbon away again, remove the paper and let some water flush out the seal.

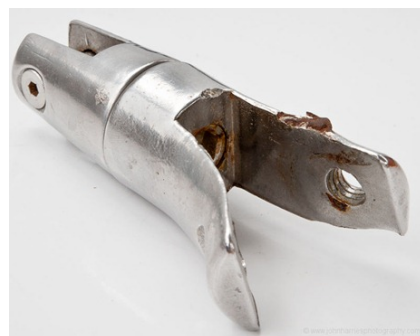
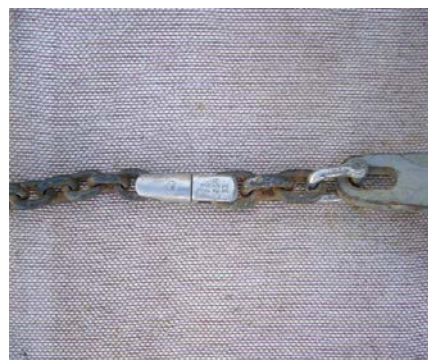
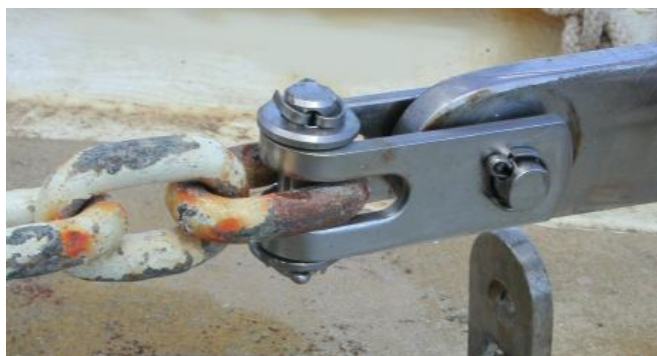
I have been looking into anchor swivels and what I read keeps reaffirming my belief that they are not a good idea. There are lots of stories of lost and nearly-lost anchors from failed swivels (see photo). When you re-set the anchor (or the anchor gets stuck) the pull on the swivel "ears" puts a big sideways stress on the swivel, prying apart the connector ears. Since most of them are stainless steel they work-harden and bend or break. 316 work-hardens more than 304.

Another attachment possibility is to use a rigging toggle, as illustrated below. Having thought about this, I would never do it. Consider the possibility of shearing the cotter pin if the anchor was dropped on a rock; or that the toggle was not designed for side loads and could spread, also shearing the cotter pin.

This is still not necessarily the best attachment to the anchor. Two forged (not cast) bow shackles are the best as they can handle loads from different directions.

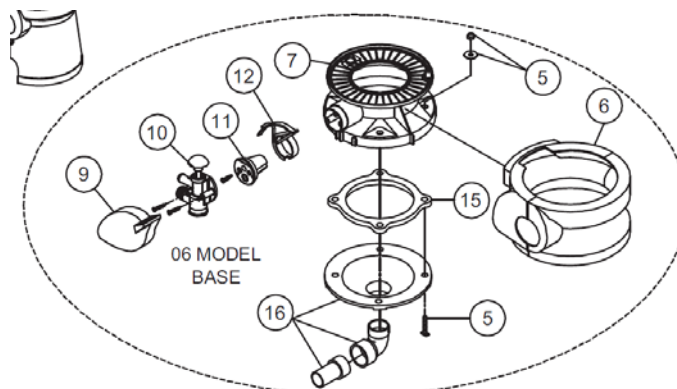
General clean-up and polishing of ball. The lever sticks in both the up and down position. We improved the down (flush) position somewhat but we still have the sticky up (water in) position. The curved portion of #12 pressed on the mushroom cap of #10. There is supposed to be enough freedom for the mushroom to return the valve to the neutral position, but it does not do that and stays in the water flow only position. It could be caused by any of the components. The Cartridge, Ball, and Shaft were replaced on April 19 of this year.

I talked with Tucker from Marine Sanitation and he agrees it HAS to be in the valve, cartridge or lever. I have ordered all three and some extra flanges. If the cartridge proves defective I'll return it for credit.

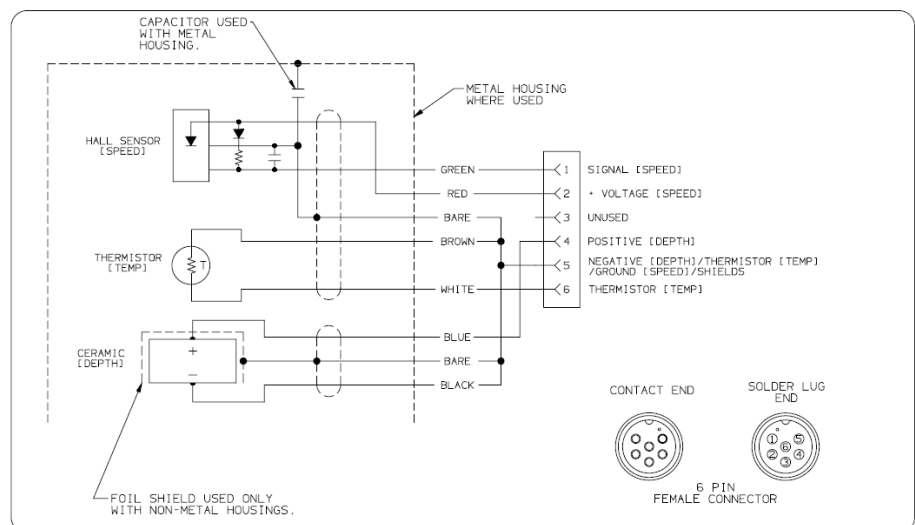
"I apologize for the faulty speed sensor (if that is the case).

That should not occur in a brand new transducer. In any case, the best way to determine if the paddle wheel is faulty is to use a volt meter...

wiring. This is the dc supply voltage from the display unit which must be between 5 V and 12 V. **MEASURED AT 8.44V (Ship volts at 13.3) (Mar 4)** Measure across green and shield (ground) on the sensor wiring and spin the . You should read a fluctuating voltage (square wave) between 0 VDC and your measured input supply voltage. **YES, FLUCTUATING VOLTAGE OBSERVED. (Mar 4)** Continue to measure across green and shield and slowly rotate the paddlewheel 1/4 revolution at a time. Each 1/4 turn should generate an on/off status as an output, i.e. 1/4 turn = 0 VDC, next 1/4 turn = supply voltage, next 1/4 turn = 0 VDC, etc. **NOT POSSIBLE IN WATER**

Connect the speed sensor to the speed display. Measure across red and shield (ground) on the sensor

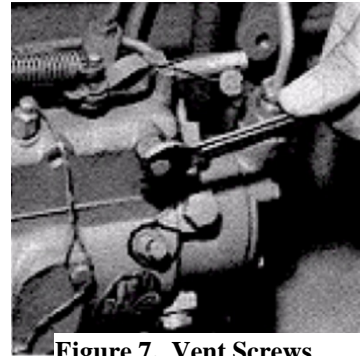
Figure 7. Vent Screws

- a) Unscrew by two or three turns, the vent plug on top of the fuel filter cover (not the return pipe to the tank).
- b) Slacken the air vent valve on top of the governor housing (hydraulic governor) Figure 7

- c) Slacken the vent valve fitted on the head locking screw of the fuel injection pump see. Figure 7
- d) Operate the hand priming lever on the lift pump (or use electric bleed pump) until fuel, free from air bubbles rises from each venting point.

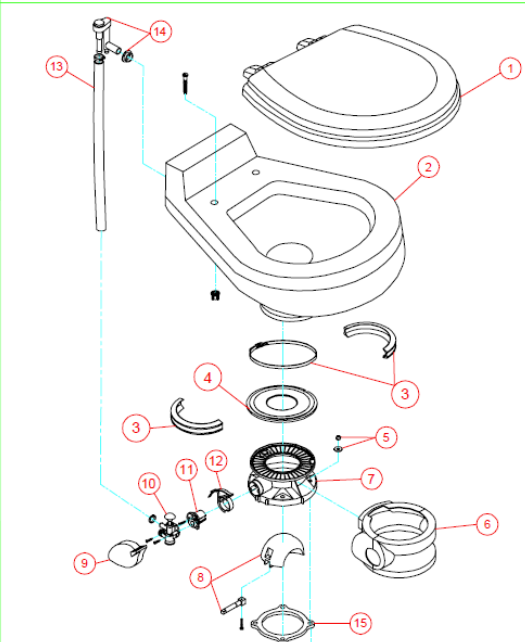
PARTS LIST: VACUFLUSH MODELS 1006

Forward Vacuflush toilet. It has not been holding the vacuum because the spring is not strong enough to return the cartridge. The cartridge was replaced in 2014. Marine Sanitation said they would take it back if the 2014 cartridge was faulty. It was. Besides that replacement we need to stock up on some other spares. The work done is shown on the diagram below: new seals, new floor flange, new water valve, new lever. An old ball was polished as the one in use is caked with scale and needs cleaning with muriatic acid. We are out of spare balls, so they have gone on the "to buy" list. The water is now retained in the bowl and the new cartridge has solved the return problem and the problem where the lever would not return to a closed position.

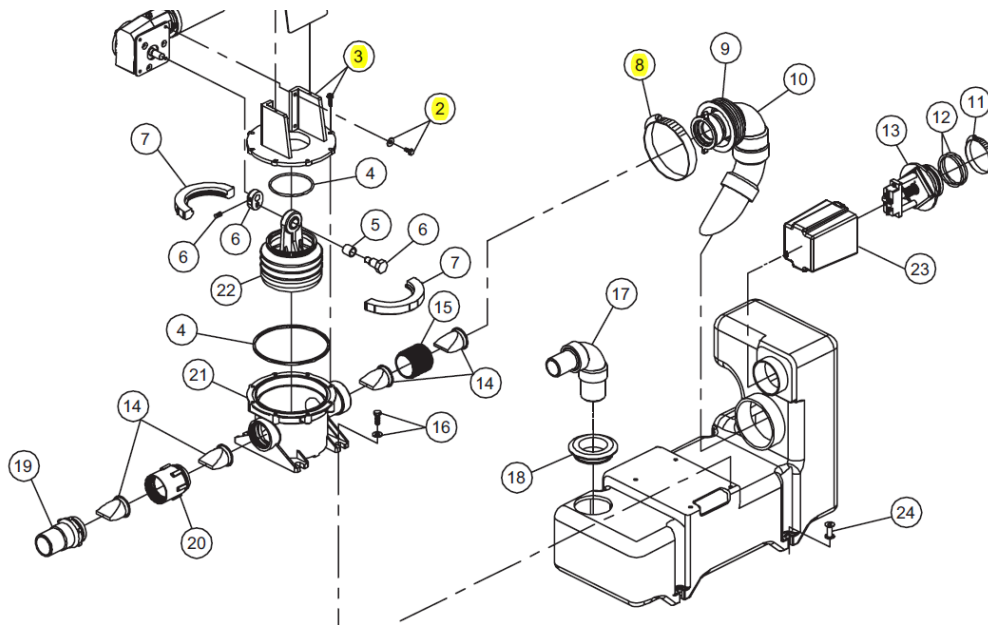
The repairs on the toilet fixed one problem, but the pump still cycles. We replaced all 4 duckbills on

the pump (#14), two of which appeared dubious. This did not fix the problem. Note that the hoses were not clogged. We then installed a new Universal Seal grommet (#18). This did not fix the problem. We then noticed two small cracks in the white sanitation hose from the toilet to the vacuum chamber (it connects to #17). This hose needs to be flexed to get to the pump to replace the duckbills. The cracks were on top and Rescue Tape was wrapped around to seal the hose. The pump now cycles every 30 minutes or so instead of every minute so improvement has happened. New hose should be purchased and saved until next time maintenance is needed. The size is 38mm (1½") and 750 mm long.

- Use flat food containers to catch the water when disassembling components.
- Remove hose clamps from hose coming from toilet to vacuum chamber.
- Pull pipe out of Universal Seal (18) to allow access to pump mounting bolts.
- Put paper towel in hole to prevent nuts/bolts from dropping into the tank.
- Disconnect vacuum hose from the toilet.
- Uncouple the pump from the tank (9) Unbolt the pump from the vacuum generator.
- Leave inboard bolts in place so the pump can slide out once the outboard bolts are removed.
- Use a pipe wrench to gently remove parts 19 and 20 and 15. Clean everything up. HCL may be used if necessary.
- Replace duckbills (14) and Universal Grommet (18) if necessary.
- Use thread sealant (Loctite) for reassembly.

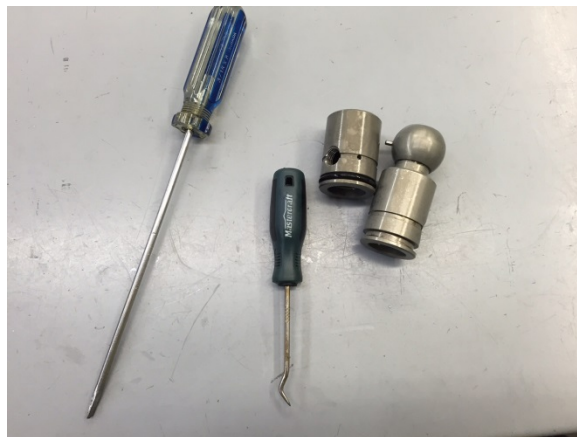
I know that this works because I just did both of the glands shown in the attached picture.

Regarding the longitudinal scratch – this is potentially serious – you must polish this out if possible. If not repaired; it will chew up your cup seals on the piston.

Completed seal replacement on the Octopus. Dave’s recommendations (above) were good but I found that 2 5/8” rigging pins from both ends of the glands would “pop” in the O-ring and Back-Up ring. It still was very difficult as the Back-Up Ring has a special side that must face the O-ring and be positioned at the correct end of the gland. The gland with the trunnion was particularly difficult. There were scratches both on rod and inside the tube that needed to be sanded & polished out. I used rubber cement to glue sandpaper to the plastic extension for the vacuum cleaner. It was just the right size. 320/400/600 was used on the tube and 400/600/1000/2000 on the rod.

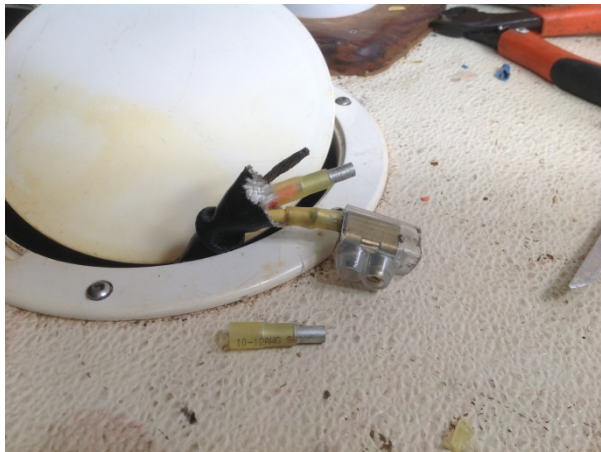
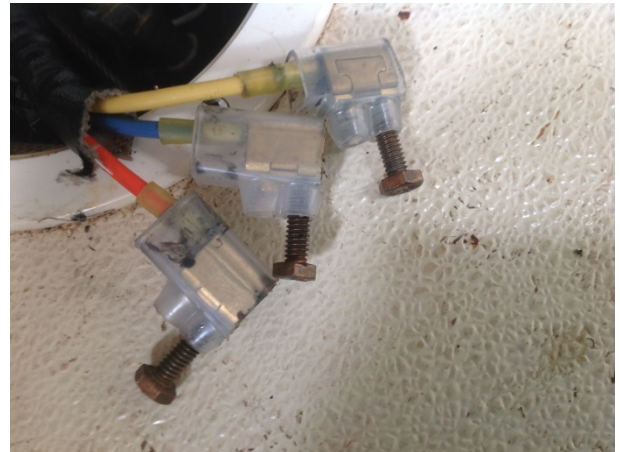
Back to refrigeration again. After my last discussion with Mark he said it felt like an electrical problem. So I went back to the connections and found them HOT, probably the blue wire, because it seemed to be the most heat-damaged. I trimmed the wires and re-made new connectors, like below. I took heavy duty connectors and heavy (yellow) butt connectors. I cut half the insulation off the pin connector and ran wire up the full length (I had to drill out the little boss in the center that is there to position two wires. Therefore the wire is squeezed both the crimp and by the brass connector. The end of the connector that is on the compressor power lug had the screw replaced with a bronze hex machine screw so I could use a hex wrench to tighten things. It's a big kludge but at least everything is tight and not heating up. I don't like the exposed hex heads but I can look for a plastic sleeve to cover them.

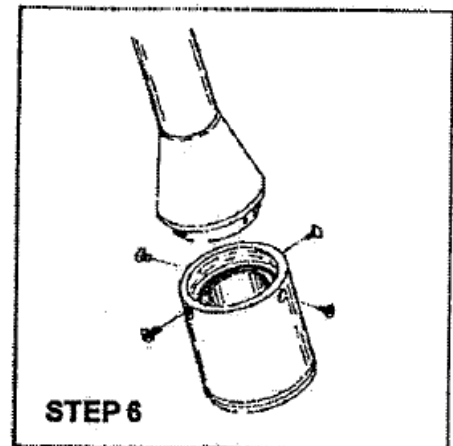
The ¼-20 flat head machine screws that connect the jib furler drum to the “torque tube” were all loose. They had been fastened down with TefGel as an anti-seizing compound but they obviously needed Loctite. They were re-installed with medium strength Loctite.

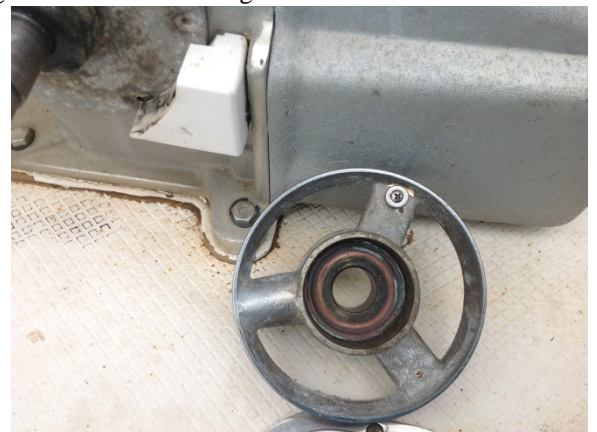
Today I hooked up the CH30 Chain Controller for the Lofrans Tigres Windlass and LO it works! UP and DOWN controls worked. The Hall Effect sensors tested good and all I had to do was replace the magnet in the Emergency Wheel. Instead of gluing a magnet on the outside, I tapped a spoke and screwed down a “doughnut” magnet (see right). This apparently works fine, but we will see how it works with re-calibration. While I was at it I serviced the cones on the gypsy. Also, the rope drum had a missing key for the keyways. I fabricated a new one from SS ¼” key stock.

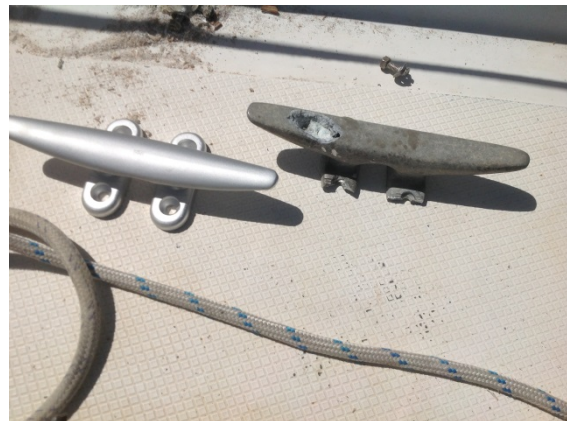
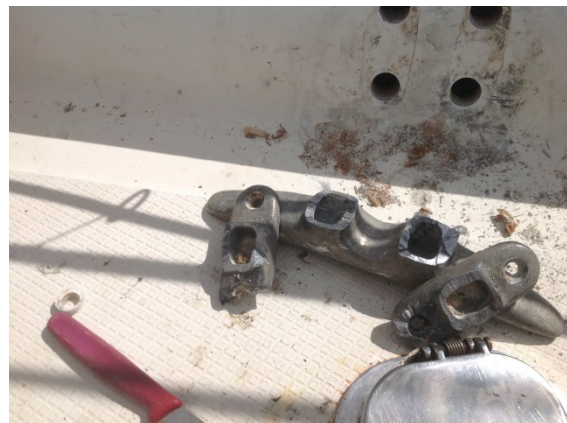
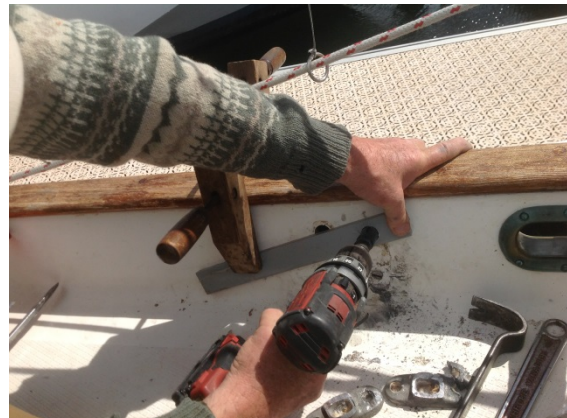
I now had 4 7/8" holes roughly corresponding to the new cleat's feet. I used a router bit and laminate trimmer to hog out some of the wood inside the bulwark. This is to allow the epoxy filler to have a solid base to press on.

fiberglass matting around the vertical sides and bottom edge of the square formed by the four holes. This is to restrict the flow of the epoxy filler. The area was wetted out with un-thickened epoxy (resin+hardener) 403 thickener was used to create a thick but still pour-able paste to fill up to the lower holes. After this had set up a bit (about an hour) a thicker paste (peanut butter) was created to fill the holes.

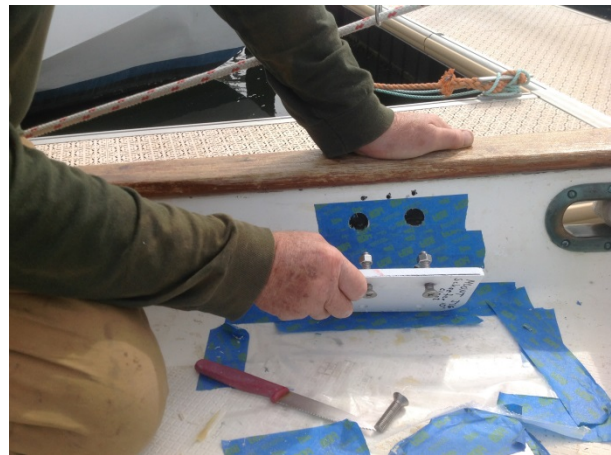
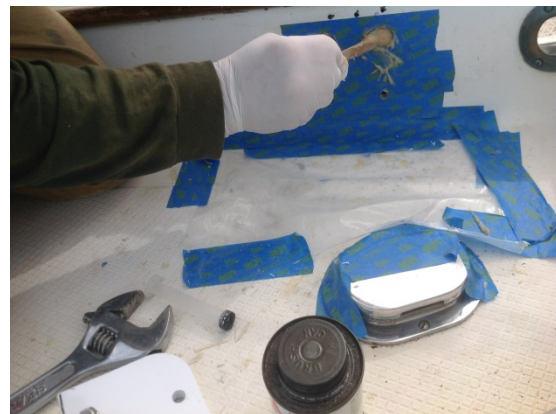
I added one 3/8" hole and two threaded holes to the grey plastic jig to assist in aligning the holes and setting the proper depth. The concept is to get one lower hole correct, then the jig aligns the second lower hole correctly, then the intervening space is filled from the open top holes. Last, the two top holes are filled.

Because the plastic jig is threaded I can use over-long 3/8"-16 machine screws with a nut on the end. I adjust the position of the screw so the nut at the correct depth. The screw is treated with mold release. When pressed into the filled hole the nut remains embedded in the hardened epoxy and threads are "cast" into the rest of the plug.

Grease the jigs with Silicone paste prior to use. Use masking tape to keep the squeeze out from sticking to the bulwark.

The three small holes at the top are used to inject a final fill with barely thickened epoxy so a syringe can be filled by sucking up the mix.

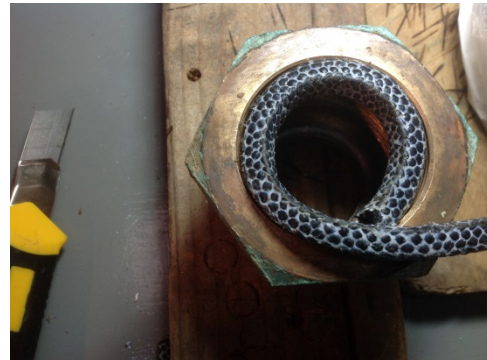
I worked again at the rudder issue. I picked off the useless sealant around the base of the tube and also test-drilled a couple of holes to confirm that the “shelf” appears to be solid fiberglass. Leaking appears to be mostly from the stuffing box. The stuffing box and lock nut are on top. There appears to be a thick bronze flange under the nut at the bottom.

Peter on Blackbird came over to help. He was sceptical at first because we were in the water but that was never a problem. The bilge pump wasn't even running continuously. We had some difficulty removing the parts. The stuffing box itself was removed with a pipe wrench. The locking nut (packing nut) was also moveable. I picked out the old stuffing, cleaned the threads with a pick, and repacked with the typical three rows of packing with the cuts offset by 120°. It was some effort to get the repacked fitting over the shaft and onto the log, after that we tightened it until it no longer leaked. We also used a bit of TefGel on the threads. We repacked with [Tefpack Synthetic Shaft Packing, 2' x 5/16"](#) and the leaks have stopped, at least from the stuffing box.

We had failed to move the bottom nut because there is NO WAY to swing a pipe wrench at the bottom of the threaded tube. I did note the nut diameter is 3" and I might look into making a special wrench for this purpose e of the nut to drive it in the direction you want to go. At first, I loosened the nut a bit, and then drove it as tight as I could.

Guess what! The rudder post tube no longer wobbles or has noticeable play. It still leaks, however, but I think it can be left, if watched and inspected, until the next haulout. At that time it could be replaced or repaired with a seal of some sort under that bronze flange (or spacer or whatever it is). Possibly a top bearing could be used instead of the stuffing box. At least it's not a problem now.

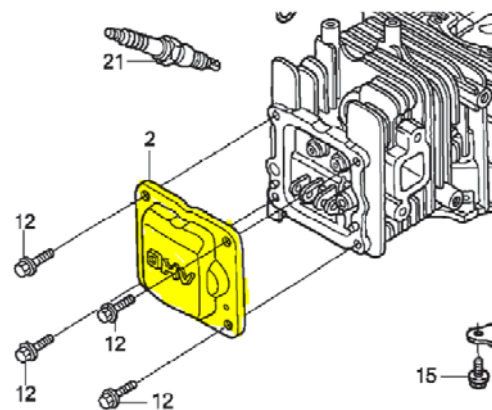
I talked with Graham at Brooklyn Yamaha and thanked him for diagnosing the oil leak problem. He gave me a part number (12311-ZVA-000-ZA) for the rocker cover and I have ordered a replacement from Callaghans Marine, also in Brooklyn, which was THE GUY I had thought we were with. So, it cost \$110 to diagnose the problem and I’ll try to fix it myself and maybe the engine will run some more. We also have the option of repairing and selling the old one and purchasing a new BF2.3. We will sail to Brooklyn and pick the part then.

The part was installed on 16 May. We used [Loctite 587](#) which is a “gasket maker” and appears to be similar to what was inside. It was tricky to remove and replace the cover and the vertical bars in the plastic casing aft had to be permanently removed.

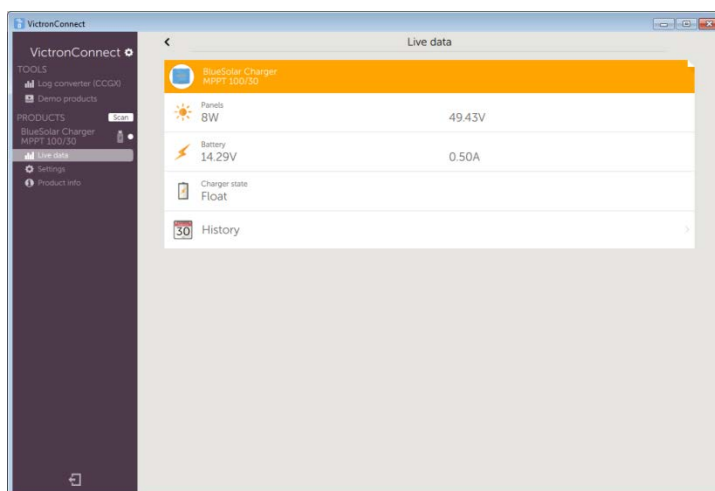
The MPPT is not letting any power through!

I manually shut off and restarted the unit. It spent a minute in BULK mode, then into ABSORB mode where after 1 minute it went into FLOAT mode, still showing the erroneous 14.55v. The panels show voltage so the problem has to be with the MPPT.

Note 19 October 2017: Warranty is being honored through Peter Blume at Federal Batteries. It is ready to pickup. Old unit will be exchanged.

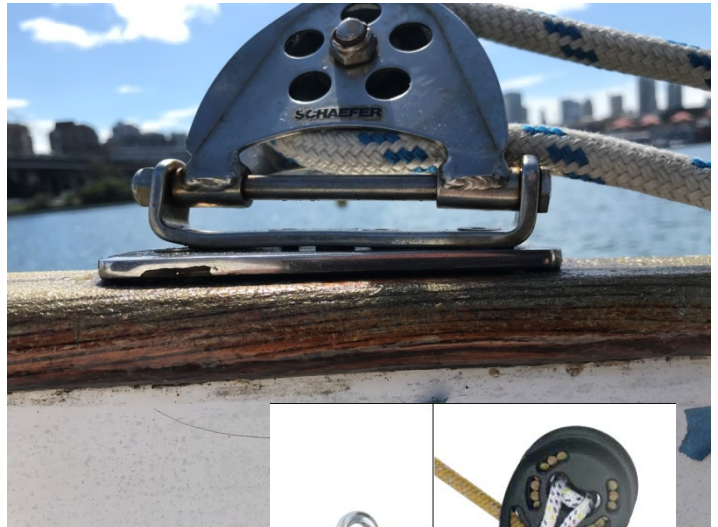
Today, actually much earlier in the year! we noticed a bent bracket on our starboard flip-flop block for the preventer. This is a Schaefer 32-17 with SWL of 3000 lbs (1362kg). I have written Steve Majkut at Schafer about a replacement bracket. I think if I can get new brackets they should be reinforced with a welded stiffener strip on the bottom. Original quote for the bracket was \$86, Steve came back with \$61 quote.! I think Jeff ask a replacement pin, too. Do not know if it is to be enclosed. ?

In the meantime I need to re-mount this block with the bent part aft as it is clearly the forward part of the bracket that is taking the brunt of the force.

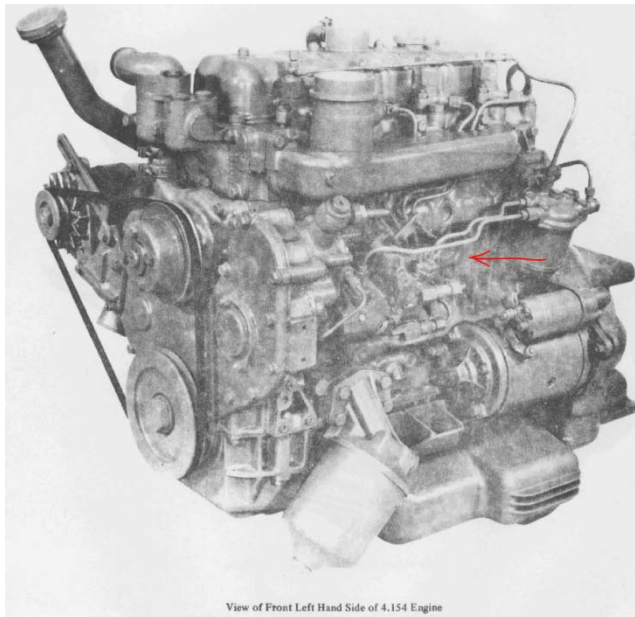
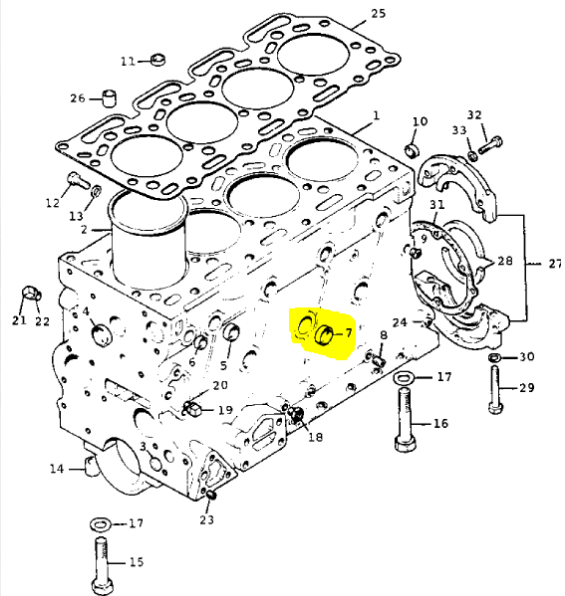
Big Trouble. Leaking coolant turned into a flood; perhaps 3 litres in 15 minutes. All of it ended up in the bilge. There is no contamination of the oil or white or black smoke. At first I thought it might be a blown head gasket to the outside of the engine but on looking closer I can see heaps of coolant escaping from the aft-most water jacket plug (#7 below, shows the middle plug). I don't know how one can remove the plug or replace it. It looks like a pressed-in part.

It was hard to take photos, but I have two showing the leaking coolant. One shows a chopstick pressed into the recess where the plug is. Part number of plug is 32418119. I was wondering if I can't clean it out and put epoxy putty in place.

It turns out this part is a “Welsh plug” or “Core Plug”; a common item found in all cast iron engines. The core plug is used to fill the sand casting core holes found on found on water-cooled engines. At the right is a picture of a corroded core plug. On our Perkins 4.154 there are dozens of these things, but the one that failed was in the coolant space on the port side. There are lots of YouTube videos on how to change the plug. I used a pin punch to “turn” the corroded plug and plucked it out with pliers. Just getting to the plug was arduous as it required removing a fuel line and the stop solenoid.
