***s/v Beatrix* Repair, Maintenance and Improvements Log**

**January 14, 2004
To
August 8, 2020**

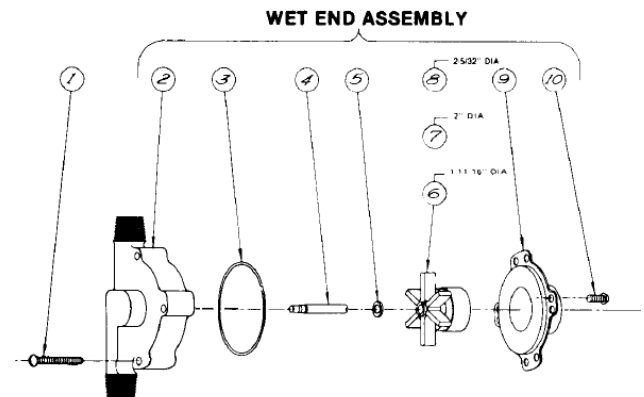
This pump is a magnetic drive pump; a rotating magnet drives an impeller/magnet (#6)

There is enough slack in the feed and output hoses to allow the pump to be pulled onto the floor without removing the hoses. Upon disassembly the shaft (#4) was found to be loose. It is a left-hand thread and was difficult to screw back in as some threads may have been damaged when it worked loose. The thrust washer (#5) was nowhere to be found as it probably washed away when the pump was disassembled.

The pump was re-assembled with a nylon washer which was necessary to have it run correctly. It was possible to test the pump without fully assembling the motor to the wet end; just manually hold the motor to the pump head. At first a very thin plastic washer was tried and the impeller was not rotating. With no washer it sounded like a washing machine full of gravel. With the thicker washer it seems to be working well. The water flow is measured at 1.8 gpm (7.5 lpm) which seems very low. This pump is supposed to deliver 5 gpm at this head; possibly there is some frictional loss in the heat exchanger. We are NOT having any over-heating issues.

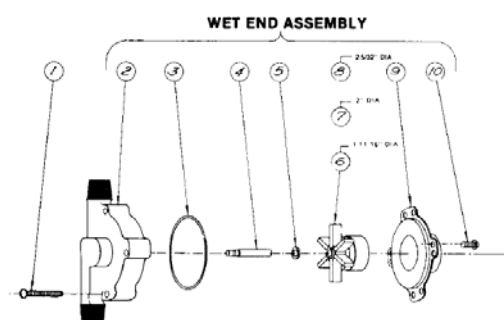
I had figured that losing prime was very unlikely so we needed to take apart the pump. The hose clamp worm screw on the intake side broke in place. The other three clamps came off OK. We attempted to remove the hose on the outlet side and it could not be pulled off or even rotated. Only cutting the hose would work. To remove the broken hose clamp would require cutting the hose. So we disassembled the wet end of the pump in place. One of the pump housing screws (#1) was chewed out and I had to drill off the screw head. All four pump housing screws were replaced with new SS 8-32 x 1" screws from stores.

There was a fair amount of corrosion on the back end of the impeller which was scraped off with a knife and then scrubbed clean. The O-ring appeared to be fine. We cleaned up any obvious discolorations, replaced the temporary nylon thrust bearing with the proper one (obtained from Depco pump) and put the wet end back together with the original rear housing screws. These were left loose and then, by cracking the through-hull open just a bit, the wet end could fill with water before the final tightening of the rear housing screws (#10).

The pump was then tested and we could tell that the pump was able pump water when run in either direction. It's a centrifugal pump so it makes sense. We reconnected the pump with correct polarity. I would have changed the gender of the connectors on one pair of leads except I did not have any large (yellow) crimp connectors, which is probably why the opposite gender method was not used in the first place.

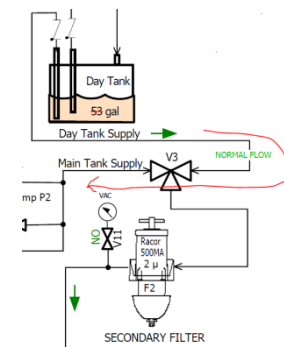
The "Day Tank Supply", which is the direct fuel line from the Day Tank through the manifold to valve V3, had no way of being bled of air. I was able to "crack" V3 while transferring fuel from the Starboard Tank to Port Tank allowing some suction to be placed on the Day Tank Supply line. The action was visible in the primary filter (900) which showed bubbles in the bowl flowing through the filter. This seemed to work as the main engine has run for 15 minutes without any problem.

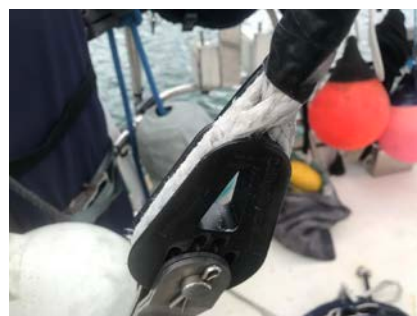
I had an email exchange with Colligo regarding replacing the Dyneema (Dynice) Dux backstay. It was starting to look "fuzzy" so I was concerned. John Franta at first offered a wholesale price if I returned the backstay for testing. After learning there was no chafe possible he sent along [this chart](#). It was new in January 2013 so is only six years

old. It should probably be replaced at 8 years old in 2021. John wrote “If its just UV 2 more years is easy. Chafe keeps exposing new material and that make damage penetrate. Damaged material is opaque to UV so damage is less internally.”

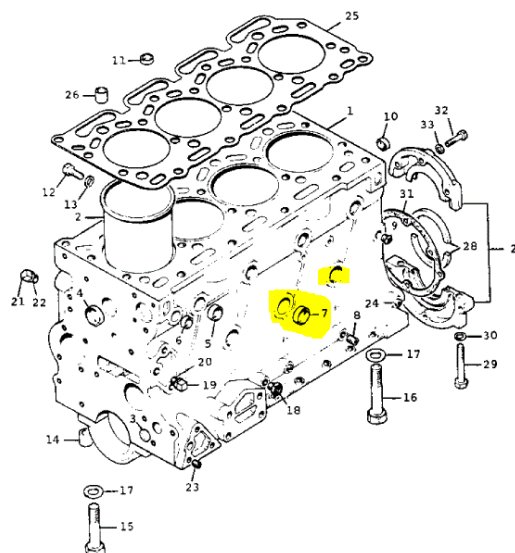
I whacked on the edge of the core plug to get it to "spin" in the hole but I must have done it wrong because it just popped inside the engine and in trying to move it around it dropped down inside. According to the Internet this is not uncommon and generally doesn't cause any trouble.

The diameter is apparently 30mm and I'll install it tomorrow.

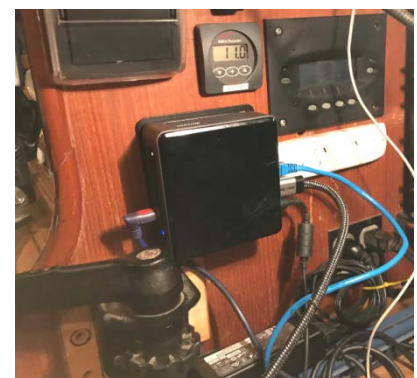
After final installation two monitors suddenly died at the same time. I think it might have been that the 2x2 Matrix switch which is a 6v powered switch may have gotten plugged into 12v. Or a power surge came along. Or something.

So... two dead monitors. I bought two new Samsungs 2 days ago but now get to return at least one because I just found out that the newer of my two old monitors is under 3-yr warranty with next-business-day advanced exchange from Dell. Wow. I also found an app that converts our ipad into a second monitor through a usb port. All very good.
I also found an app that uses the iPad as as primary or second monitor when wired up to a USB drive.

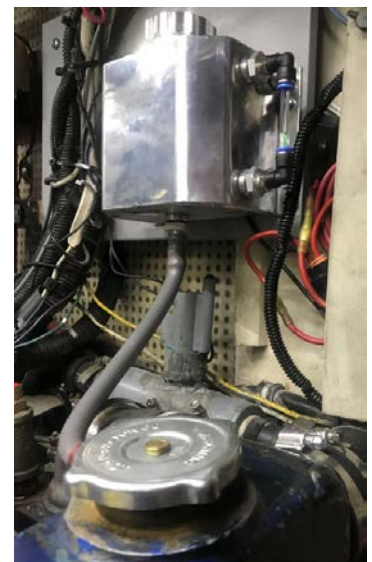
Installed new aluminium 1L recovery tank. This works with a Gates 31348 Radiator Cap designed for coolant recovery and set at 7# pressure. The original cap was set at 10# pressure but the now removed header tank had a 7#

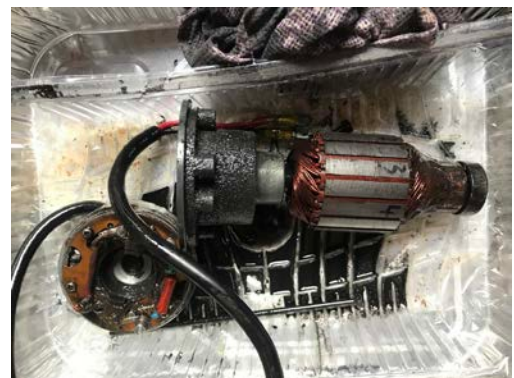
Today we took apart the Octopus 1212 hydraulic pump/motor. The Lip Oil Seal is compromised between the pump and motor. It is wobbly (I don’t think that’s normal) and the motor was full of burned ATF. We cleaned it up and I suspect the motor will run. I have written Jonathan Ingente at Octopus to see what we can do. It is certainly feasible to replace the Oil Seal. (6/6 It is best to buy a whole new assembly @ \$552; Jonathan is sending a new lip seal so I can try to repair our defunct motor/pump.

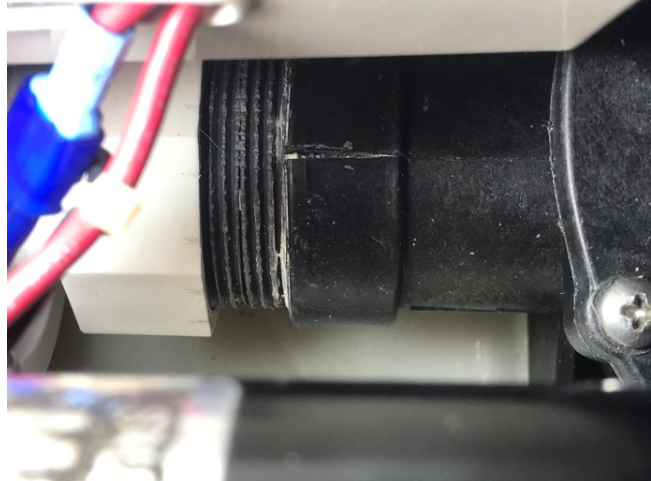
I have asked [Marine Sanitation](#) if the cracked body could be the culprit.

If so, I'll need a new pump body, threaded plastic nipple and pump cover.

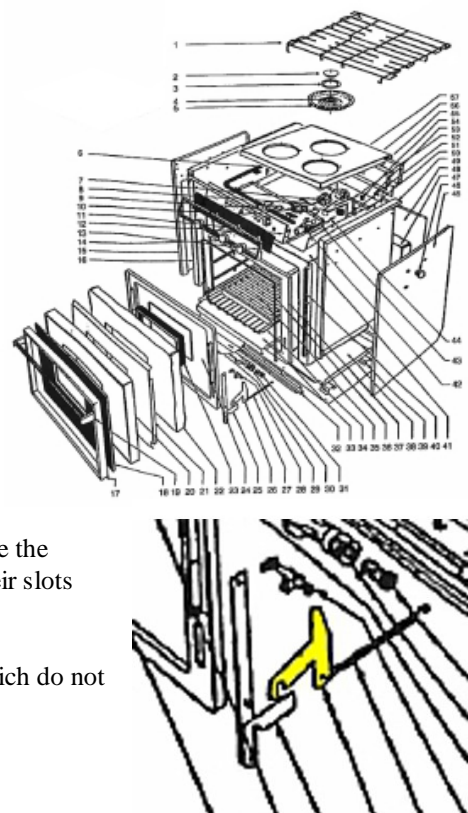
Of course we had to remove the grab bar and all hooks which were in the way. The oven was emptied of all racks and stowed cooking utensils. The knives were removed from the knife rack. The grating, the stainless surface, the burner caps rings were all removed. The companionway steps were removed. The oven door was removed. This is quite easy if procedure is followed: open the oven, put keeper pins in the holes in the spring arm, release the spring arm from the oven door, and slide out the door. The lower hinge arms fit into built-in slots inside the oven. When re-installing the door these arms **MUST** fit in their slots or the door does not hinge properly. See image at right.

Both springs were replaced with new springs.

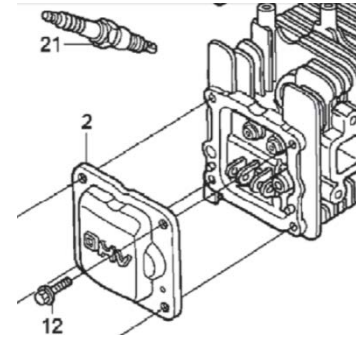
The Honda outboard is leaking oil excessively and it drips down the ventilator grille at the aft of the engine. Both Kathy and I remember this being a problem on a former Honda BF2D outboard, probably the third one. Servicing on the current outboard in May 2017 shows a diagnosis of leaking rocker cover (head cover). The Head Cover is steel and had rusted out. He almost convinced us to buy a new outboard as the cost of disassembly just to get to the Head Cover was as much as a new engine. The part, [12311-ZW6-010ZA Cover, Head *NH105*](#) (#2 at right) cost only \$12. Since I was willing to deface the motor cover and CUT OUT the grille, it became easy to install a new valve cover. Oddly this event is NOT recorded in this log as I must have forgotten to write it down.

Loctite SI-587 Blue Maxx gasket maker was used to seal the cover in place. I could not find a valve cover gasket

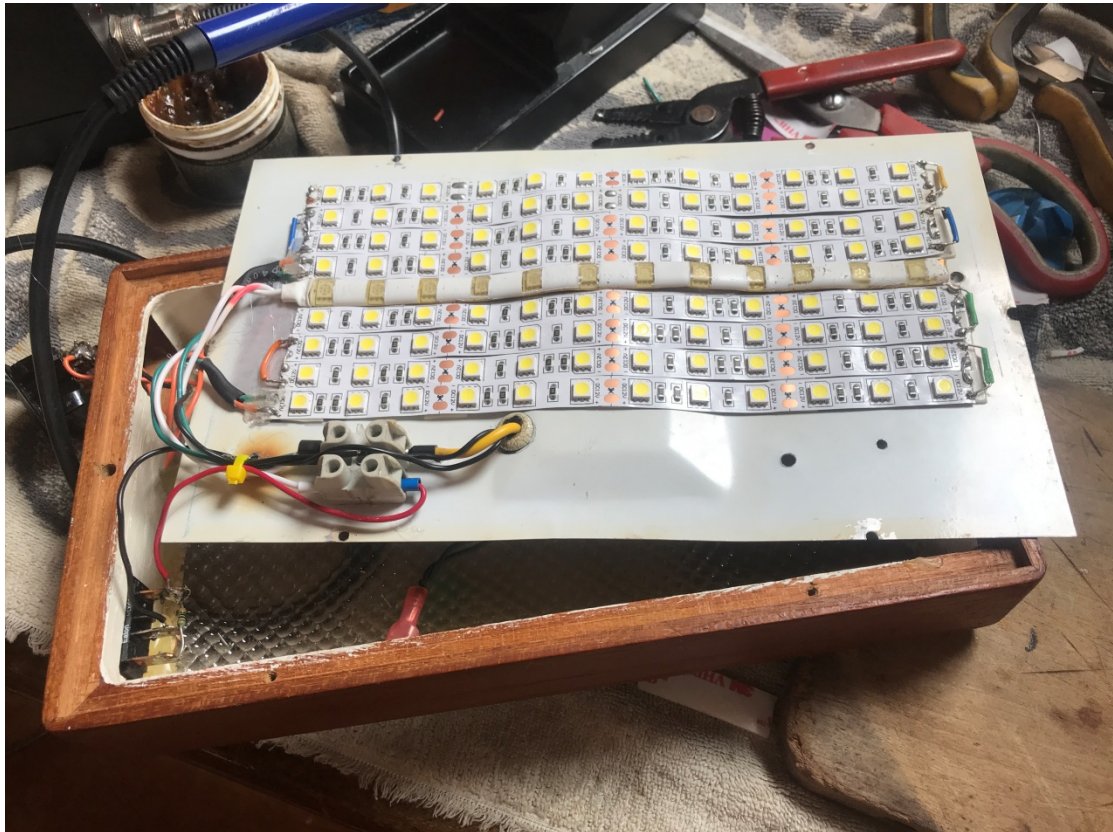
The overhead Alpenglow cabin light for the galley was rebuilt to include 8 rows of extra bright white LEDs which is what Kathy wants in the galley. The BRIGHT/DIM switch now enables either 8 or 4 rows. We love the super light we get. A single row of red LEDs is enough for night lighting and is also switched with a BRIGHT/DIM switch.

Warm LEDs are fine in the main cabin but over the galley workspace we want lots of light. I think I should do the same with the Alpenglow over the dining table, only make the second bank of LEDs warm so we can choose. Soldering the LEDs in a single parallel string helped keep the wiring down, only it is, of course, now more vulnerable to a single failure. The LEDs are not waterproof and are fastened directly to the metal base plate with strips of VHF bond. Another method would be to use hot glue. This would be a good method; if removal was required a heat gun easily warms the glue to where the strip could be removed.

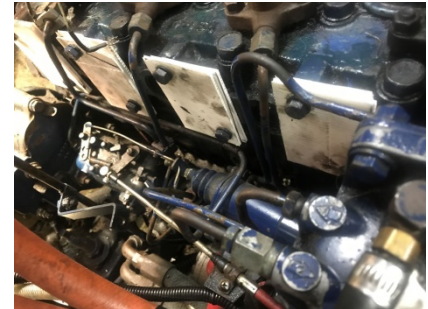
The CAV Pump has been removed without too much drama but lots of hard work and some blood in the bilge.

In order to reach the CAV pump fasteners it was necessary to remove the air intake manifold, the small alternator, the stop solenoid and bracket, and all drive belts for pumps and alternators. A great set of videos by [Bundy Bears Shed](#) told us what to do to remove the pump, preserve the timing of the injection pump and finally remove the drive hub to allow the seal to be replaced. It is possible to remove the pump without disturbing the timing. With some exceptions noted below this [Bundy Bear Video](#) was our guide.

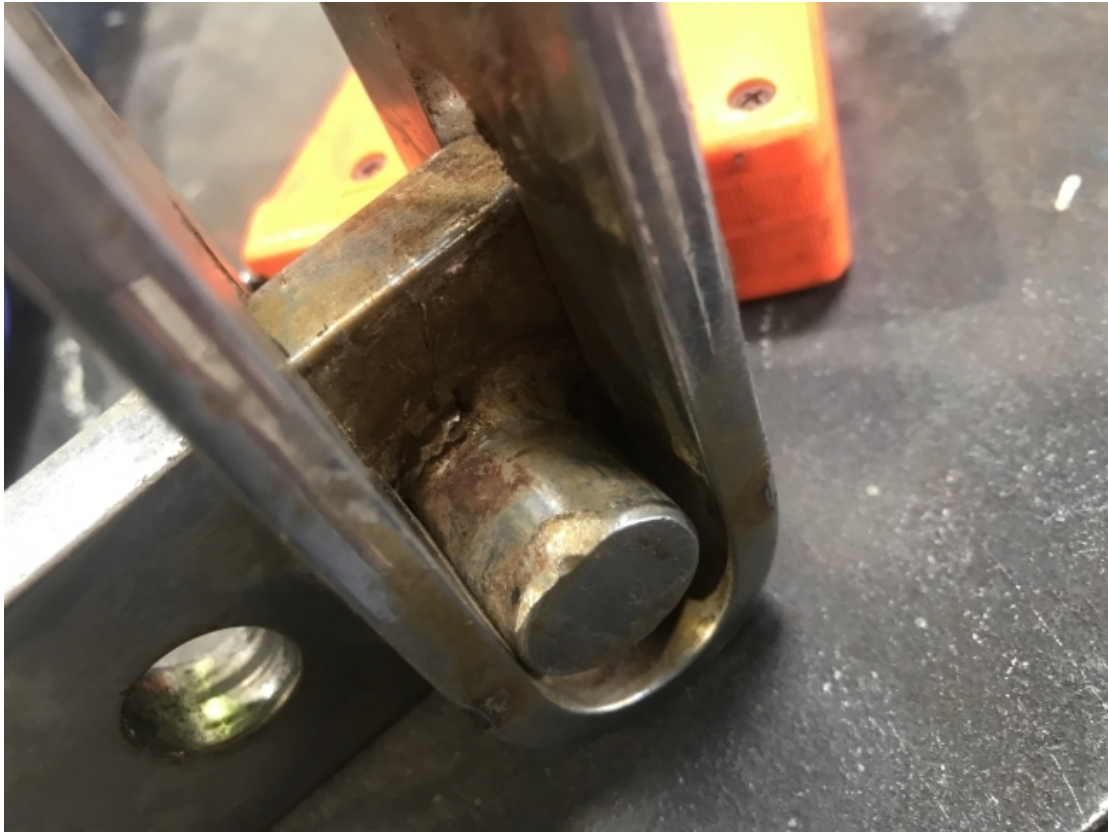
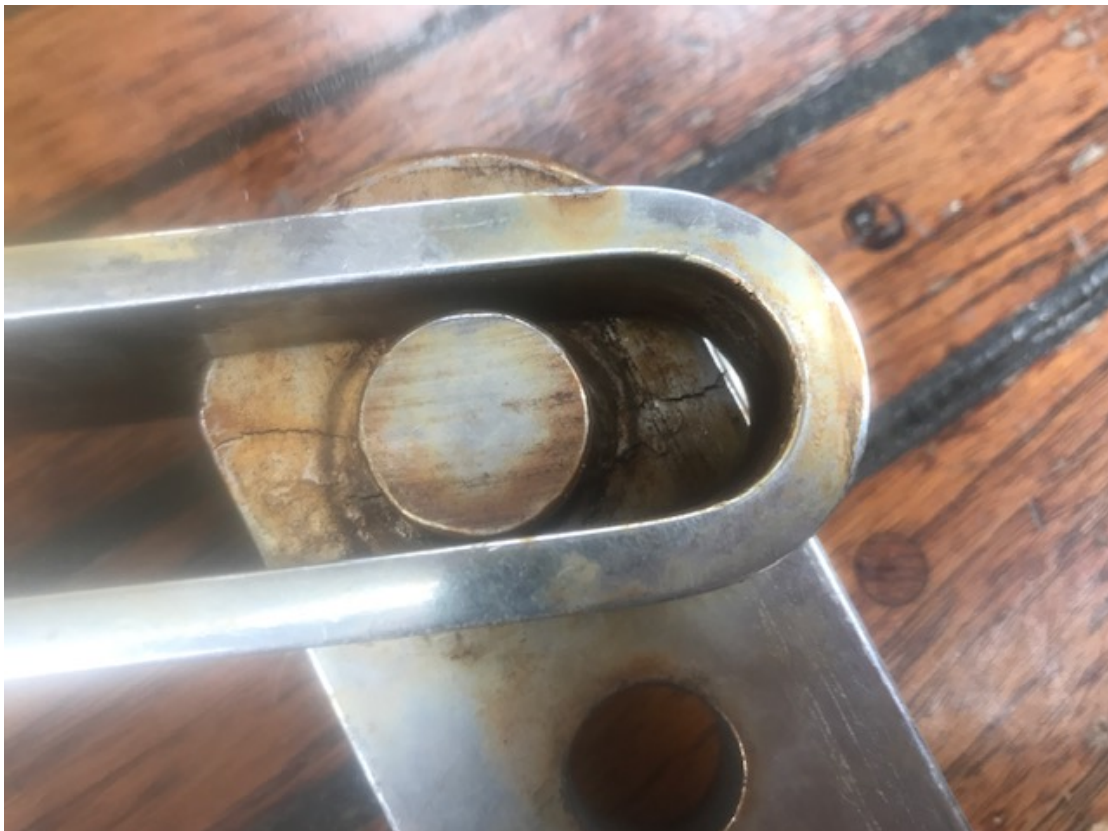
In removing and inspecting the Schafer 3100 roller furling we noticed hairline cracks in the toggle link at the pin; some of them are all the way through the metal. I cannot believe this is due entirely to stress; this steel link is $\frac{1}{2}$ " x 2"! Further inspection showed that the welding process left deep grooves in the both the link and the pin. Possibly overheating of the unit caused it to be more brittle through "heat affected zone failure".

A new toggle link is US\$400. Ouch! And this on top of \$400 excess I owe to the Marina for damaging their Courtesy Car. We can have a custom toggle link fabricated here in Hobart for about AUD350. Below is the design drawing for the fabricator. The 14.5" (11.5"+3") pin-to-pin measurement is the same as the former string of toggles.

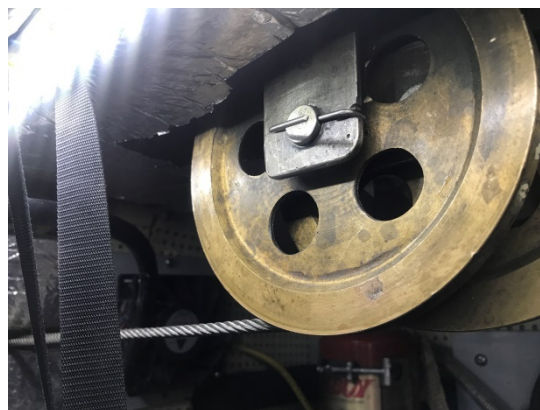
Work on the steering system has been completed except for checking the chain and sprocket in the binnacle. We inspected and lubricated all wire. Clevis pins in the engine room (and maybe elsewhere) rotate in the bracket holes instead of the sheave rotating on clevis pin. I also found that clevis pins are both expensive and vary widely in diameter. Note that two marine engineers say that mild wobble is fine. No need to re-bush. Both did NOT recommend using Dyneema for steering cable. However, clevis pins rotating in the bracket holes are not good. My solution is to use a stainless welding rod or bronze brazing rod in place of the split (cotter) pin. A sharp bend in one end fits into a notch ground into the bracket; the other end is bent over to hold it in place. We lubricated all sheaves and pins with light oil and sized the pins to individual sheaves. The steering tension was tuned as per Edson instructions.

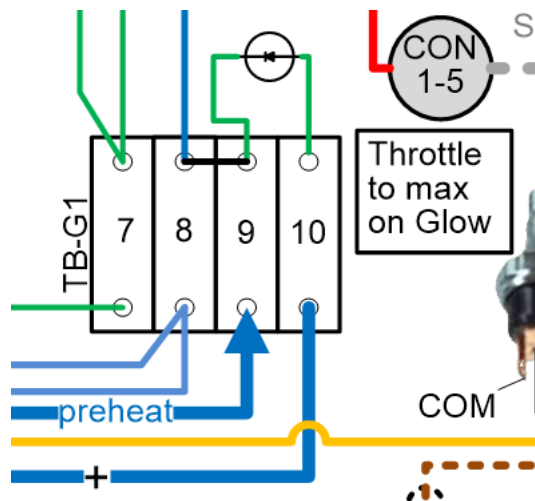
Discovered possible error in Generator wiring, but it doesn't seem explain inability to DECR the engine speed. It does appear that the preheat function would not have worked.

Testing EXISTING shows that aft control GLOW switch does increase rpm to max. INCR/DECR on aft control box is working (at least at first). On Control Panel, DECR is now working, but INCR does not and GLOW may not be working.

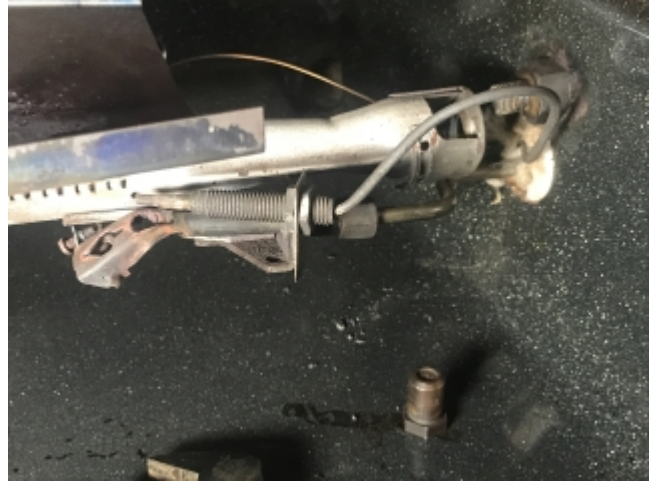
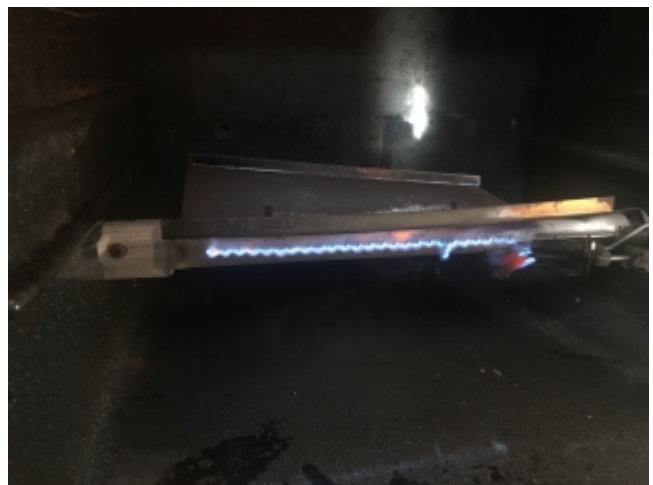
Two days ago I called Todd at SureMarine to talk about why the oven was not heating up. He referred me to the oven repair instructions from his website with the implication I should have just RTFM. In all fairness the problem turned out to be the main gas fitting which comes through the oven wall and is shown sitting on the oven floor in the image at right. The instructions do not even mention that fitting. I could see some obstruction in the tiny hole and after cleaning simply reassembled the whole thing. It did not appear there was any problem with the pilot. After reassembly it lit up with a good flame and the oven reached over 450°F so a great pizza and bread were made that night.

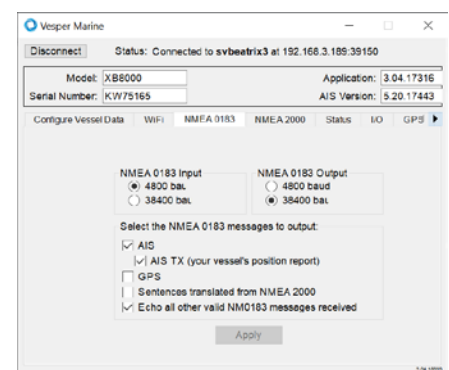
1. Left the anchorage and found the TRIP distance had reset its units to KM instead of NM.
2. DEPTH dropped out and came back after a while.
3. FLASHING “Time to Next” field. Fixed by resetting XB8000 as at right.

Disconnecting SONAR and rebooting had no effect on fixing the missing DEPTH. The change in UNITS configuration for the GPSMAP is suspicious.

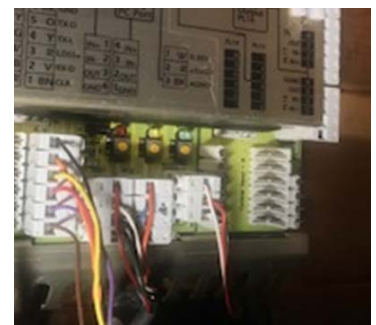
The Cetrek Autopilot stopped working, again. The control head would not turn on the system. I opened the a/p computer and pressed the middle button (at right) which is the ON button. A green lamp lit up. The left button turned the wheel to port; the right button turned it to starboard. The control head started working with the press of the ON button. Installing the lid caused the system to fail. Removing the lid and carefully replacing it caused the system to work again. Possibly there is a loose connection or a split trace? I don’t know.

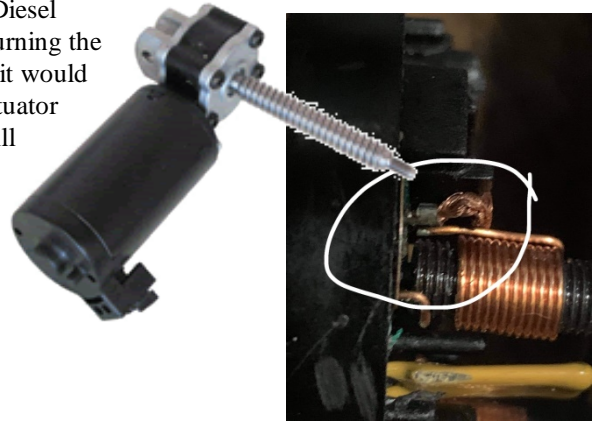
I finally fixed the throttle control issue with the Kubota Diesel Generator. I removed the motor but left it connected. Turning the motor one way – it would work; turning it the other way it would not run. It turns out there was a loose wire inside the actuator motor which had come loose from the circuit board. I still replaced the motor with a spare on and will keep the broken one if I need it later as it is possibly repairable. I suspect the heavy vibration from the diesel engine contributed to the problem. If I find the time I could “pot” the circuit board to strengthen and stabilize the board and connections.
