Failed Blister Repairs

A Case History and Solutions

by David Pascoe

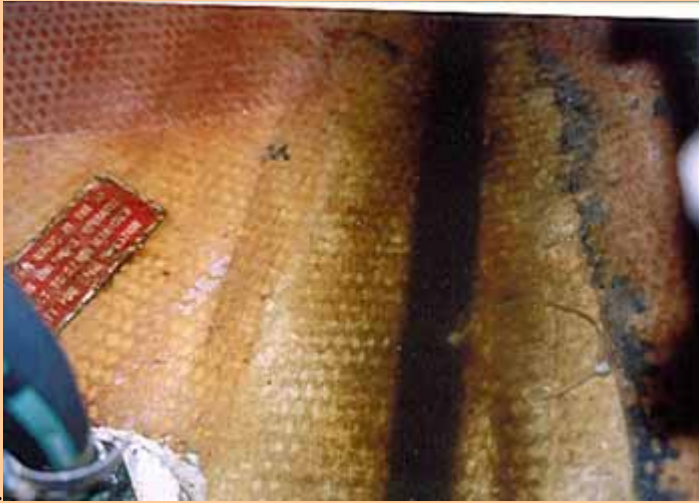
2.

Photo #2. This is one of the most graphic illustrations you will ever see of differing rates of water absorption in various areas of one hull. This is looking straight down at the centerline bilge in the forefoot where a bit of black water lies at the bottom of the vee (the black vertical line). The yellow section at the center is a separate layer of fabric which has absorbed far more water than the surrounding laminate and turned yellow. Whereas in the upper part of the photo, you can see a different layer of fabric that is pinkish and is not as opaque, meaning that it has absorbed less water.. Notice that the coloration is the exact opposite of that in photo #1, where it is only the tabbing that remains pink and translucent. Since both sections of laminate are equally hard, most likely what this is telling us that two different kinds of resin were used in this lay up. Because of the hardness, cure rate does not seem to be a factor as it is in many cases.
