# Avoiding the Blister Blues

Good Detection and Communication Techniques Critical to Avoiding Complaints

by David H. Pascoe, Marine Surveyor

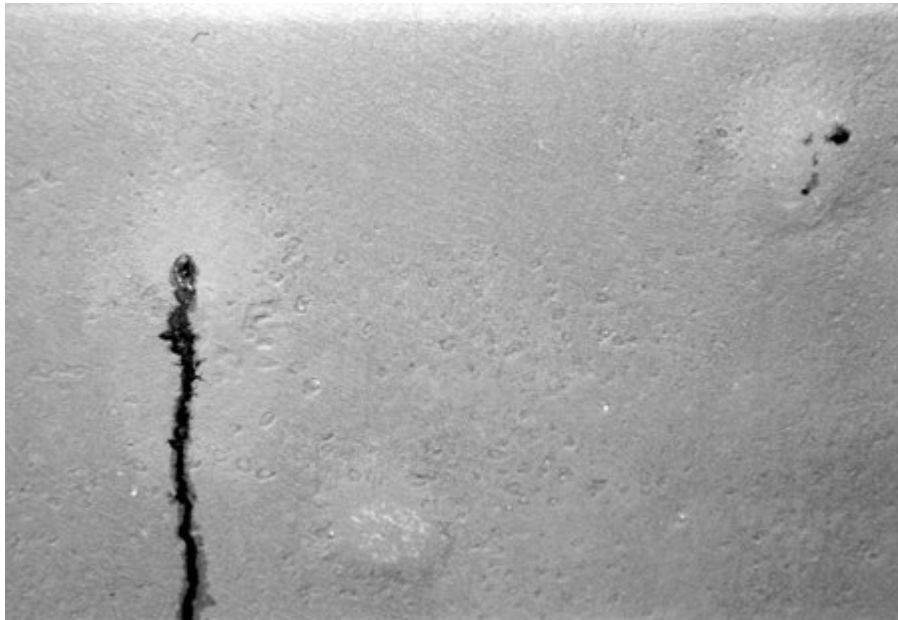
**There are three blisters appearing in this photo of a boat bottom which is very clean and smooth. Two of them are easily revealed by the fluids that leaked out after the boat was sitting for many weeks. But the blister at lower center is barely visible. All of these blisters were highlighted by good artificial lighting used to take the photo. Without that lighting, and absent the weeping, it would have been very difficult to locate these blisters. After wetting down with water, they became much easier to see. If the bottom were dirty, it's not likely that they would have been located.**

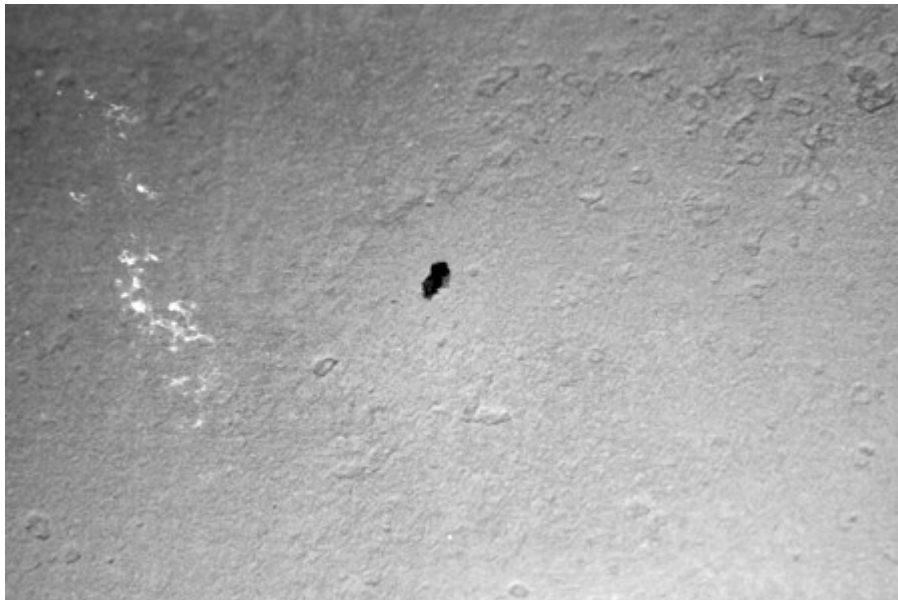
**Without the dark weephole to announce its presence, this blister is not visible under ordinary conditions. It has very little raised contour and is only slightly revealed by a strong light played across it at a low angle. Yet tapping it with a coin clearly reveals the separation of the gelcoat by sound.**

**Sounding** Sounding a hull is an audible technique that requires a high degree of skill and finesse. We've seen surveyors attack hulls with a plastic hammer as though they were driving nails. That may turn up a severe delamination, but its not likely to reveal a small blister. Our experimentation with plastic hammers have determined that these are far from the best instruments to use to detect smaller flaws. For one thing, the impact surface is too wide. For another, plastic against plastic is not a very good combination for getting the best audible result. Blisters are most responsive to a small piece of metal, preferably steel, about the size of a silver dollar. Very light tapping with an instrument of this sort will do a much better job of audibly revealing differences in laminate thickness, particularly blisters.

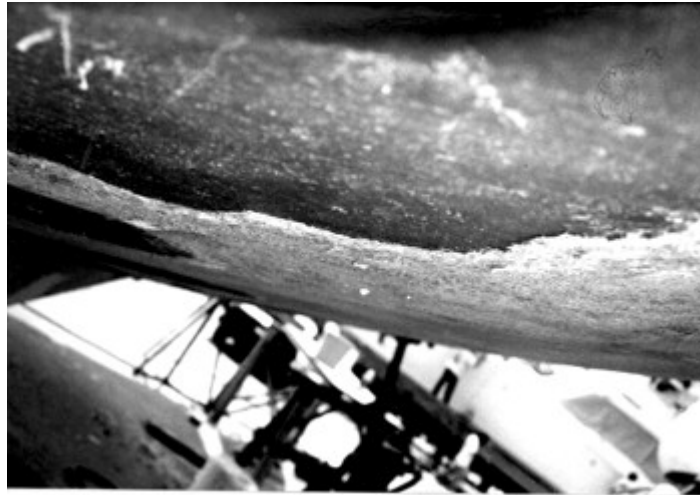
**This is an example of severe ply separation. The peeled away ply here measures about 3 feet across. In this case the skin out mat was so dry that there was little bonding to the inner structural laminates. The whiteness clearly indicates how dry it is. This allowed the interface between the two plies to fill with water. While this is an extreme example, incomplete bonding to lesser degrees is commonplace. To make matters worse, it was not detectable by sounding, although there was a bit of a warning sign in that the whole hull sounded somewhat "dead." These were not blisters but water filled ply separations that do not appear to have been initiated by osmotic pressure but rather enhanced by it. Scraping with a knife below the gelcoat easily revealed the dryness of the fibers.**

**Lamination Problems** Boats that display extreme numbers of, or numerous and very large blisters may be suffering from more than just water permeation through the surface coating. My studies of hundreds of blistered boats reveals that many boats that display very large blisters are also suffering from secondary bonding failures. Bonding failures that result in blisters usually occur between the gelcoat and skinout mat, or the skinout mat and the first layer of structural fabric, usually roving. The failure to bond can be due to environmental conditions (temperature and humidity), contamination, or excessive delay in the layup process. Whatever the cause, the result is an incomplete bond that provides an ideal environment for very large blisters to develop. When a vessel has numerous large blisters, secondary bonding problems should be suspect. For a more complete discussion of bonding failures, see article titled *Blisters Again?* on this site.

If the bonding of laminate is weak, you may be able to separate the skinout mat for very long distances, in which case you've got a serious bonding problem that no commonly accepted method of blister repair will solve. To remedy the situation, all of the loose laminate will have to be stripped off.

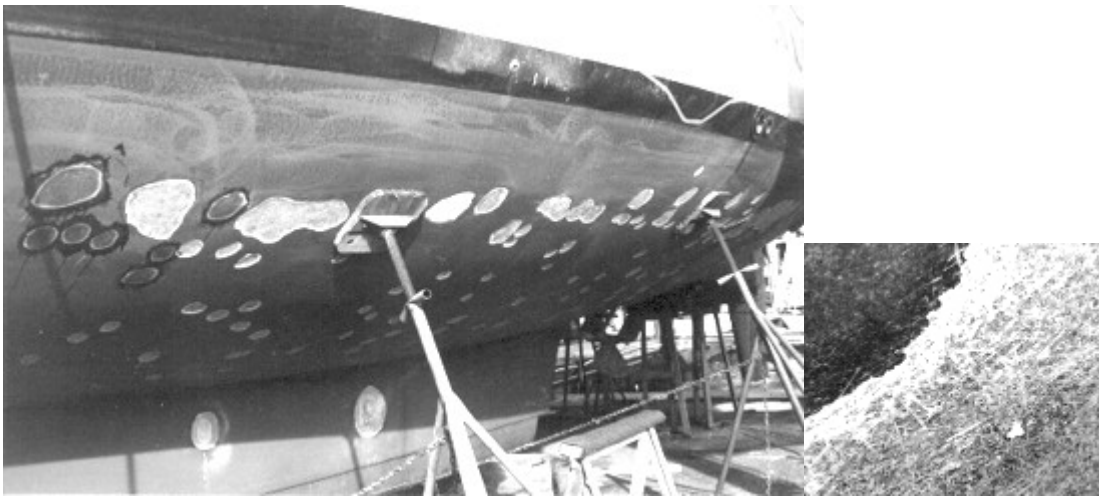
**Notice on this hull how the blisters run along a band about one foot below the waterline. Also note how they appear in clusters lower down on the bottom, and that some areas between clusters are not affected. Examples like these prove once and for all that blistering is not merely a function of material, but also a matter of the quality of the layup. On this boat, the areas of blistering are not random but area-specific and directly related to permeability of the laminate due to imperfections. Once again, the skin out mat was found to be poorly saturated. Photo at right contrasts the dry mat against the fully wetted out structural laminate.**

Since blisters do not always show up evenly over the bottom surface, but can appear in clusters or bands, it is probably best not to attempt to give an exact count, but rather to determine the density and state the condition in terms of *maximum density*, but not attempt to indicate specific sizes or locations. Attempting to describe the size of the area and specific density can be difficult and dangerous. This way, if the blistering spreads rapidly to other areas, the surveyor won't get caught short. In other words, it's better to overstate than understate.
